QUARTERLY AMBIENT MONITORING PROGRAMME FOR BIRKENHEAD WORKS

COMPLIANCE DATE: 31/01/16 – Quarter 4, 2015

EPA Licence 1126

Licensed site: Adelaide Brighton Cement, Birkenhead Works
 62 Elder Road, Birkenhead, SA 5015

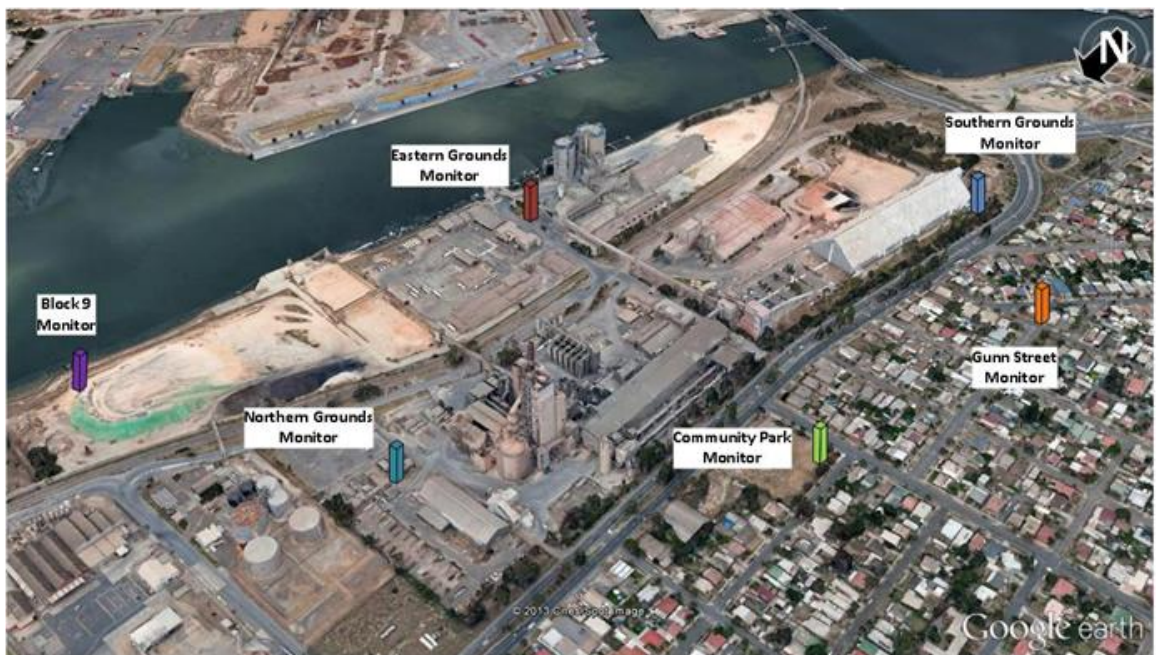
- *Map showing sampling locations, major infrastructure, sensitive environmental receptors, and north arrow*

Sampling locations are indicated by colour coded dots on the above map.

NB: Four sampling points are located on the Birkenhead Works site; the other sampling points are in the community (corner of Gunn/ Well streets and Community Park).

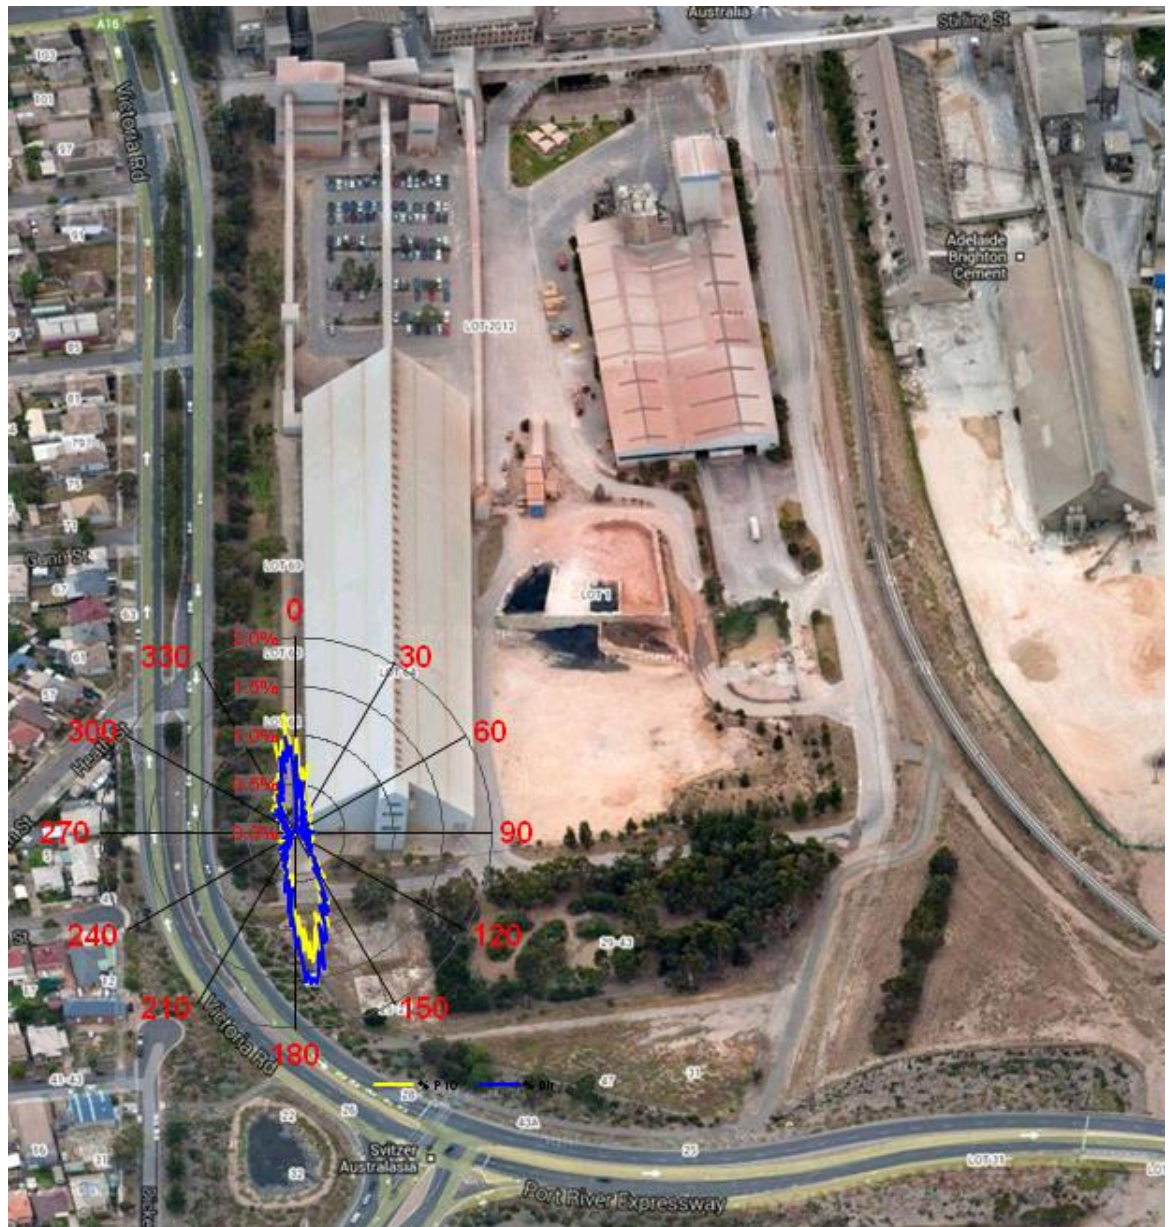
Southern Grounds Monitor

The Southern Grounds reflects data measured from all of the fourth quarter.

This is the third full quarter since the installation of the canopy system covering the MM stockpile area and the foam suppression system on the loading hopper (both EIP projects). The wind plot implies low dust levels for this quarter and is similar to previous reports.

Dominant winds were southerlies and northerlies. Very low levels of PM10 fugitive dust were mostly captured from the north direction.

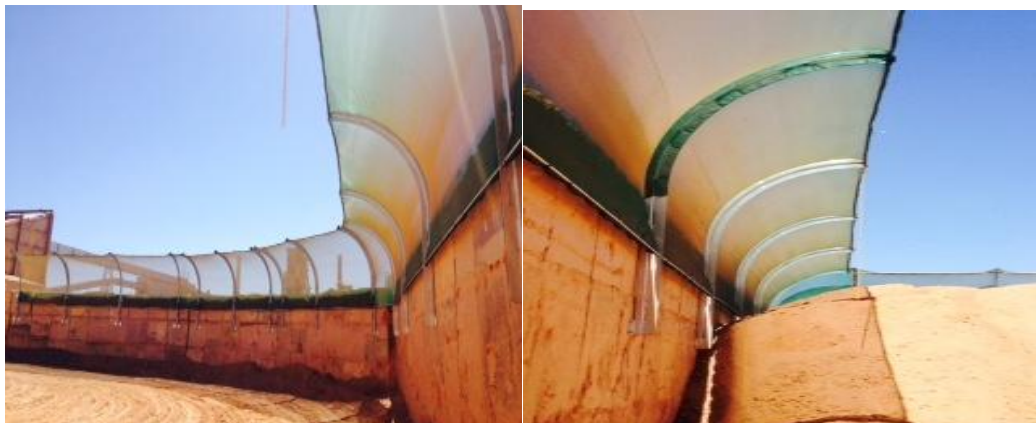
- Installation of foam mist spray system (EIP project) on the MM tipping loading hopper was installed and commissioned in late December 14
- **Fabric/Mesh canopies** were installed at the fringe MM system on top of the concrete bunker walls in March 2015. This will reduce the tendency for dust to become airborne when loading/unloading material as it acts as a wind break. This is an EIP project.

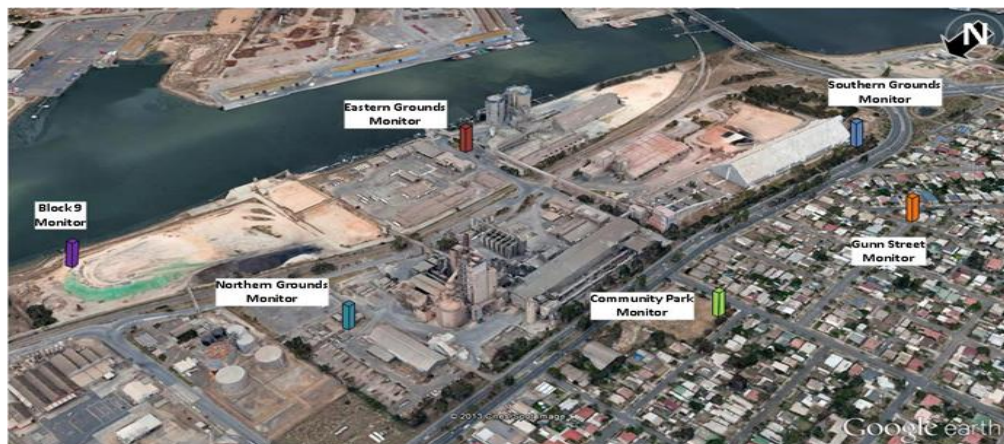
- **Standardisation of Ambient air monitoring network**

- Four of the older generation ambient air monitors were replaced during quarter 3, 2015 with current generation systems as used on Community Park and Block 9 area (2013).
 - The older generation models were Osiris monitors (Northern Grounds

and corner of Gunn Street) and DustTrak 8520 (Southern and Eastern grounds).

- The older generation monitors were over 10 years old and suffered from reliability and integrity issues
 - Several break downs resulted in periods of data loss throughout the years.

- Two of the older DustTrak units also had no wind measuring capabilities and required extrapolating wind conditions to the other monitors.
- All monitors are now the DustTrak TSI DRX model
