South Australia's Environment Protection Authority

Beverley Community Working Group

Tuesday 17 May 2016

Broader Beverley area results

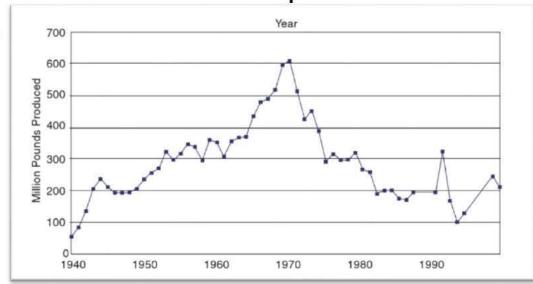
Amounts (tonnes)
3090
2098
1924
2235
2168
1988
2101
2873
3015
2709

US production of TCE (Doherty 2000, Lee et al 2003 and Leppart 1945)

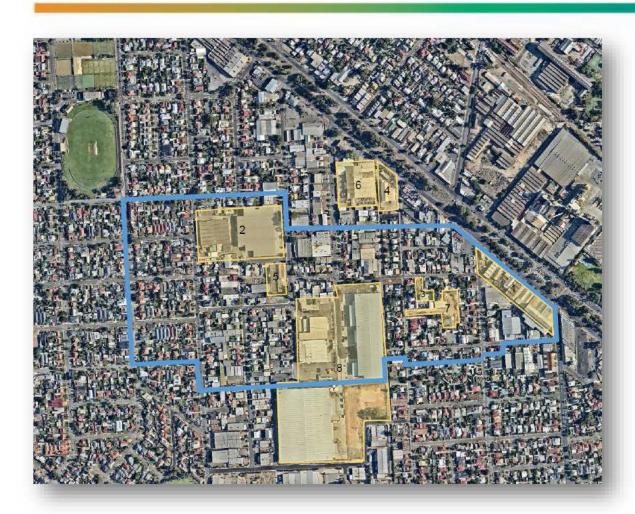
Pug-hole map

The EPA has found no evidence to suggest that the two pugholes within the current assessment area were used as land fills or disposal areas.

1949 Aerial

1979 Aerial

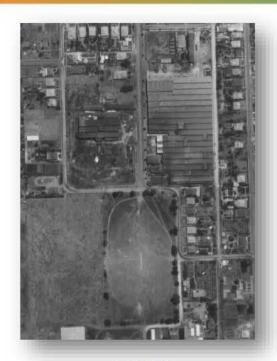
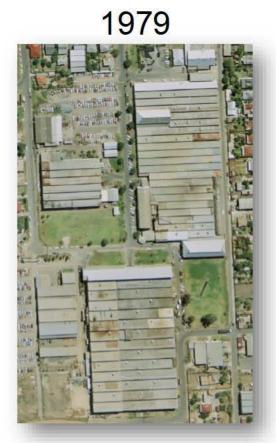
Growth of industry

1949

2009
