QUARTERLY AMBIENT MONITORING PROGRAMME FOR BIRKENHEAD WORKS

COMPLIANCE DATE: 31/07/16 – Quarter 2, 2016

EPA Licence 1126

Licensed site: Adelaide Brighton Cement, Birkenhead Works
 62 Elder Road, Birkenhead, SA 5015

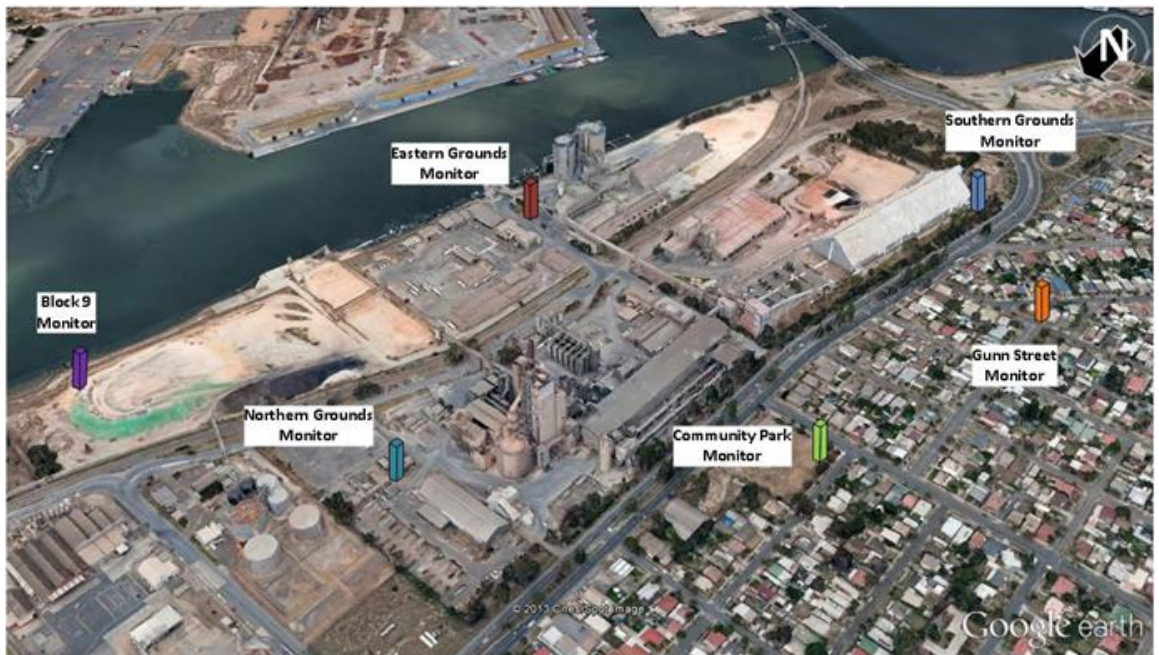
- *Map showing sampling locations, major infrastructure, sensitive environmental receptors, and north arrow*

Sampling locations are indicated by colour coded dots on the above map.

NB: Four sampling points are located on the Birkenhead Works site; the other sampling points are in the community (corner of Gunn/ Well streets and Community Park).

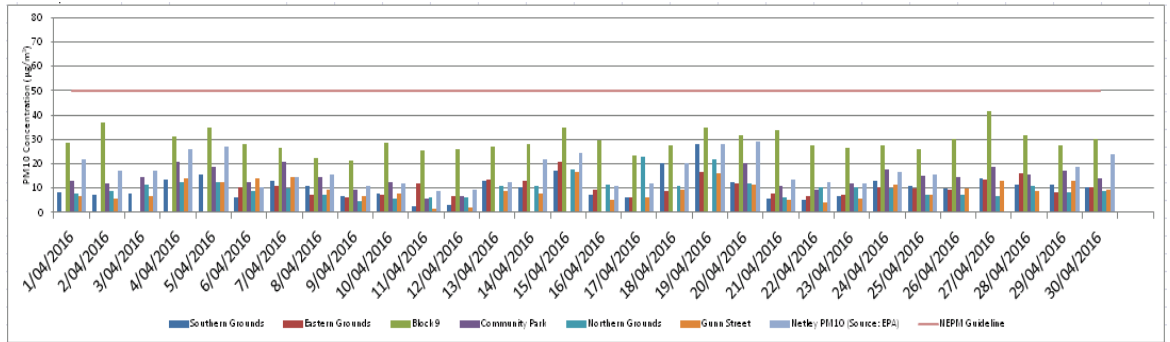
April 2016

All monitors displayed similar PM10 trends throughout the month with nothing exceeding the daily average of 50 ug/m^3 . The Block 9 monitor was reading higher in comparison to the other monitors. This monitor is directly adjacent to the Port River and the main limestone reserve stockpile. The higher readings could be related to the location of the monitor and the reclaiming of the reserve stockpile while the limestone carting ship (Accolade) was at dry dock in Singapore. Heavy traffic and loading activities occurred during this period (early March to the 19th of May) to supply limestone to the main process. This process was managed by the constant application of water and a dust suppressant agent using a dedicated water cart.

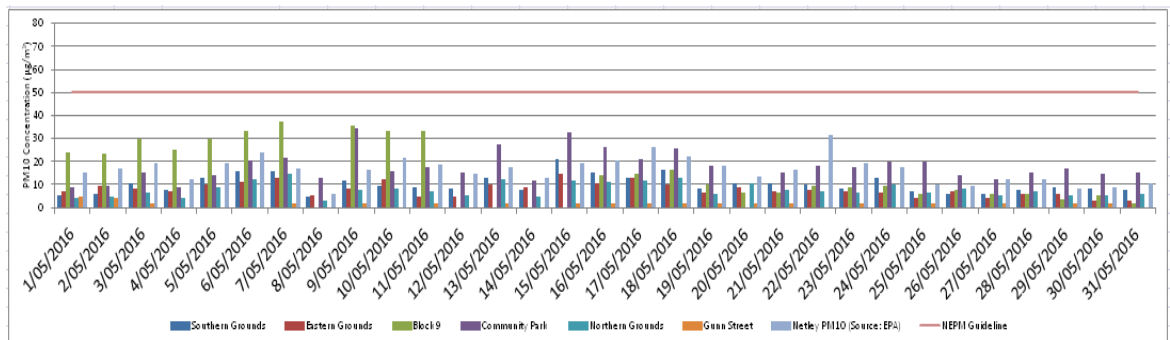
May 2016

All monitors displayed similar low PM10 trends throughout the month with the exception of the Block 9 monitor as mentioned above. The reclaiming of the stockpile ceased in mid May and the Block 9 monitor levels were reduced and more in line with the other monitors.

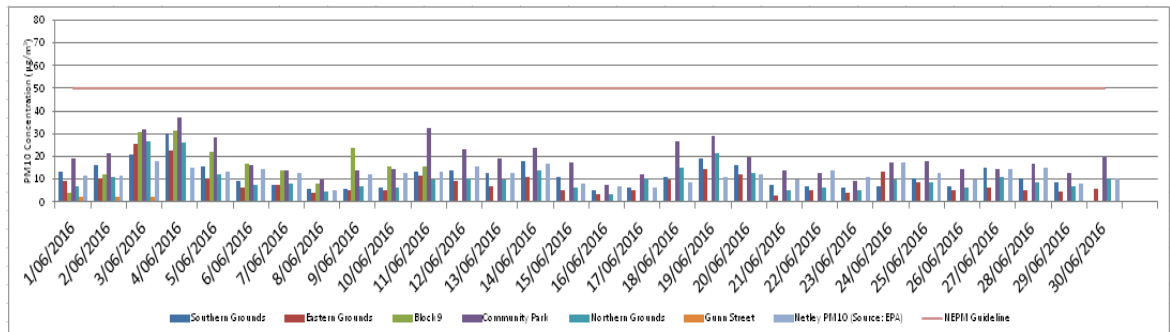
June 2016

All available monitors displayed relatively similar PM10 levels throughout the month.

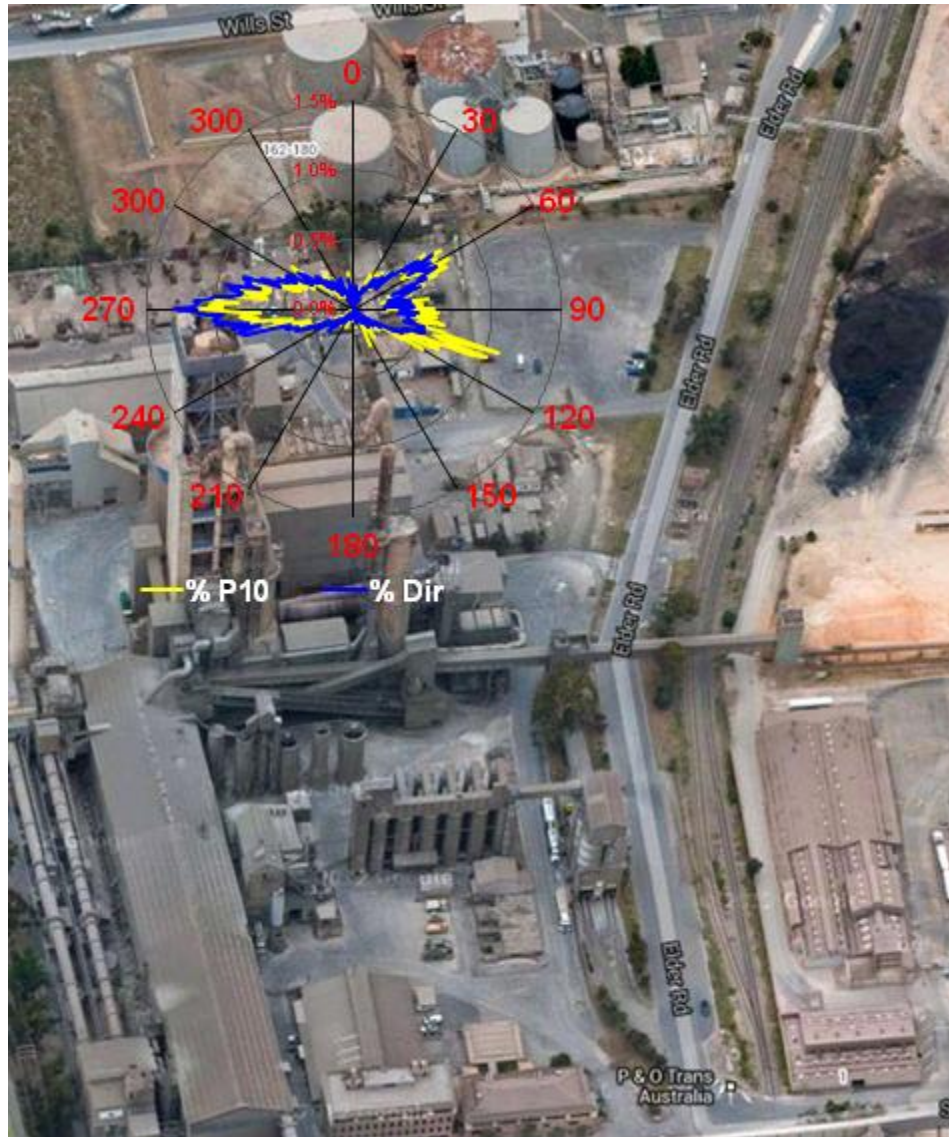
Northern Grounds Monitor

The wind-rose implies that dominant winds are westerly and easterly. Elevated PM10 levels appears to be coming from most notably the southeast. Possible sources could include stockpiles, truck and traffic movements while the Accolade was at dry dock. This process was managed by the constant application of water and a dust suppressant agent using a dedicated water cart.

Note: During normal activities, limestone is pre wetted as it is transferred to Block 9, stockpiles are sealed and dust reducing polymers are applied to unsealed surfaces.

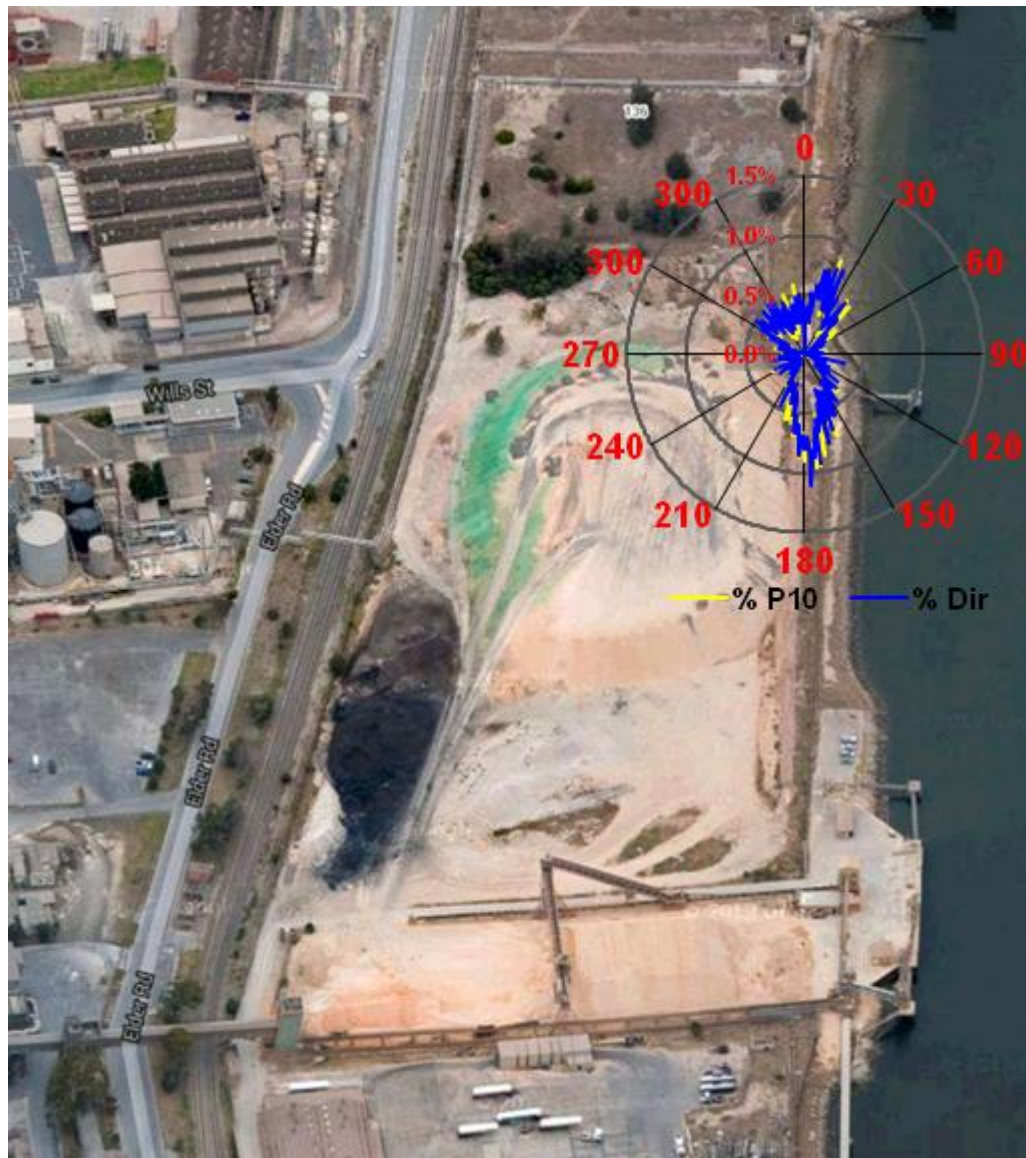
Block 9 Monitor

The wind rose implies winds are predominately from the south and north.

The wind rose of PM10 suggests fugitive dust proportional to the wind direction. Actions taken to minimise dust in this area, including: pre-wetting material at Block 9 before its transferred to main stockpile, regular addition of green dust suppressant sealant and sprays (both at Klein Point and Birkenhead), regular wetting with water and polymer sealing of unsealed surfaces.

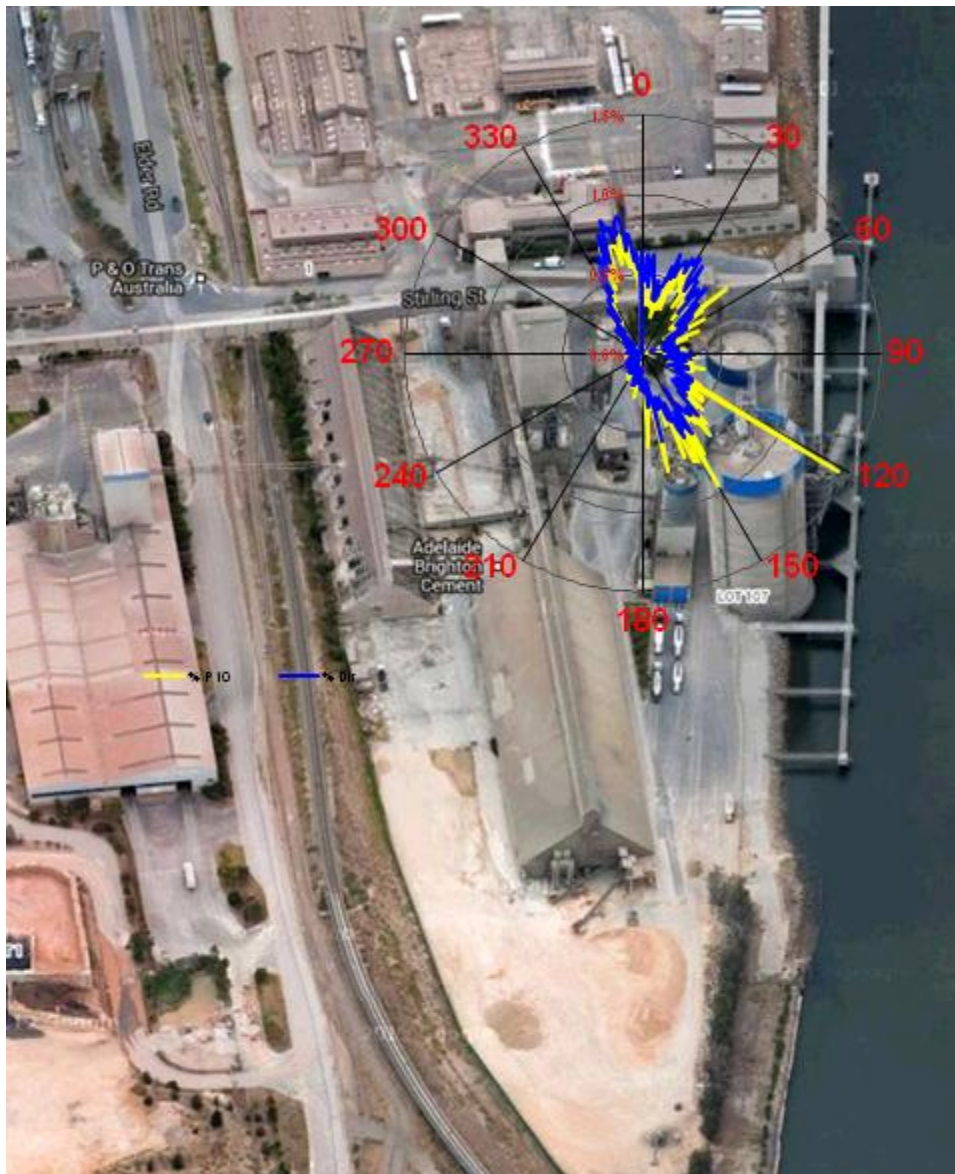
Eastern Grounds Monitor

The wind rose implies that prevailing winds originated from a north and south. There appears to be a contribution of PM10 dust from a southeast direction and there are several spikes during this period. These could be related to localised short term events, including the continuous movement of cement tankers exiting the despatch loading facility via a truck wash.

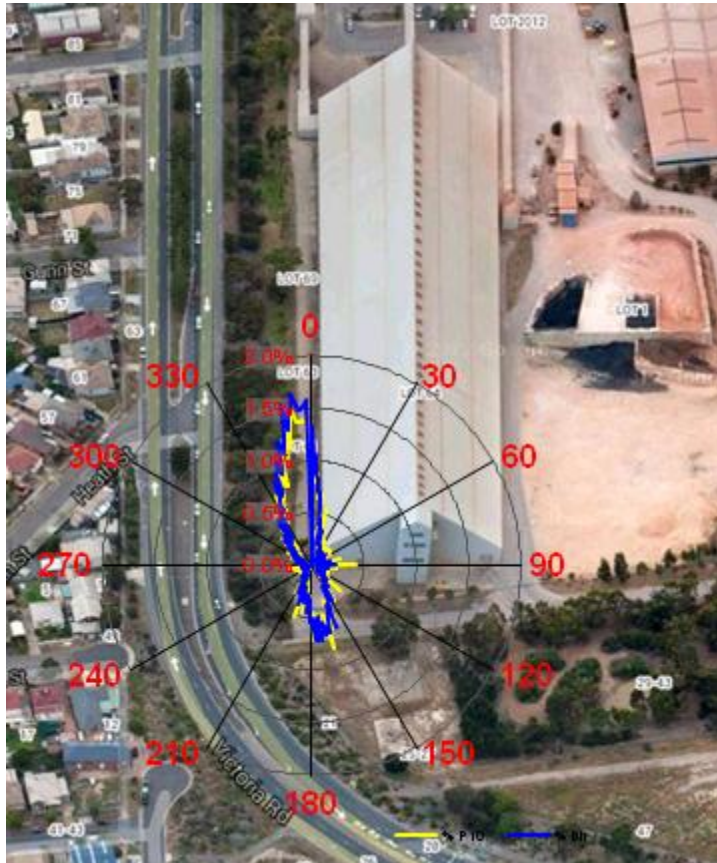
Southern Grounds Monitor

This is the fifth full quarter since the installation of the canopy system covering the MM stockpile area and the foam suppression system on the loading hopper (both EIP projects). The wind rose implies low dust levels for this quarter and is similar to previous reports.

Dominant winds were northerlies and southerlies.

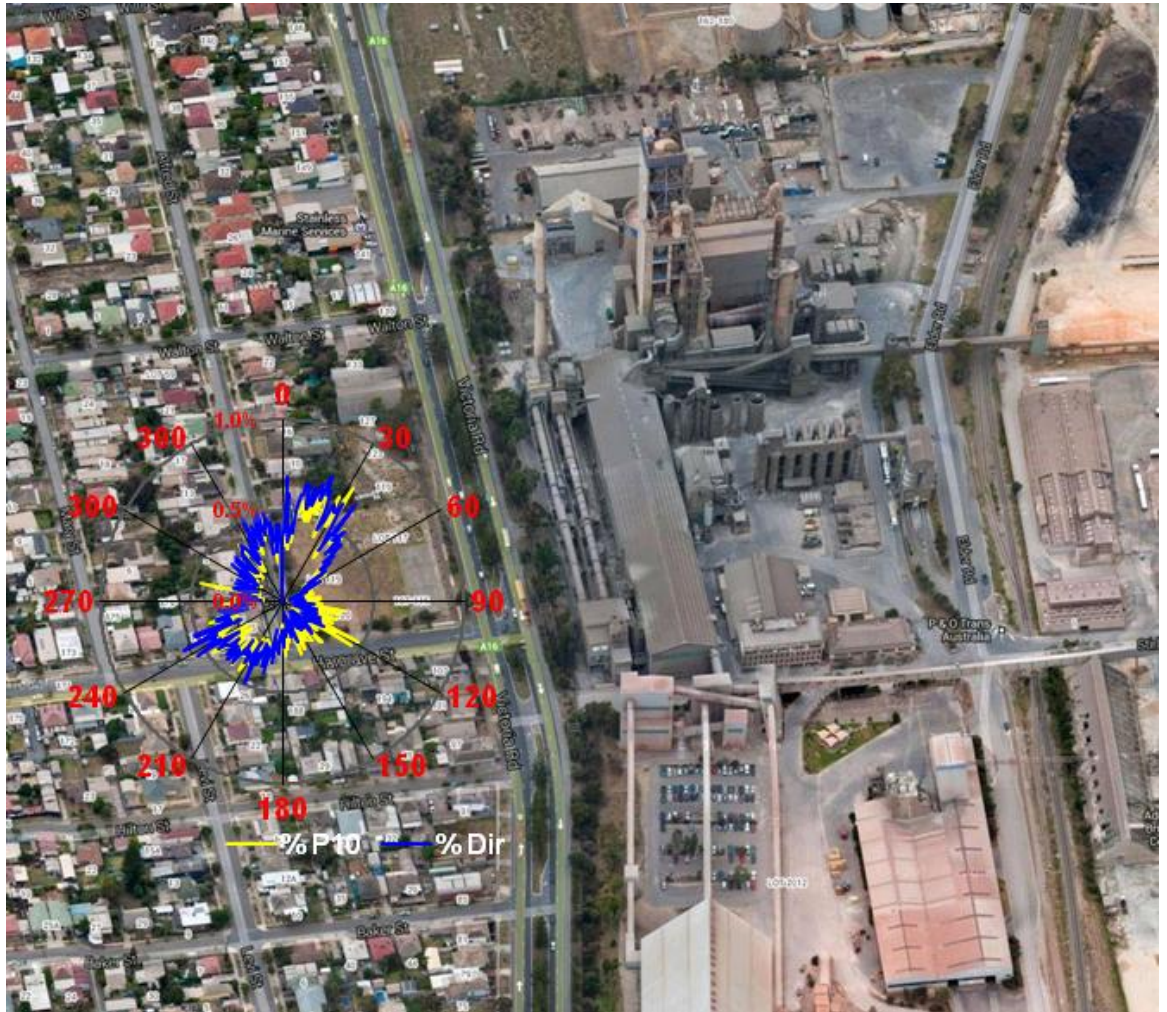
Community Park Monitor

The wind rose implies winds prevailing from all directions but predominantly from the northeast. The PM10 trend on the plot originates predominantly from the east.

Higher proportion of PM10 are coming from a southeasterly direction. Possible contributors may include activities around the limestone conveying system/activities, traffic movements at Victoria Road/Hargrave Street, council works on Hargrave Street directly adjacent to the monitor and activities at the Community Park.

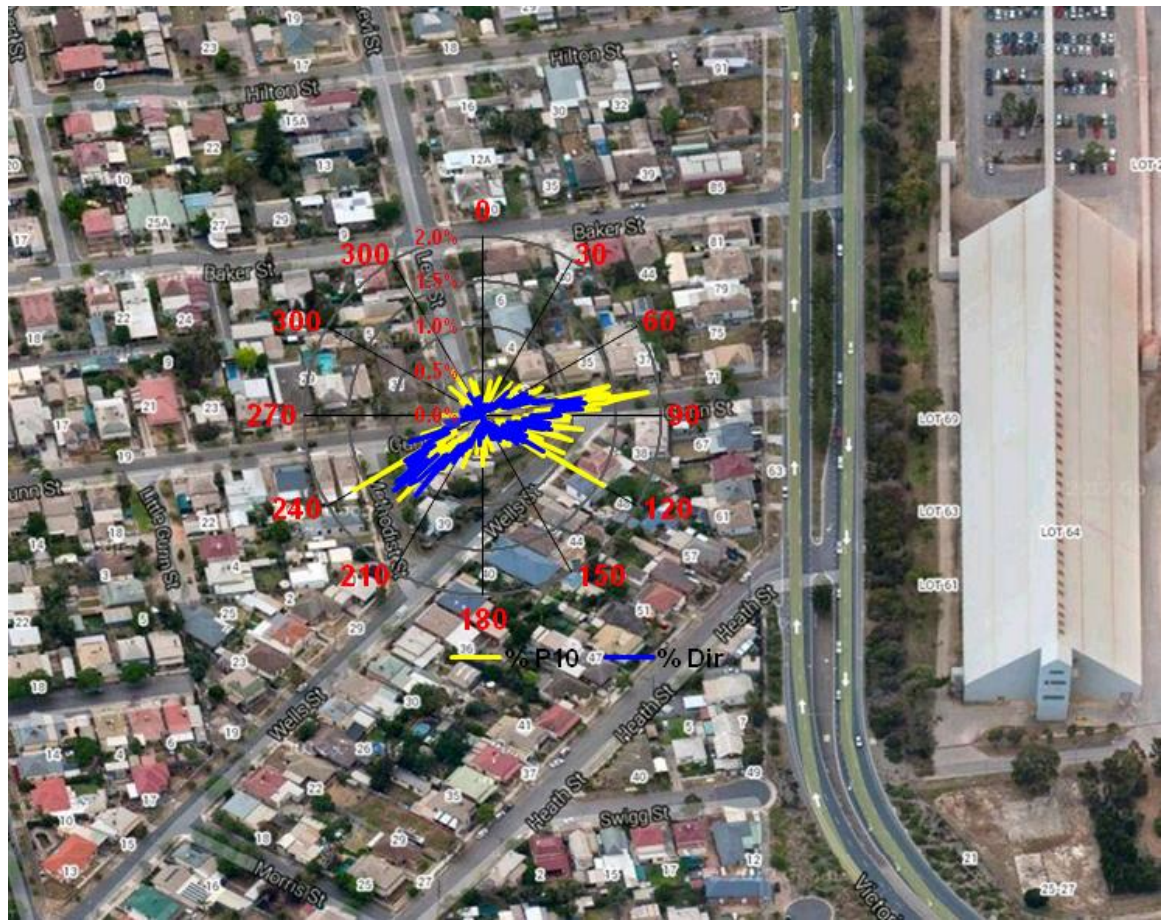
Gunn Street Monitor

The wind rose implies prevailing winds were southwesterly and easterly. The PM10 trend on the diagram implies PM10 dust originating from predominantly an eastern direction with some coming from the north and south west. Considering the PM10 originates from a number of directions, the loads could be related to localised events including traffic in the area. However, as shown earlier in the 24 hour average graphs, the average PM10 levels from this location are low.

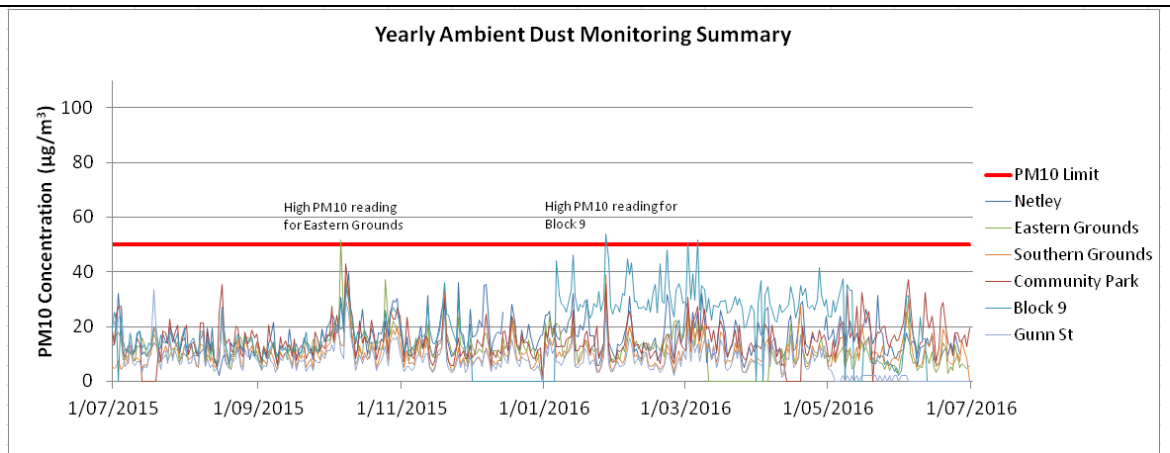
Overall progress of ambient PM10 tracking was graphed to observe what happened to the plant over the past year.

From July 2015, PM10 levels from all site monitors are following a very consistent trend with the exception of Block 9 for the first month of this quarter. This is most likely due to limestone reclaiming activities while the Accolade was at dry dock as mentioned earlier.

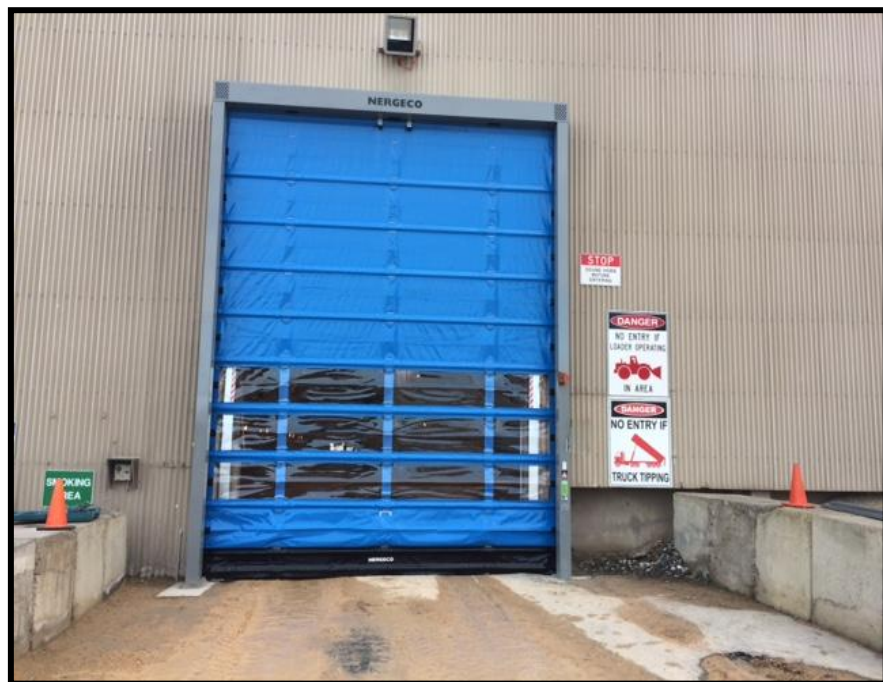
Figure 1 - Rapid Raise door - Wallaroo shed

- Installation of a large rapid raise door was installed on the southern side of the Wallaroo raw material storage shed. This type of door closes automatically and quickly to minimise fugitive dust excursions.
