South Australia's Environment Protection Authority

Beverley Update: Vapour mitigation pilot trial

Community Working Group

Thursday 6 December 2016

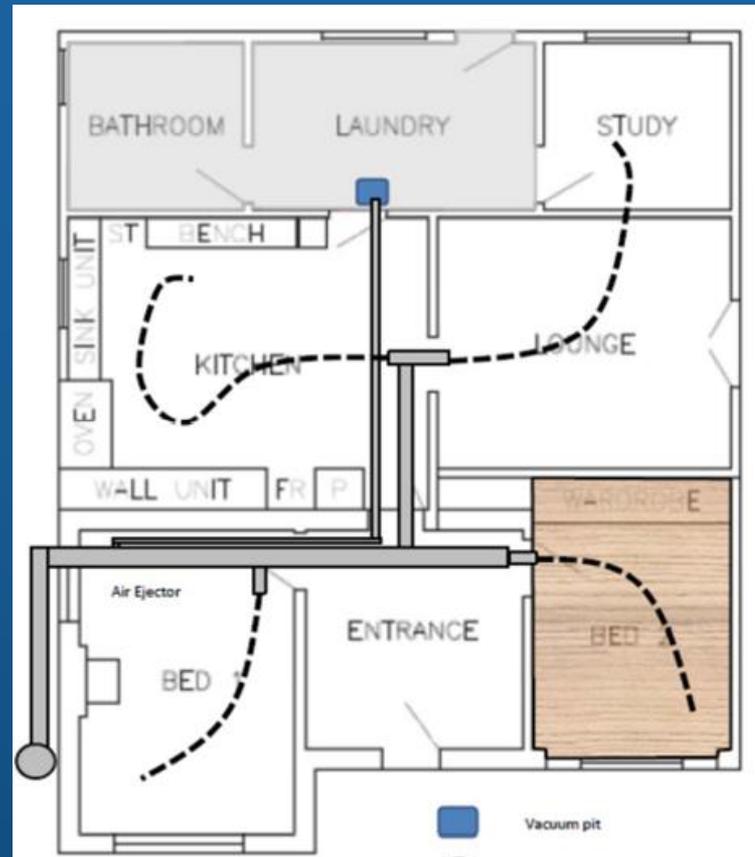
Conceptual design

Key aspects of conceptual design:

- false floor and membrane installed in Bedroom 2
- CSD in all crawl space areas and beneath false floor
- SSD in rear slab areas
- Single 70 watt capacity fan
- fan mounted on eastern exterior wall; and
- sealing of ingress into roof space.

The conceptual design put forward by Coffey was based upon two key principles:

- removal of the driving forces of vapour intrusion where possible; and
- reversal of the vapour flux via active depressurisation.

The depressurisation concept adopted was ‘crawl space depressurisation’ and ‘sub slab depressurisation’.

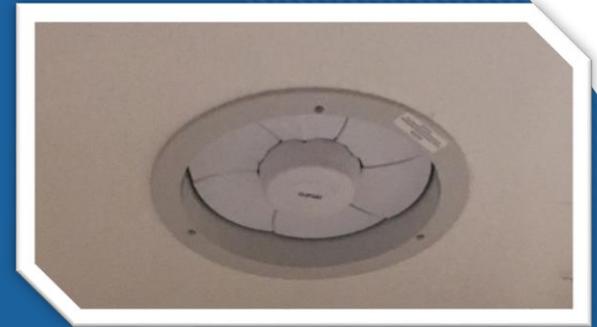
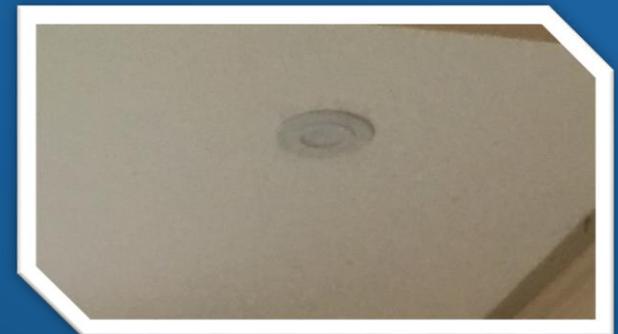
Other considerations

Exhaust fans in kitchen and bathroom replaced to have closing valve when not in use.

Evaporative air conditioner checked to ensure a self closing plenum was present.

Old incandescent lights were replaced with sealed LED downlights.

Backdraft from the combustion heater was considered during design to prevent accumulation of combustion by products (e.g. carbon monoxide).
