QUARTERLY AMBIENT MONITORING PROGRAMME FOR BIRKENHEAD WORKS

COMPLIANCE DATE: 31/10/17 - Quarter 3, 2017

EPA Licence 1126

Licensed site: Adelaide Brighton Cement, Birkenhead Works
 62 Elder Road, Birkenhead, SA 5015

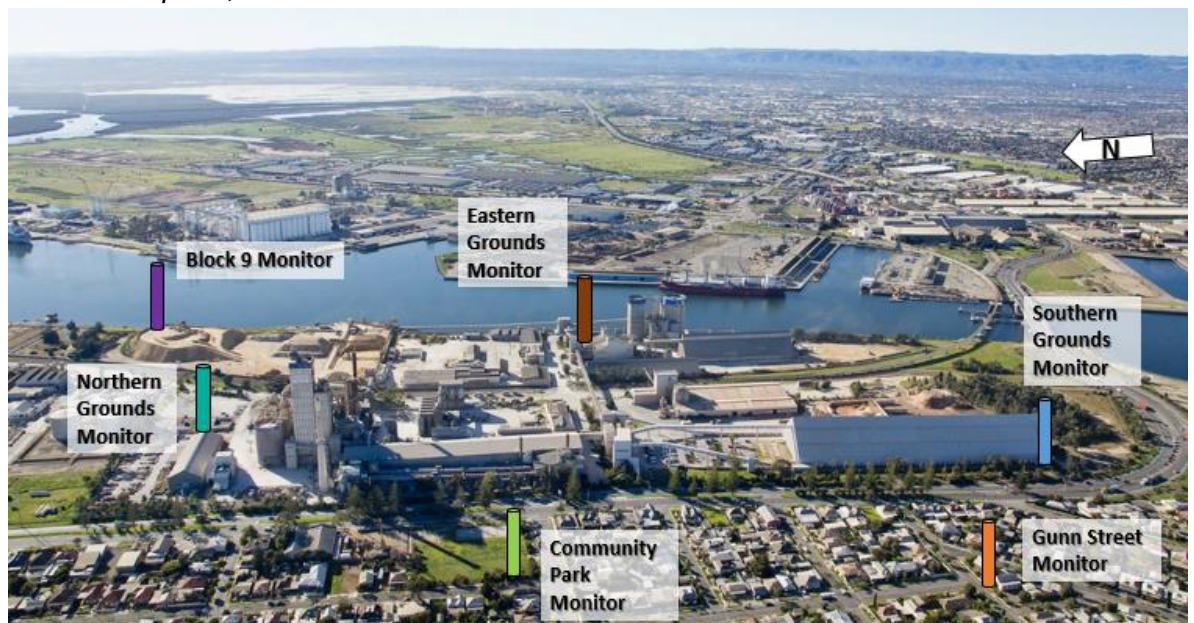
Sampling locations are indicated by colour coded dots on the above map.

NB: Four sampling points are located on the Birkenhead Works site; the other sampling points are in the community (corner of Gunn/ Well streets and Community Park).

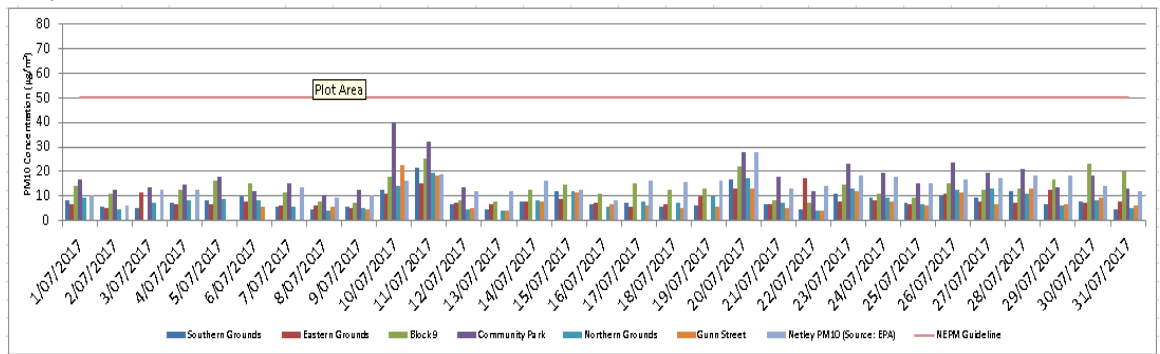
July 2017

All monitors displayed similar PM10 trends throughout the month with nothing exceeding the daily average of 50 ug/m³.

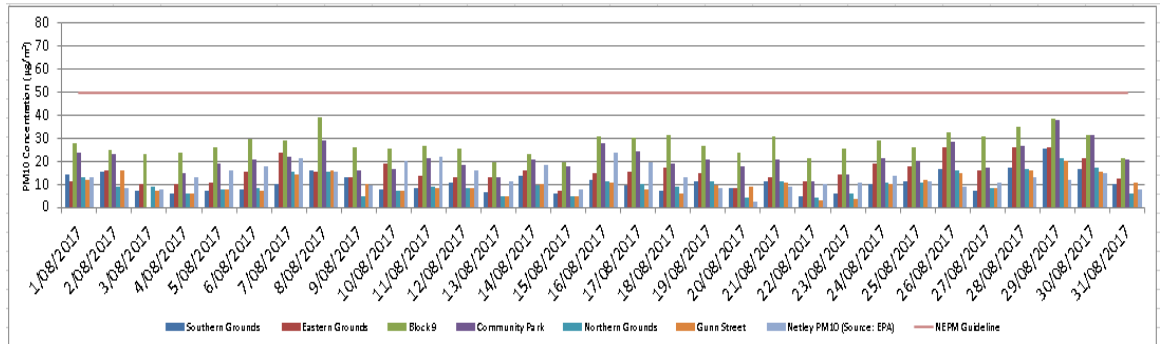
August 2017

All monitors displayed similar PM10 trends throughout the month with nothing exceeding the daily average of 50 ug/m³.

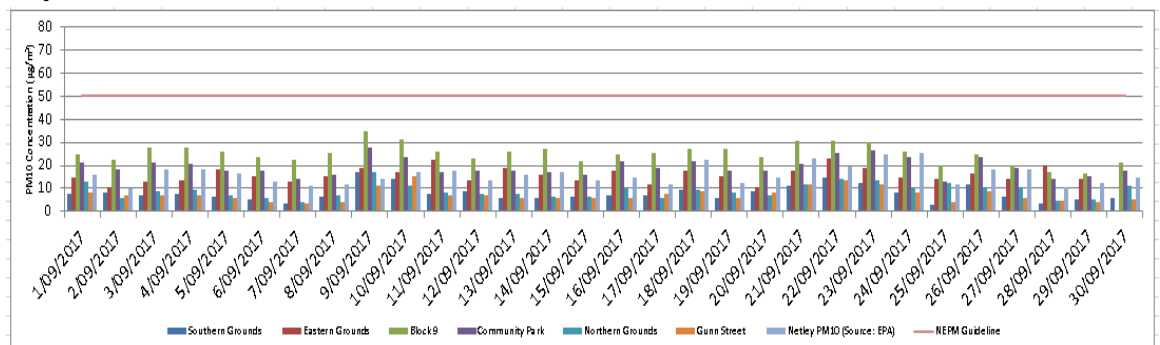
September 2017

All monitors generally displayed similar PM10 trends throughout the month with no exceedances of the daily average of 50 ug/m³.

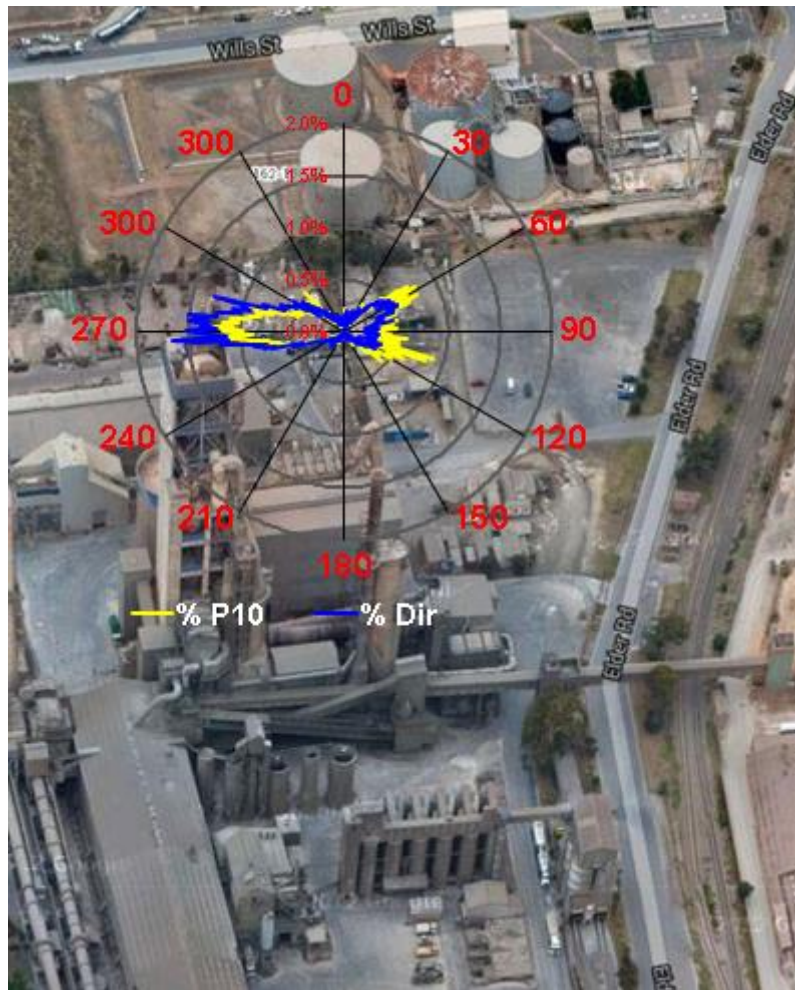
Northern Grounds Monitor

The wind-rose implies that dominant winds are westerly and easterly. Higher proportions of PM10 levels relative to wind directions appear to be coming from most notably the southeast and northeast. Possible sources could include stockpiles, truck and traffic movements, including along Elder Road. This process is managed by the application of water in the area using a dedicated water cart, the use of dust suppressant agents, regular road sweeping and trucks passing through the Elder Road Truck Wash before leaving site.

Note: Limestone is pre wetted as it is transferred from the ship to the Block 9 storage area, stockpiles and unsealed surfaces are sealed with dust reducing polymers.

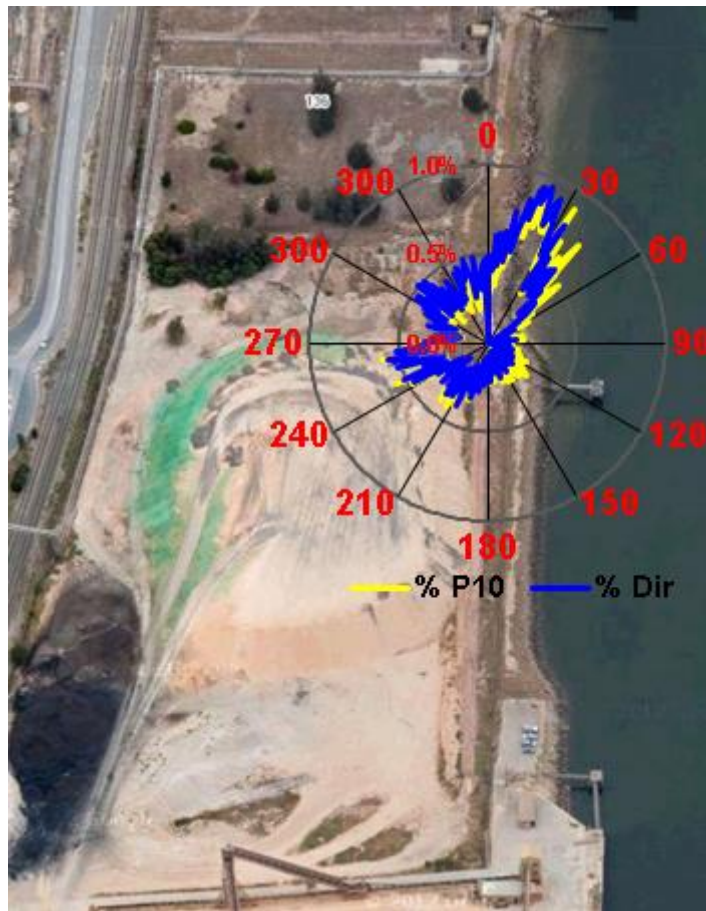
Block 9 Monitor

The wind rose implies winds are predominantly from the south and north.

The wind rose of PM10 suggests the majority of fugitive dust originates from a southeast and northeast directions (i.e. east river side activities).

Actions taken to minimise dust in this area, including: pre-wetting material at Block 9 before its transferred to main stockpile, regular addition of a dust suppressant sealant on stockpiles, dust suppressant agent sprayed onto all limestone as its loaded at Klein Point quarry, regular wetting with water and polymer sealing of unsealed surfaces.

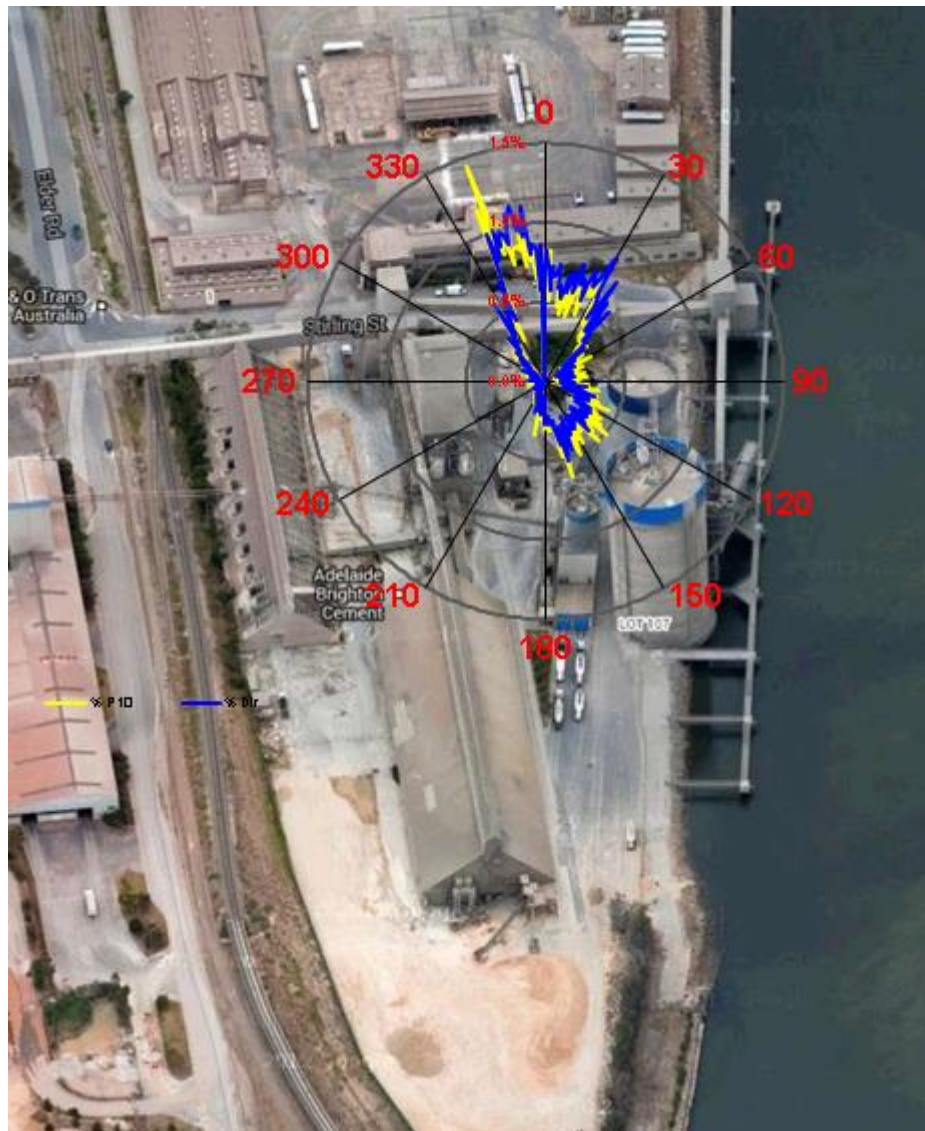
Eastern Grounds Monitor

The wind rose implies that prevailing winds originated from a north and south of the adjacent truck wash.

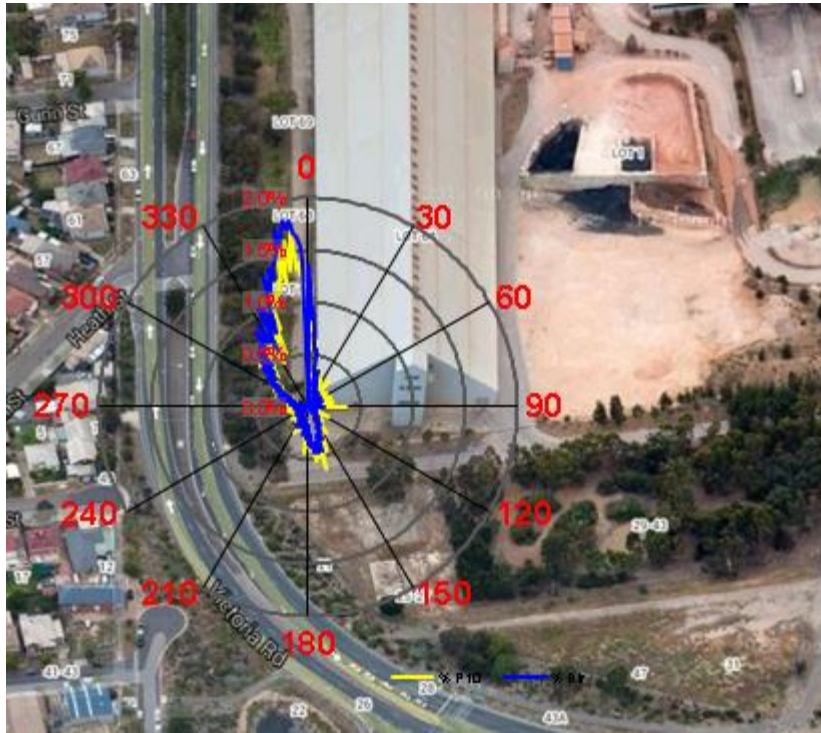
Southern Grounds Monitor

The wind rose implies that prevailing winds originated from a north and south.

Improvements in the area include: the installation of the canopy system covering the Materials Management (MM) stockpile bunker area and the foam suppression system on the loading hopper (both EIP projects).

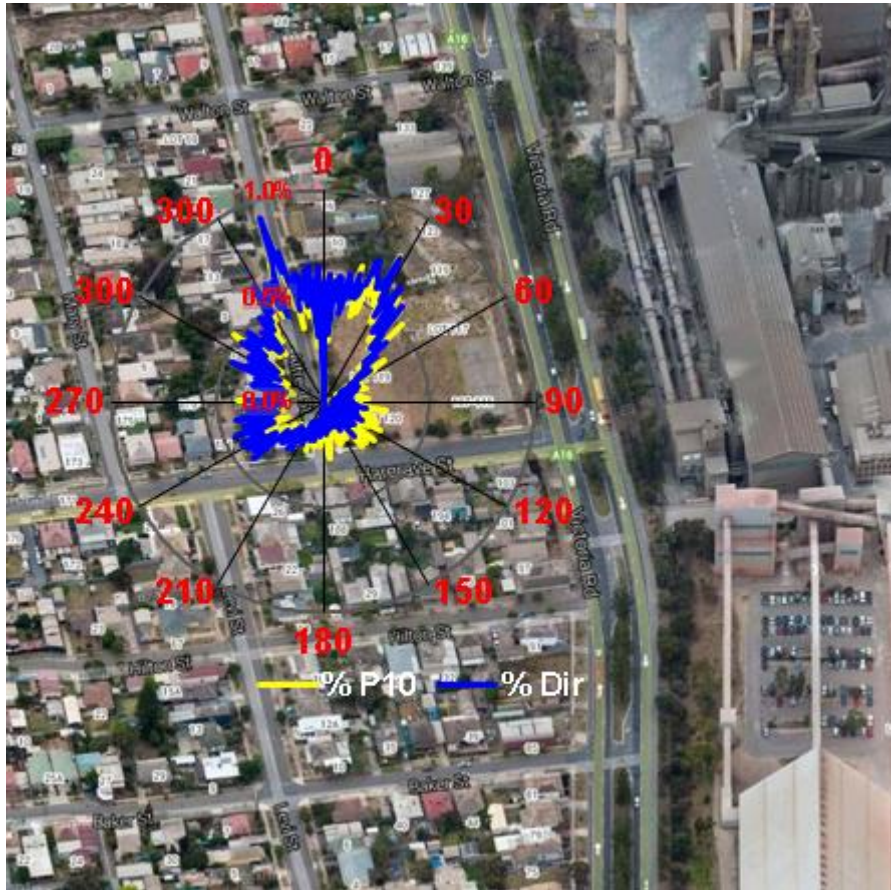
Community Park Monitor

The wind rose implies winds prevailing from all directions. Higher proportions of PM10 levels in comparison to wind direction originate from an easterly direction.

Possible contributors may include activities around the limestone conveying system/ activities, traffic movements along Victoria Road/Hargrave Street and construction works along Hargrave Street.

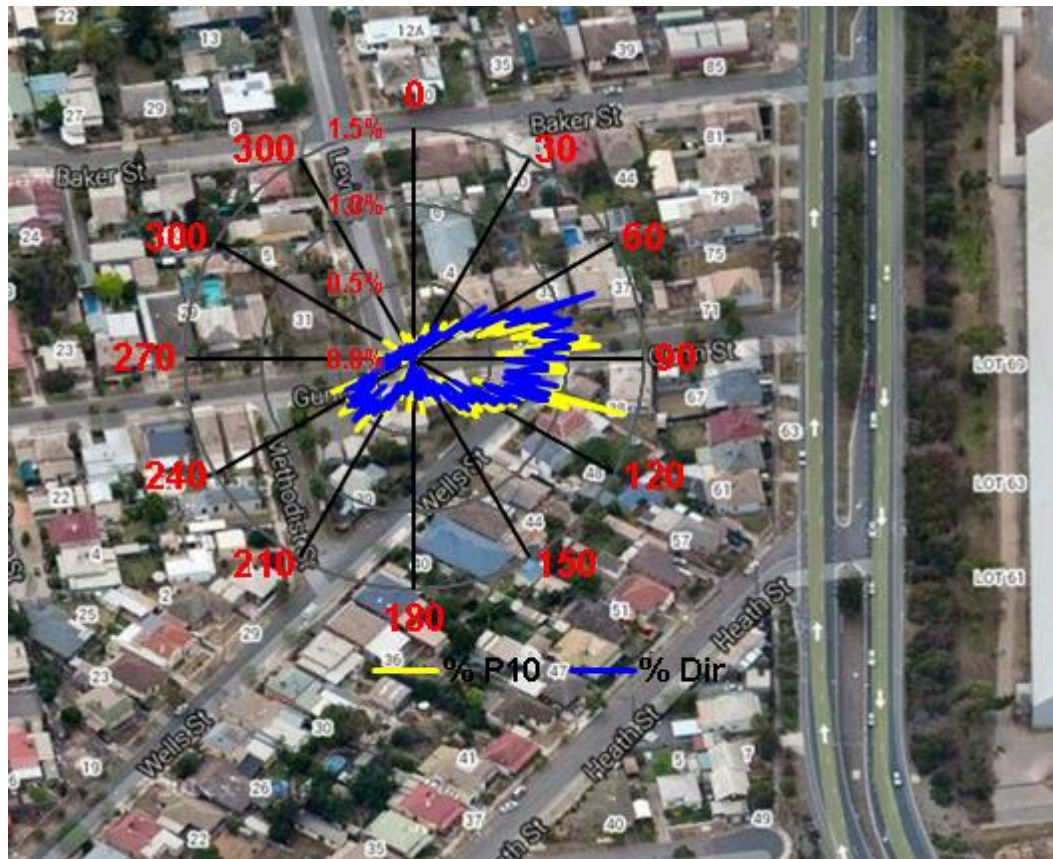
Gunn Street Monitor

The wind rose implies prevailing winds were southwesterly and easterly. The PM10 trend on the diagram implies PM10 dust originating from a predominantly eastern direction. The PM10 loads could be related to localised events including traffic in the area. However, as shown earlier in the 24 hour average graphs, the average PM10 levels from this location are low.

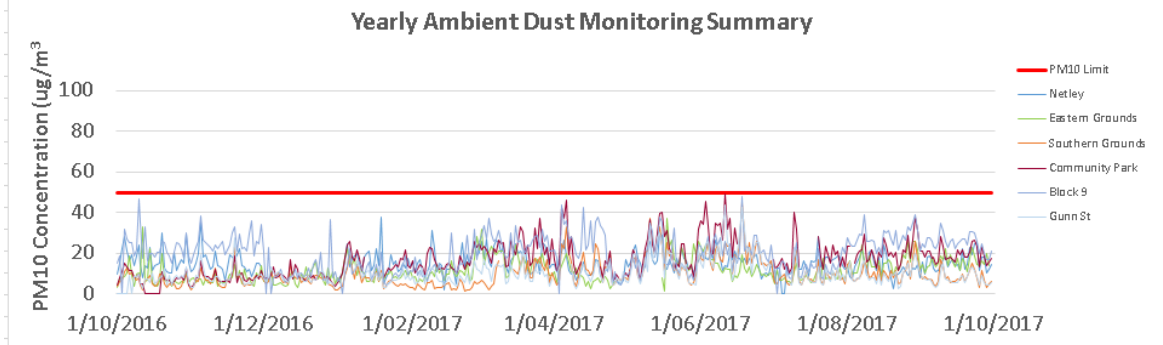
Overall progress of ambient PM10 tracking was graphed to observe what happened to the plant over the past year.

All monitors generally displayed similar 24 hr PM10 trends throughout the year with no exceedances of the daily average of 50 ug/m³

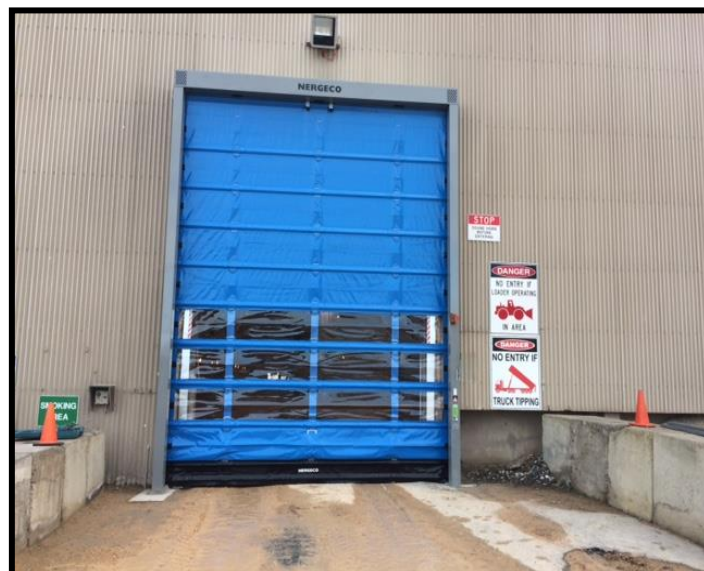
Rapid Raise door - Wallaroo shed

- Installation of a large rapid raise door on the southern side of the Wallaroo raw material storage shed. This type of door closes automatically and quickly to minimise fugitive dust excursions.

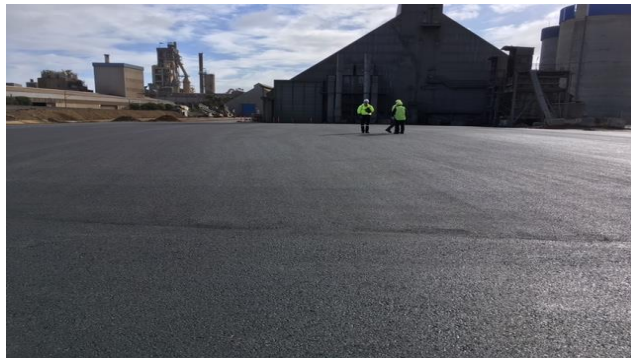
- All heavy traffic areas at the southern end of the plant adjacent the Cement Mill 1 Gantry have been sealed. All traffic movements will now travel on the sealed surfaces, subsequently reducing fugitive particulate emissions. The sealed surfaces will also allow for the area to be regularly road swept, which will further reduce and contain particulate emissions
- **Actions & Improvements for Quarter 3, 2017 include:**
 - From the second quarter of 2016 to second quarter of 2017 maintenance inspections and sealing repairs on the main clinker storage Gantry adjacent Victoria road included:
 - the north west side on the Gantry, directly adjacent the eaves
 - the eaves on the east side of Gantry
 - two small openings on the east side of the Gantry
 - small opening in the eaves on northeast side of the Gantry
 - These actions will assist in reducing fugitive particulate
