YEARLY AMBIENT MONITORING PROGRAMME FOR BIRKENHEAD WORKS

COMPLIANCE DATE: 31/10/17 – Yearly Report, 2017

EPA Licence 1126

Licensed site: Adelaide Brighton Cement, Birkenhead Works

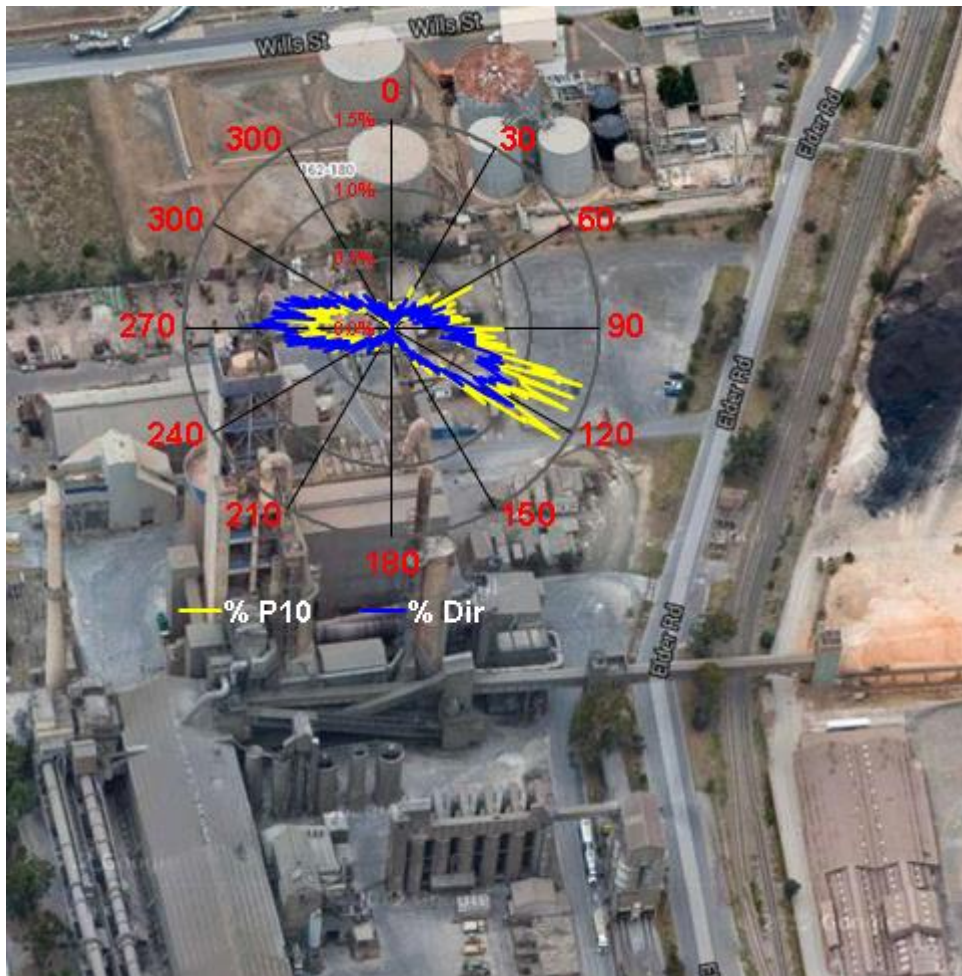
Northern Grounds Monitor

Westerly and easterly winds were the most dominant throughout October 2016 – October 2017. The higher proportion of PM10 to wind direction from the southeast suggest that there may be a contribution to PM10 loads from that direction. Possible sources could include stockpiles, truck and traffic movements.

This process is managed by the application of water in the area using a dedicated water cart, the use of dust suppressant agents, regular road sweeping and trucks passing through the Elder Road Truck Wash before leaving site.

Note: Limestone is pre wetted as it is transferred from the ship to the Block 9 storage area, stockpiles and unsealed surfaces are sealed with dust reducing polymers.

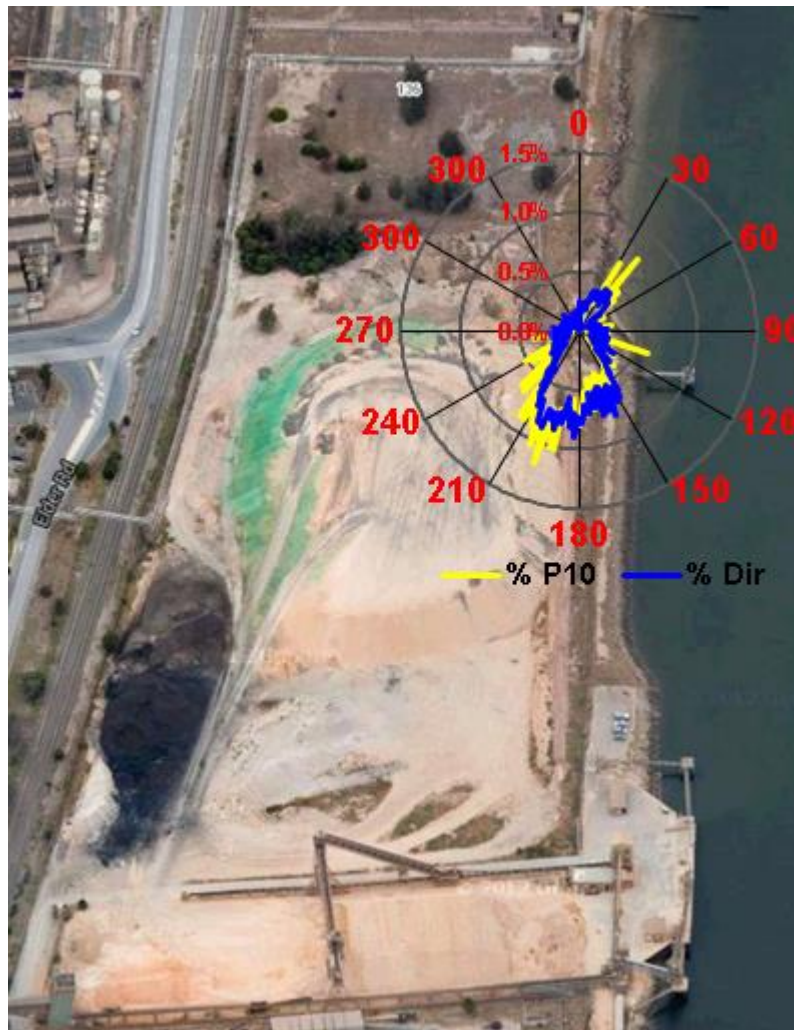
Block 9 Monitor

Southerly winds were most common throughout October 2016 – October 2017. The wind plot of PM10 suggests some fugitive dust may be coming from stockpile activities.

Actions taken to minimise dust in this area, including: pre-wetting material at Block 9 before its transferred to main stockpile, regular addition of a dust suppressant sealant on stockpiles, dust suppressant agent sprayed onto all limestone as its loaded at Klein Point quarry, regular wetting with water and polymer sealing of unsealed surfaces.

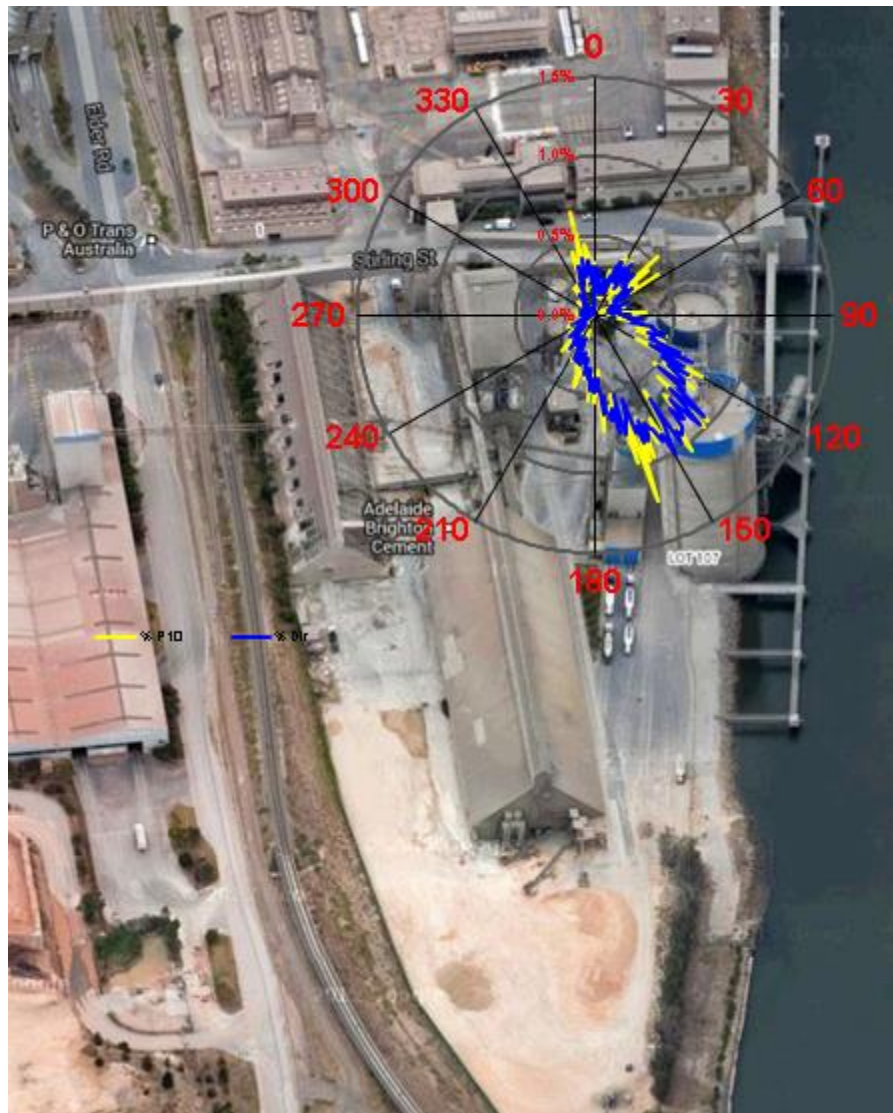
Eastern Grounds Monitor

Southeasterly winds were most common throughout October 2016 – October 2017. There appears to be a contribution of PM10 dust from a southeast direction and there are several spikes during this period. These could be related to localised short term events, including the continuous movement of cement tankers exiting the despatch loading facility on route to the adjacent truck wash.

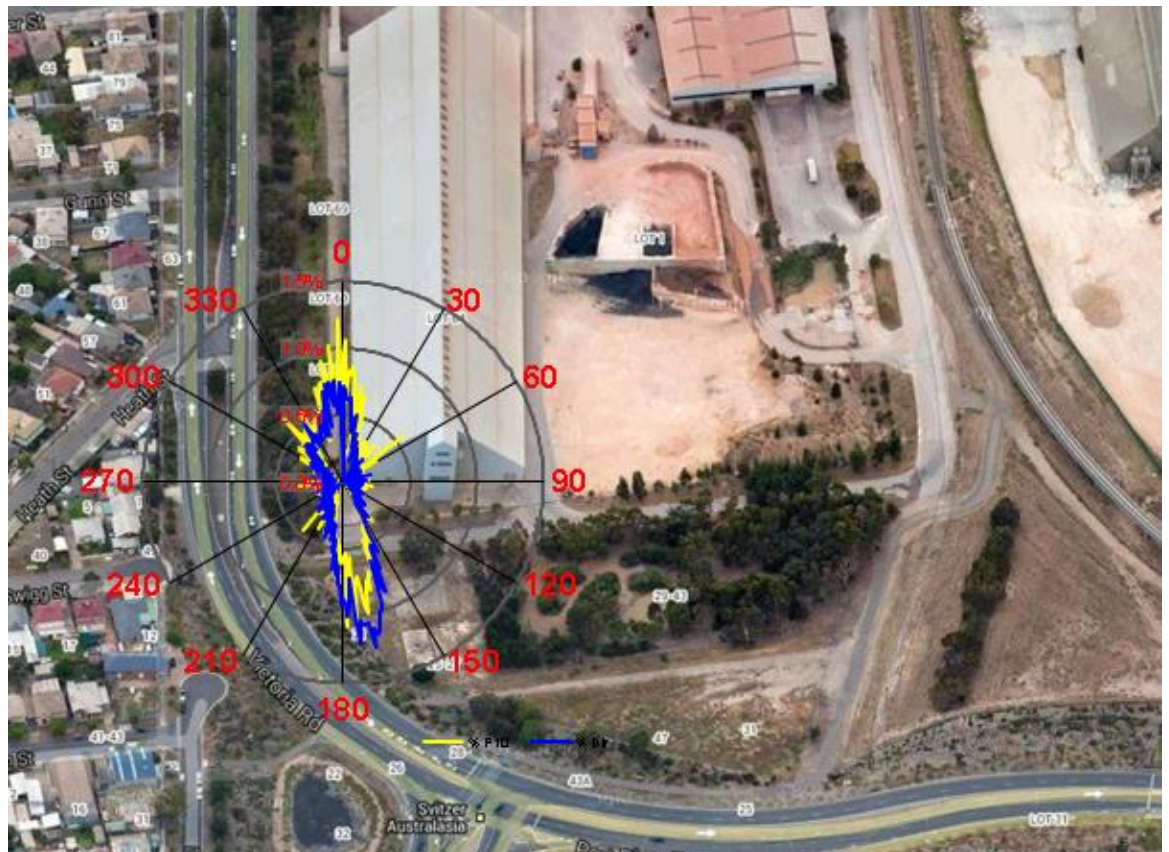
Southern Grounds Monitor

Northerly and southerly winds were dominant throughout October 2016 – October 2017. The wind rose of PM10 suggests fugitive dust is coming from a northern direction on the western side of the pre blend heap shed.

Improvements in the area include: the installation of the canopy system covering the Materials Management (MM) stockpile bunker area and the foam suppression system on the loading hopper (both EIP projects).

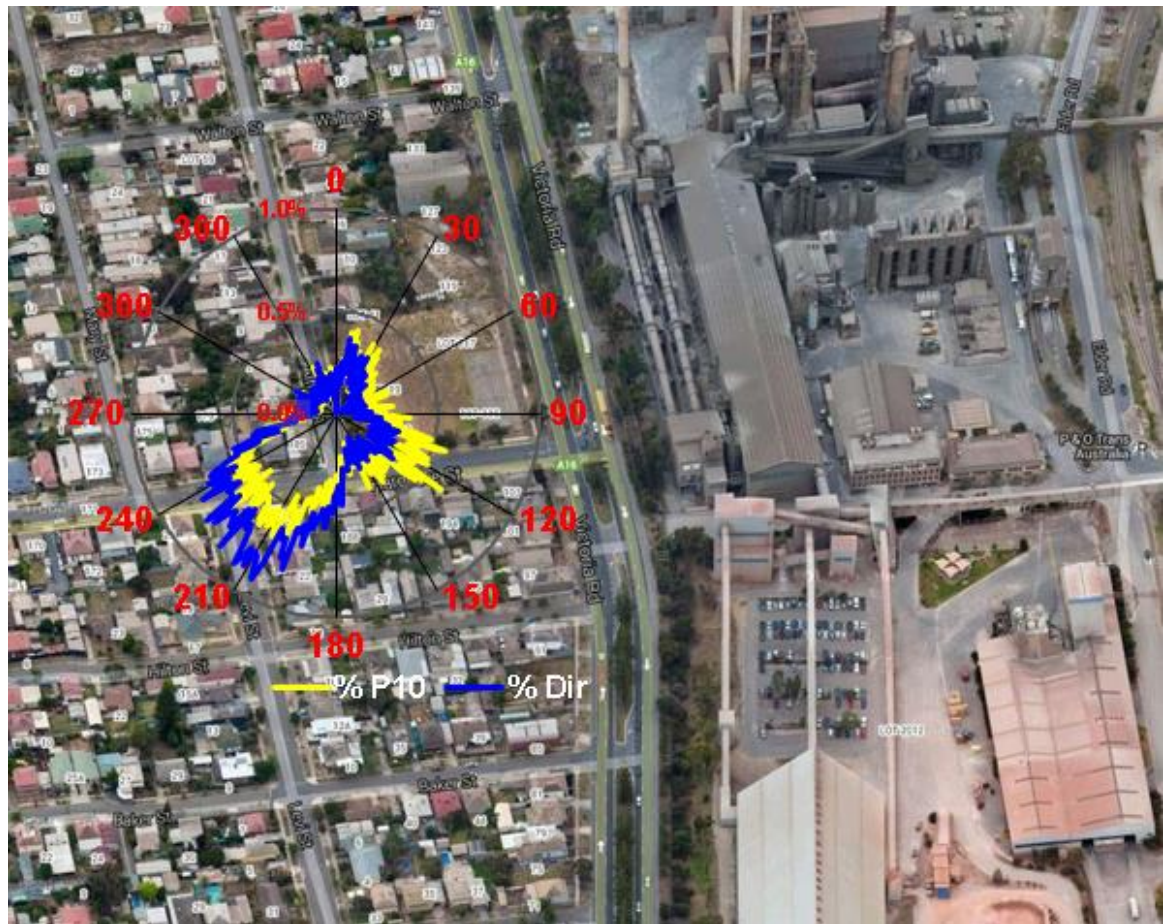
Community Park Monitor

Southwesterly and northeasterly winds were most common throughout October 2016 – October 2017. Higher proportions of PM10 levels in comparison to wind direction originate from an easterly direction. Possible contributors may include activities around the limestone conveying system/activities, traffic movement at Victoria Road/Hargrave Street, council/construction works near Hargrave Street directly adjacent to the monitor.

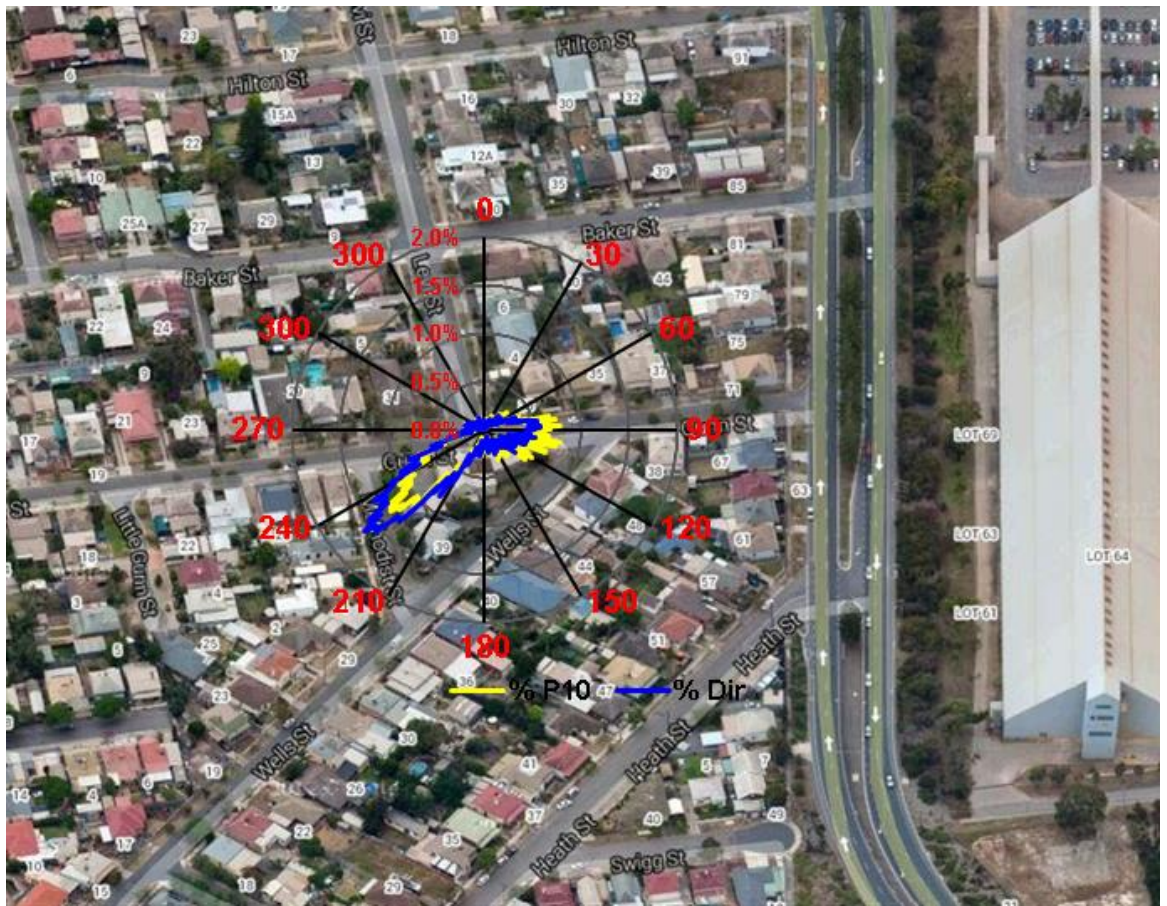
Gunn Street Monitor

Southwesterly and easterly winds were most common throughout October 2016 – October 2017. The PM10 trend on the diagram implies PM10 dust originating from an eastern direction. The dust could be related to localised events including traffic in the area. The average PM10 levels from this location are low.

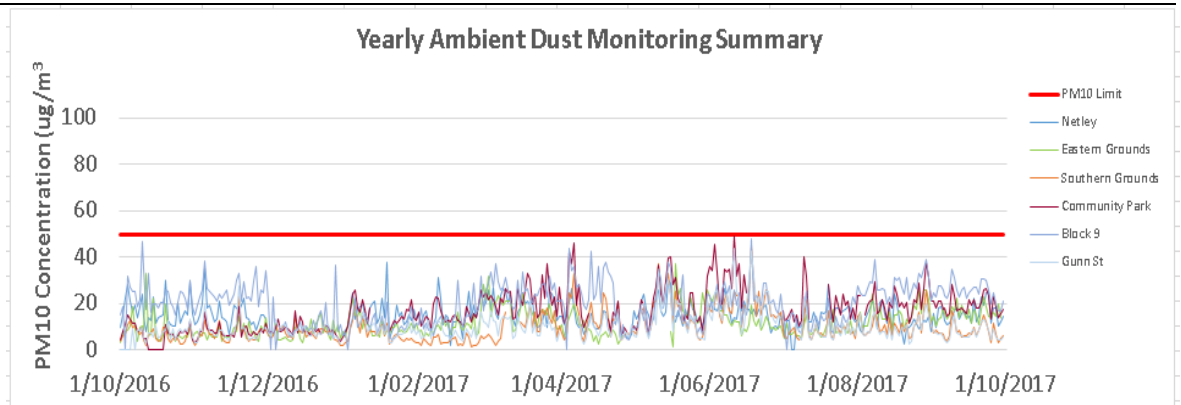
Yearly PM10 Monitoring Progress

Overall progress of ambient PM10 tracking was graphed to observe what happened to the plant over the past year.

All monitors generally displayed similar 24 hr PM10 trends throughout the year with no exceedances of the daily average of 50 ug/m³

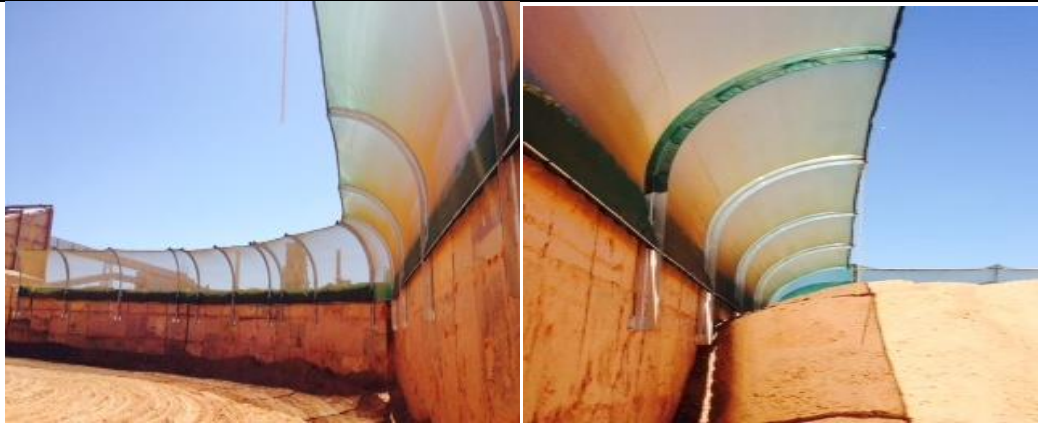
- Installation of foam mist spray system (EIP project) on the MM tipping loading hopper was installed and commissioned in late December 14
- **Fabric/Mesh canopies** were installed at the fringe Materials Management system on top of the concrete bunker walls in March 2015. This will reduce the tendency for dust to become airborne when loading/unloading material as it acts as a wind break. This is an EIP project.

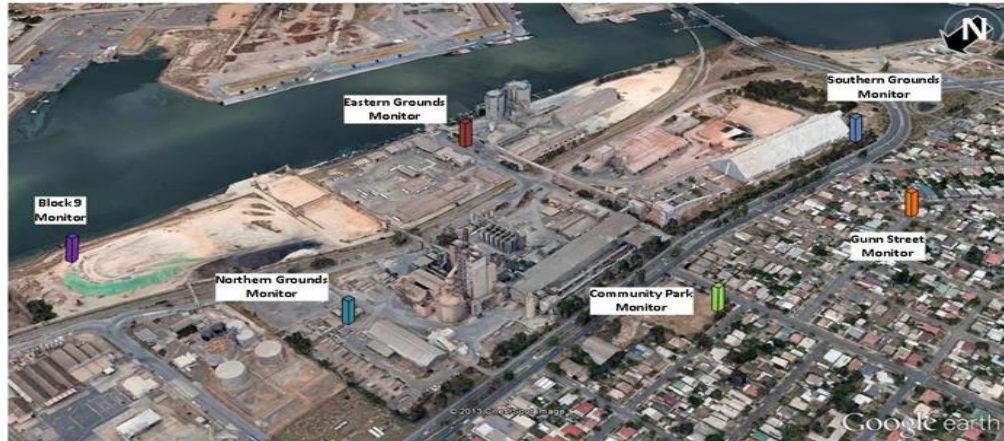
- **Standardisation of Ambient air monitoring network**

- Four of the older generation ambient air monitors were replaced during the second quarter with current generation systems as used on Community Park and Block 9 area (2013).

- All monitors are now the DustTrak TSI DRX model
- A spare DustTrak TSI DRX unit was purchased to ensure full utilisation of the network during servicing, maintenance, breakdowns etc...

- The new DustTrak TSI DRX monitors use current technology and consist of a dust analyser that can sample all of the required forms of reportable fugitive dust (PM2.5, PM10 and TSP). The system uses an ultrasonic wind sensor which is more precise and reliable than the anemometers used on the Osiris dust monitors. These anemometers also require virtually no maintenance as they have no moving parts.

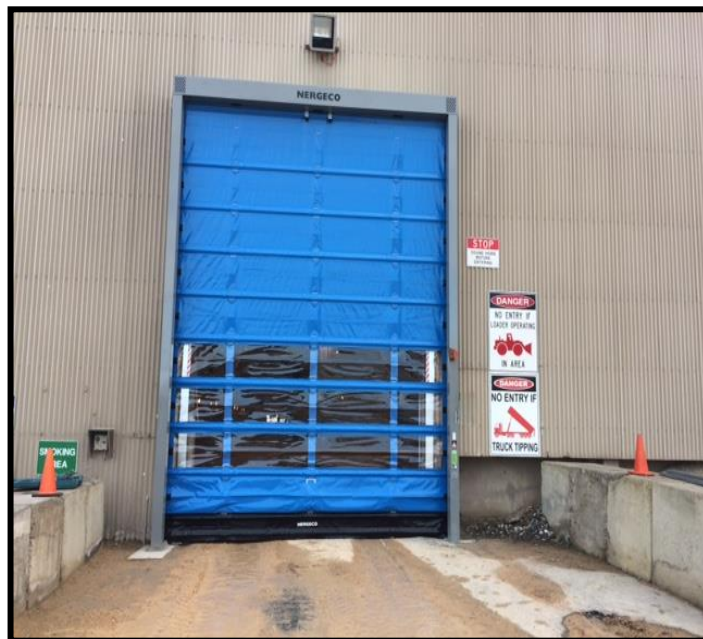
Rapid Raise door - Wallaroo shed

- Installation of a large rapid raise door on the southern side of the Wallaroo raw material storage shed. This type of door closes automatically and quickly to minimise fugitive dust excursions (Q2, 2016)

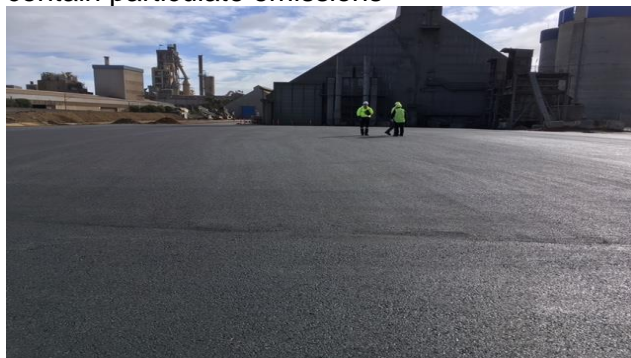
- All heavy traffic areas at the southern end of the plant adjacent the Cement Mill 1 Gantry have been sealed. All traffic movements will now travel on the sealed surfaces, subsequently reducing fugitive particulate emissions. The sealed surfaces will also allow for the area to be regularly road swept, which will further reduce and contain particulate emissions
