**Lake Bonney**  
South East, South Australia  
**Past, Present and Possible Future**

## Lake Bonney SE Problems and steps to a solution

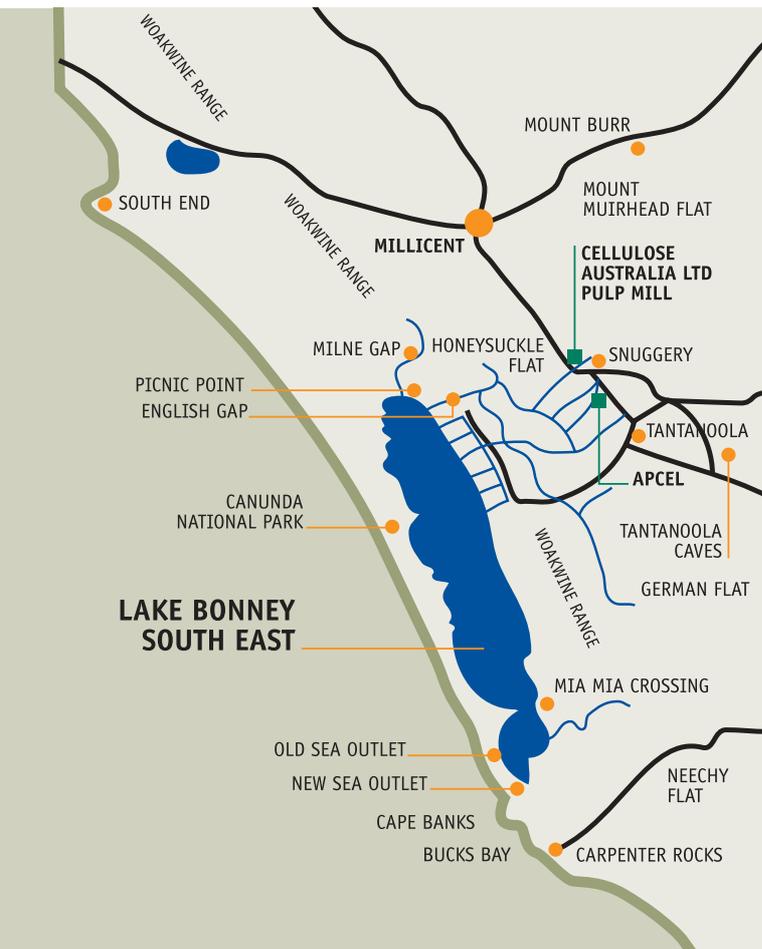
Above: Lake Bonney SE and surrounding environs (Map: from Kinhill 1990)

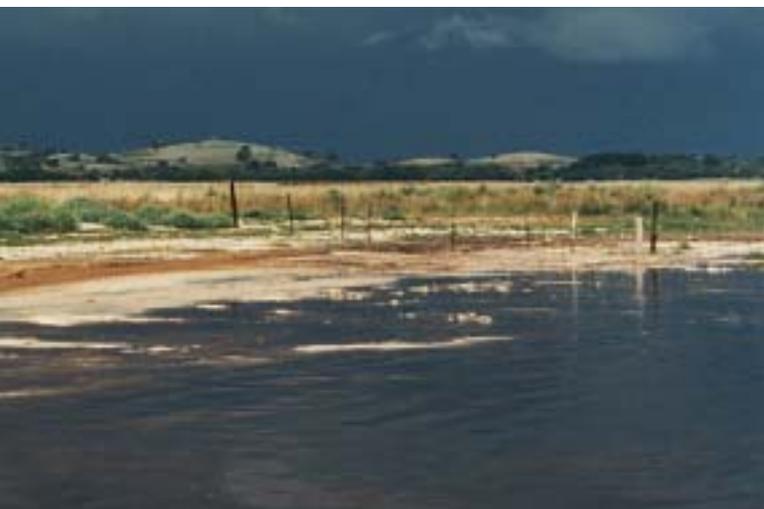
Above: Near Picnic Point at the north end of Lake Bonney in April 1991, just prior to re-opening of 1958 outlet. (Photo: Andrew Emmett, April 1991)

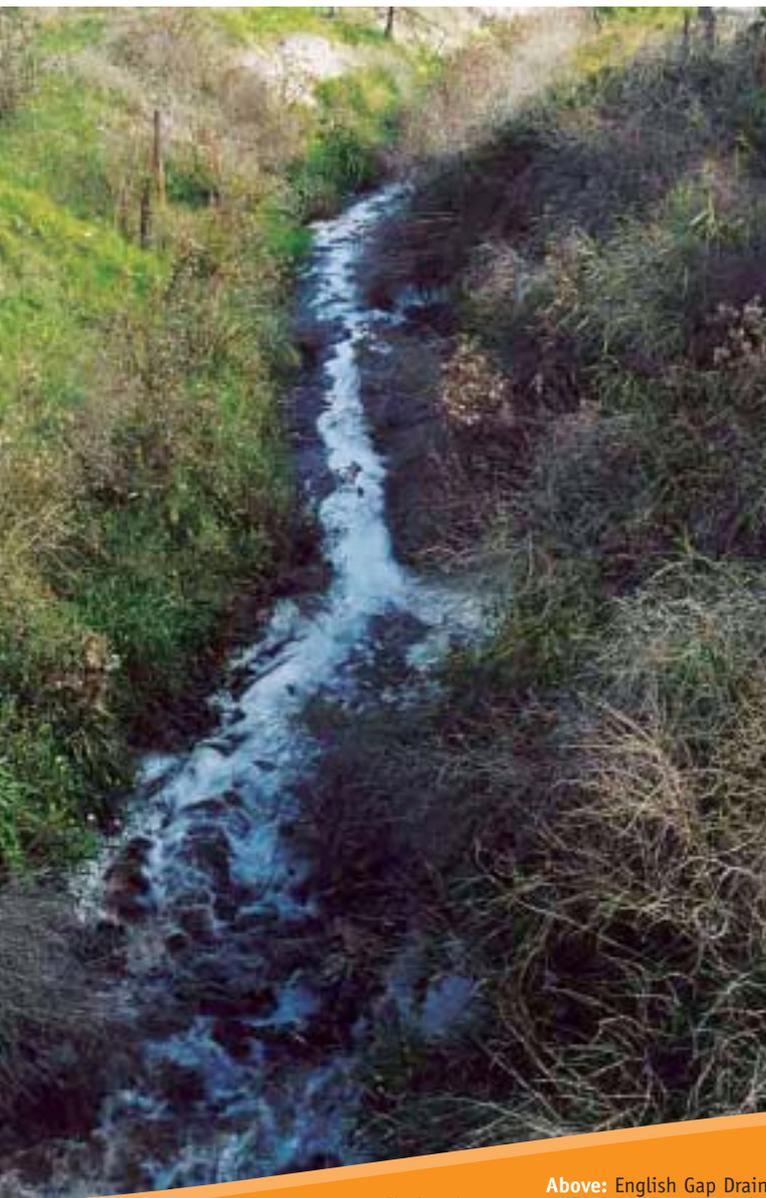
Above: English Gap Drain discharging paper mill wastewater into Lake Bonney SE, April 2003 (Photo: Skyring Environment Enterprises)

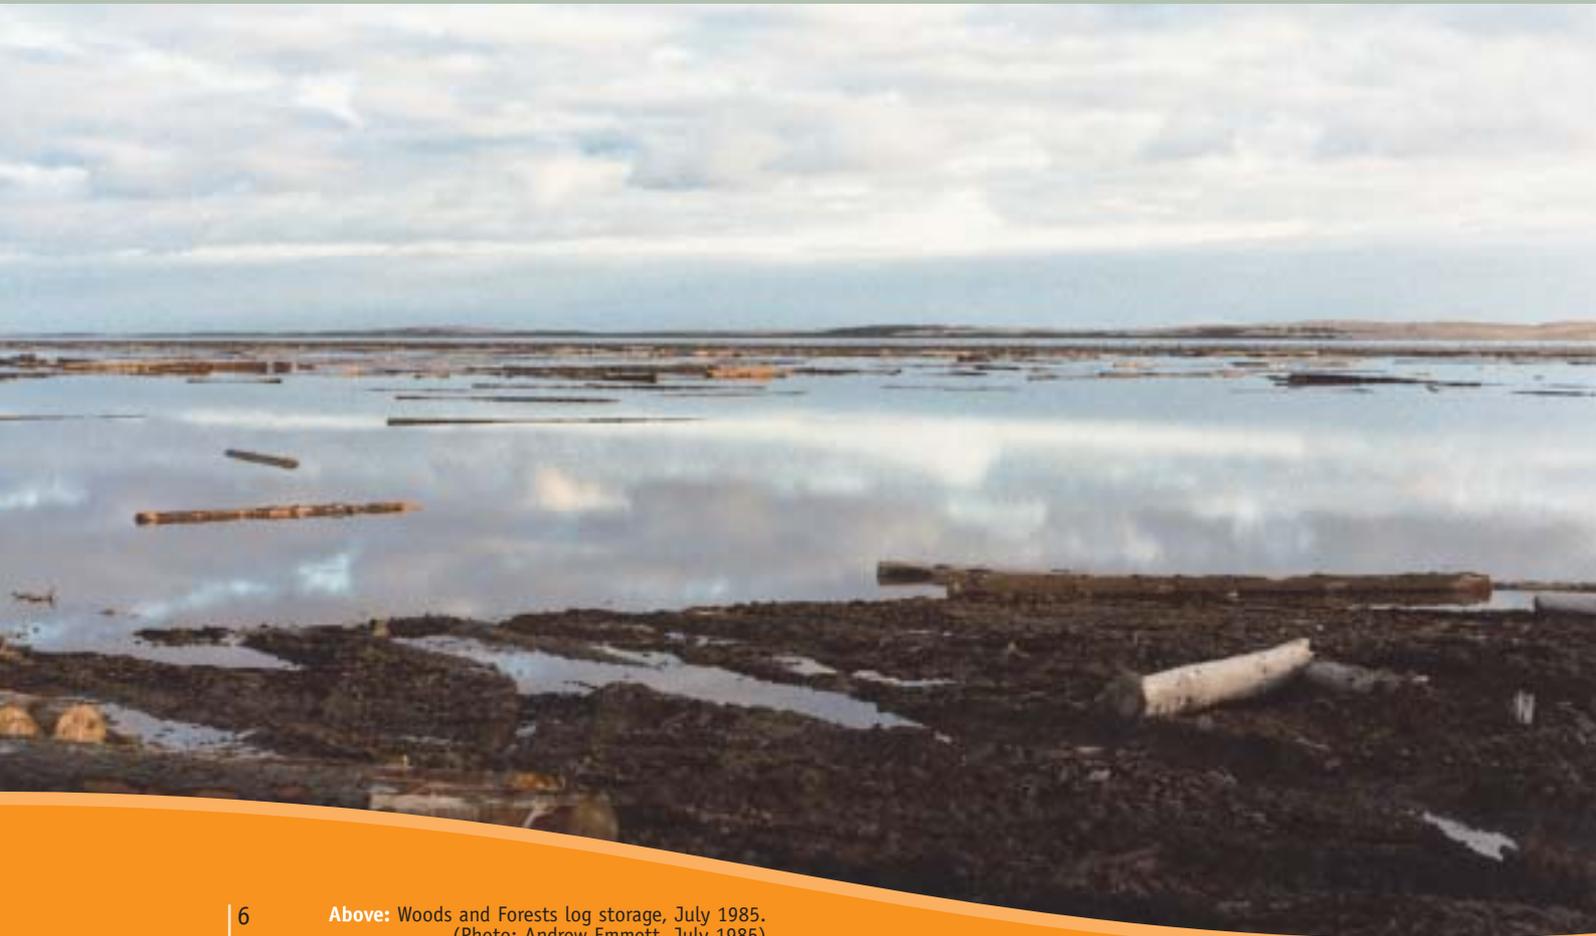
Above: Some remnant pine logs of the breakaway in 1983 on the shore of Lake Bonney SE (Photo: Skyring Environment Enterprises)

- > **Submerged pine logs:** the possible presence of submerged logs in the lake has caused the

ongoing closure of the lake to boating. The logs were stored in the lake to preserve the wood following the Ash Wednesday (February 1983) fires but an unknown number escaped from an impoundment during a storm in mid 1983.

Boating on the lake (secondary contact recreation) is currently closed because of the physical hazard of submerged logs. Exposed and submerged rocky outcrops provide similar risks for boating that also need to be managed. Any rehabilitation plan that aims to allow secondary contact recreation on the lake would need to:

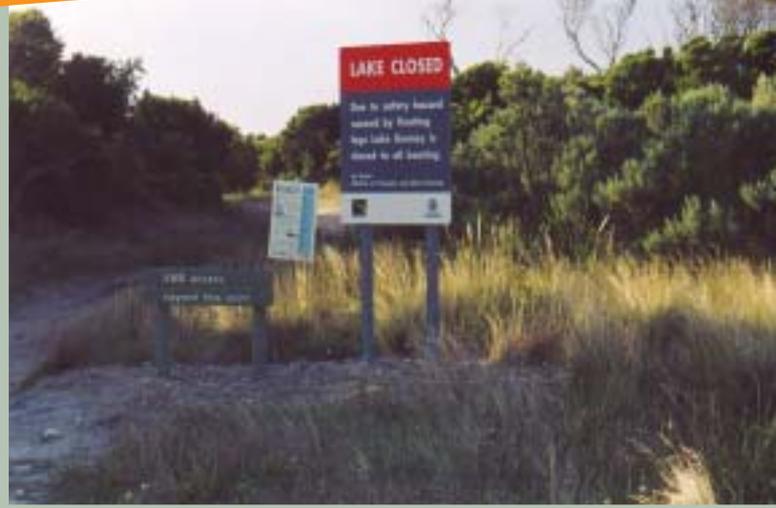
Above: Lake Bonney SE remains closed to boating activities (Photo: KCA, November 2003)

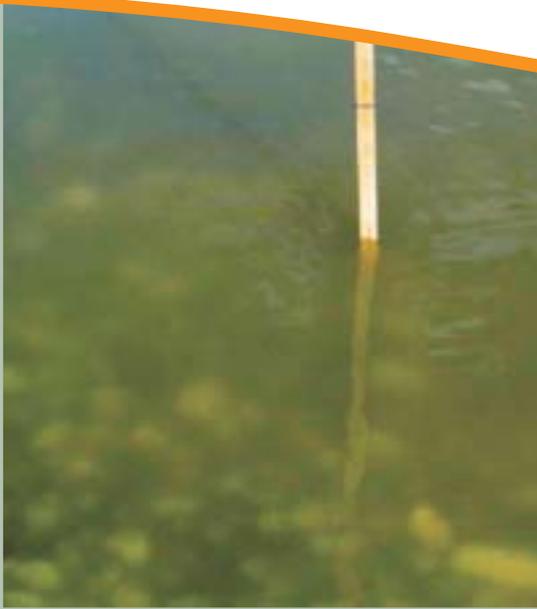
Above: Lake Bonney SE water in April 2003; both turbid and yellow in colour (Photo: Skyring Environment Enterprises)

- > **Colour:** peaked at 1400 HU in 1992, decreased to around 100 HU in 2000; coloured organic substances were (and still are) discharged from the pulp and paper mills into lake; the high colour probably affects algal and plant growth; WQP sets colour at

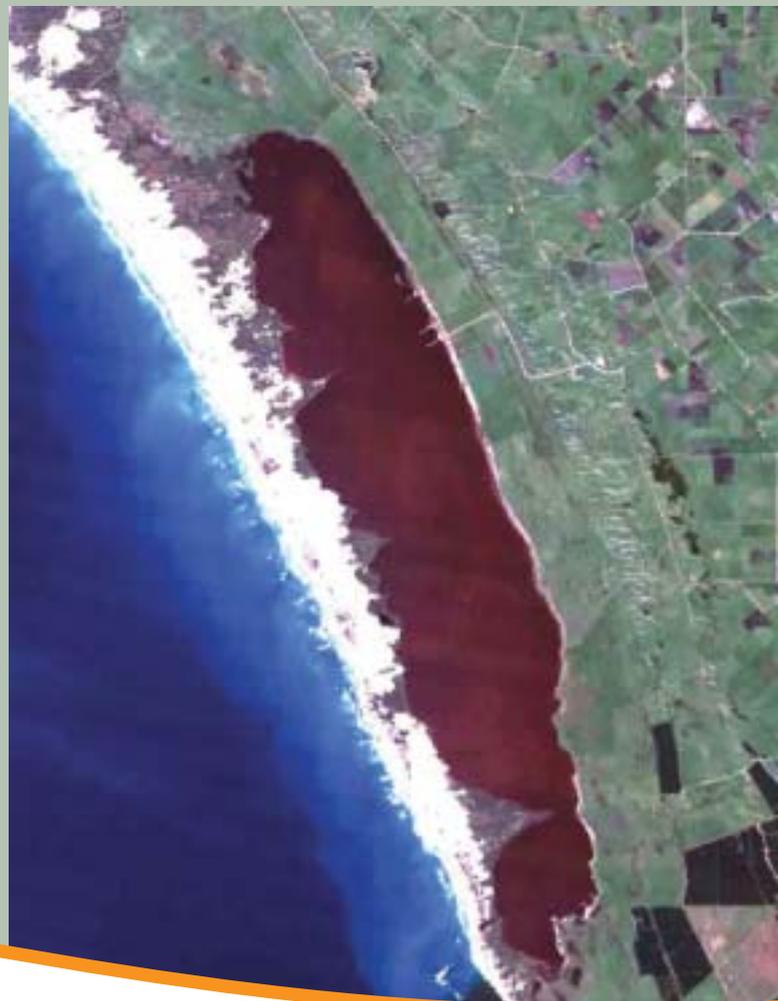
LANDSAT image 1980

8 **Right:** LANDSAT image of Lake Bonney SE in the 1980s, showing dark red colour of the lake due to the coloured organic discharge from the pulp and paper mill at Snuggery (Photo: ©Commonwealth of Australia—ACRES, Geoscience Australia)

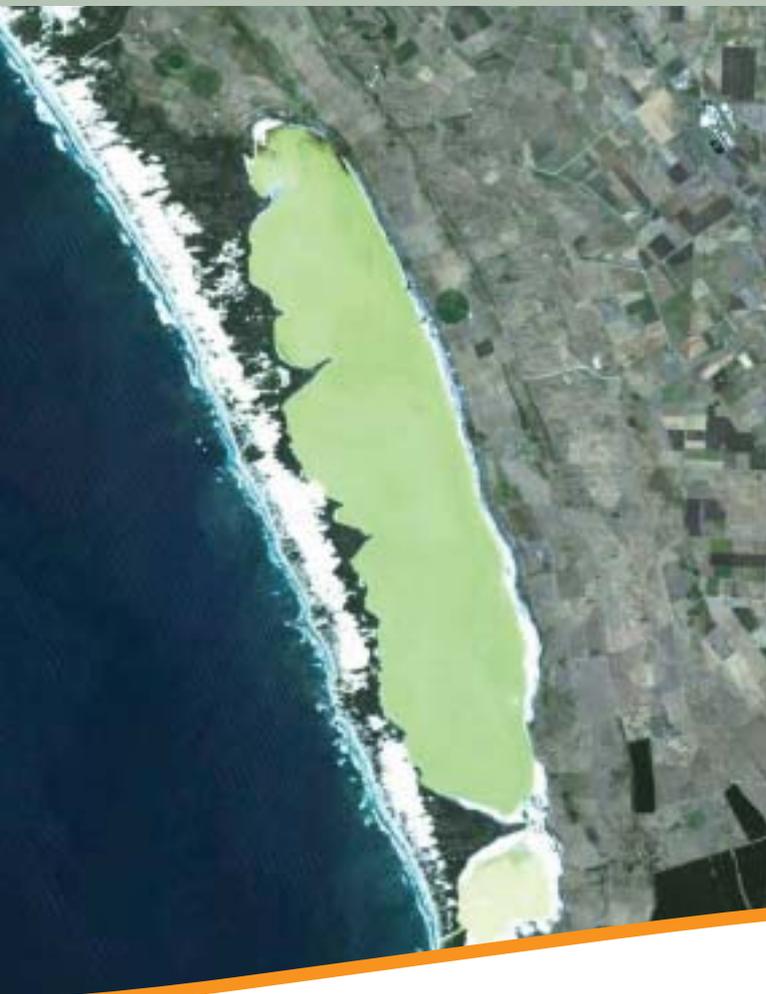
LANDSAT image 2000

9  
**Left:** LANDSAT image of Lake Bonney SE in 1999–2000, showing obvious improvement in lake colour (Photo: ©Commonwealth of Australia—ACRES, Geoscience Australia)
