Lower Lakes and Tributaries

Water Quality Report

Ambient and Response Monitoring

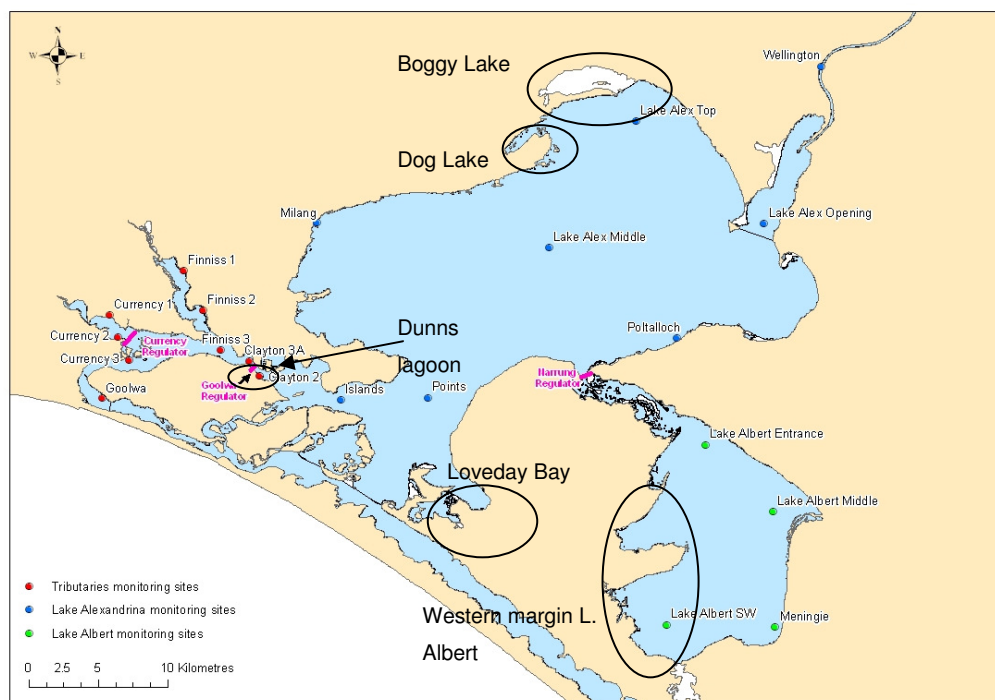
Figure 1 – Map of the ambient (points) and response (black ovals) monitoring sites

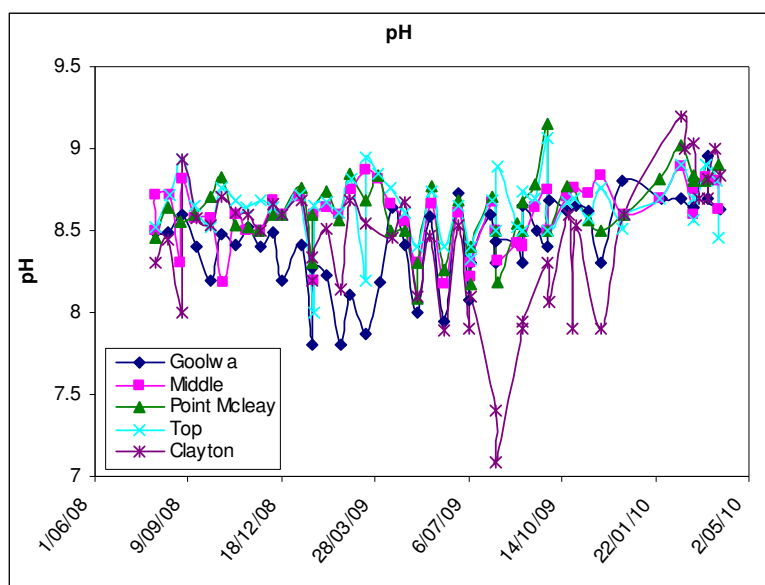
- pH levels are relatively stable and within ANZECC guideline levels (pH 6.5-9.0) at all sites in the main Lake Alexandrina water body (Figure 2).

Figure 2 – pH at the Lake Alexandrina ambient monitoring sites

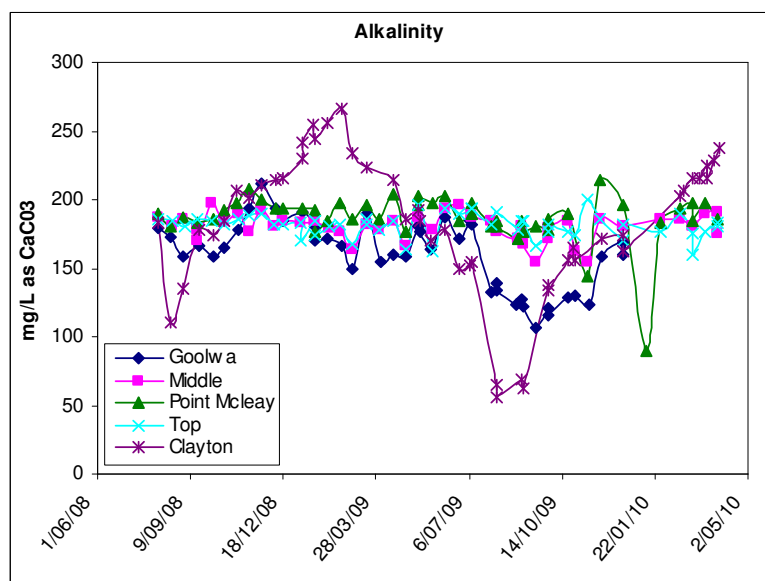
- Alkalinity remains stable and satisfactory for all sites in the main areas of Lake Alexandrina (Figure 3).

Figure 3 – Alkalinity at the Lake Alexandrina ambient monitoring sites

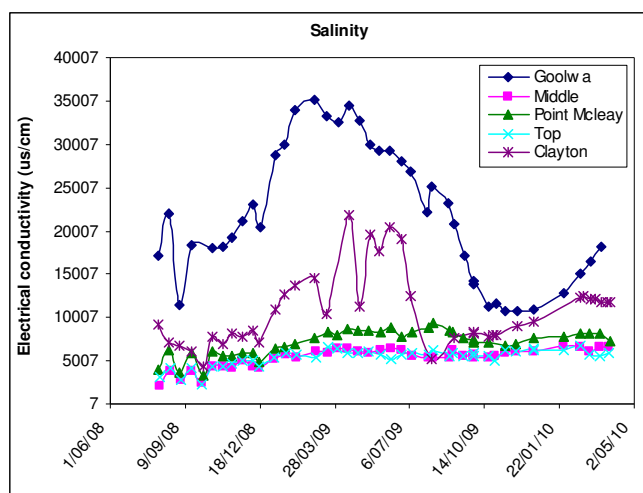
Salinity levels (as measured by electrical conductivity) have slightly decreased at most sites recently (Figure 4). Autumn rainfall and increased River Murray inflows have contributed, along with cooler autumn weather, to this decrease. Despite these minor decreases, salinity thresholds for freshwater species to live healthily in the Lower Lakes have already been exceeded in the entire Lower Lakes². A current EPA macro-invertebrate survey of the Lower Lakes is confirming this assessment with no or very few freshwater species remaining and very limited recolonisation of brackish-estuarine species. Salinity at the Goolwa site is very high and has still been increasing, possibly due to leakage through the Goolwa barrage now that water levels have decreased below mean sea level in this region again.

Figure 4 – Salinity at the Lake Alexandrina ambient monitoring sites

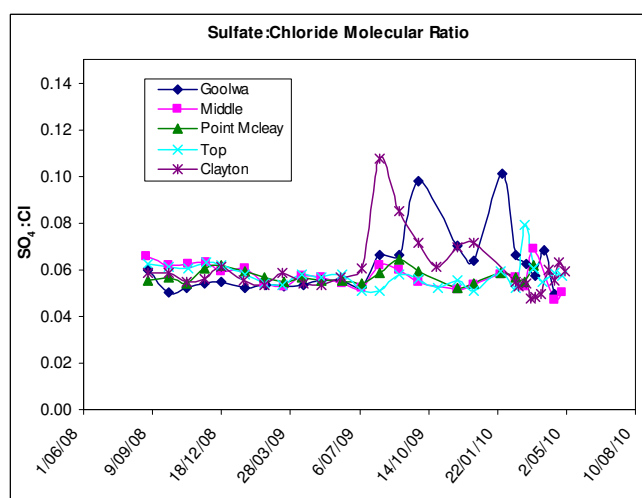
- The sulfate:chloride ratio shows some variability but is not showing any clear increasing trends that would suggest widespread acid sulfate soil influences (Figure 5). Some increases were seen at the Goolwa and Clayton sites, likely as a result of localised acidification in the Currency-Finiss region during the winter of 2009.

Figure 5 – Sulfate:chloride ratio at the Lake Alexandrina ambient monitoring sites

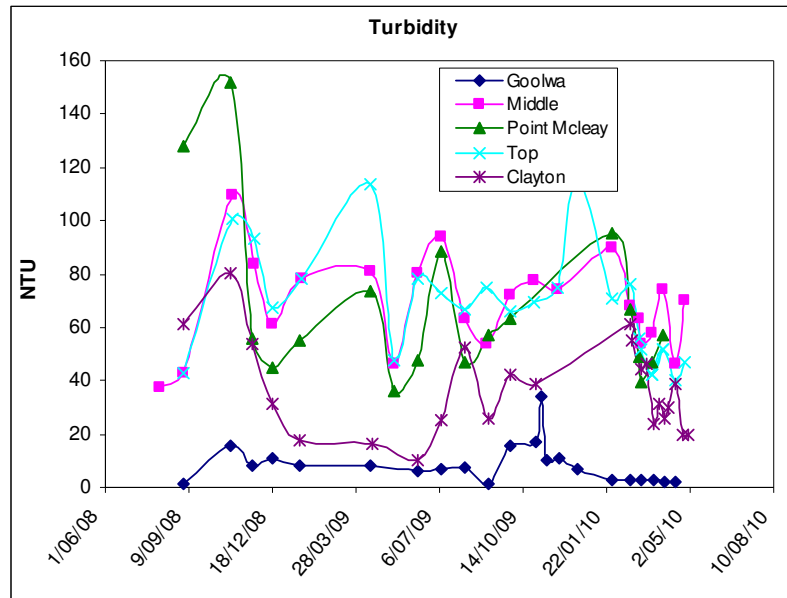
- Turbidity is very variable in Lake Alexandrina and influenced primarily by wind events (Figure 6). The sites at Goolwa and near Clayton appear to have much lower turbidity than the other sites at present. This could be due to less current-driven resuspension of sediment as a consequence of the Clayton regulator being in place. The aggregation and settling of suspended particles is also likely to be increased by the high salinities at these two sites (Figure 4).

Figure 6 – Turbidity at the Lake Alexandrina ambient monitoring sites

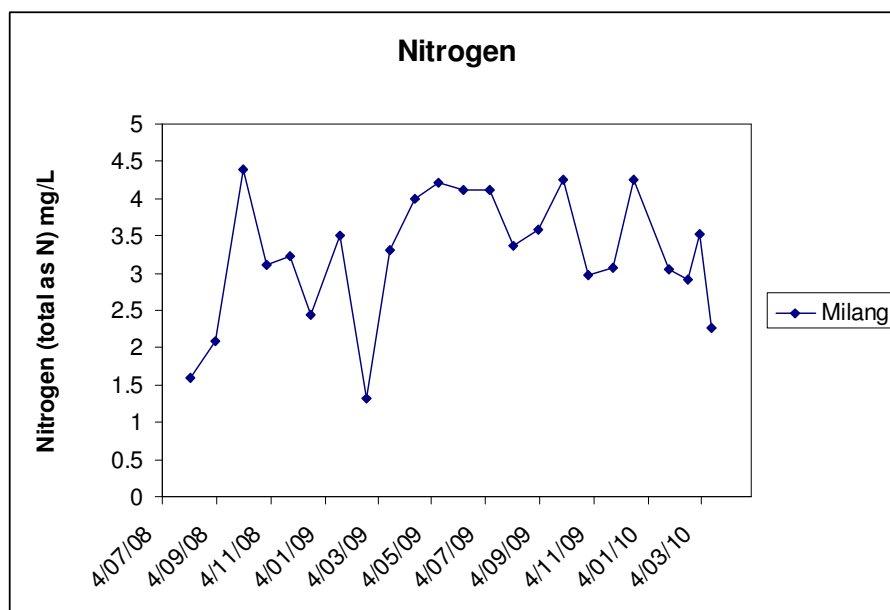
- Total nitrogen and total phosphorus remain at very high levels in Lake Alexandrina (see Milang data in Figures 7 and 8). These levels are well in excess of the ANZECC guidelines (<1 mg/L TN, <0.025 mg/L TP) and high compared to historical levels.

Figure 7 – Total Nitrogen at Milang

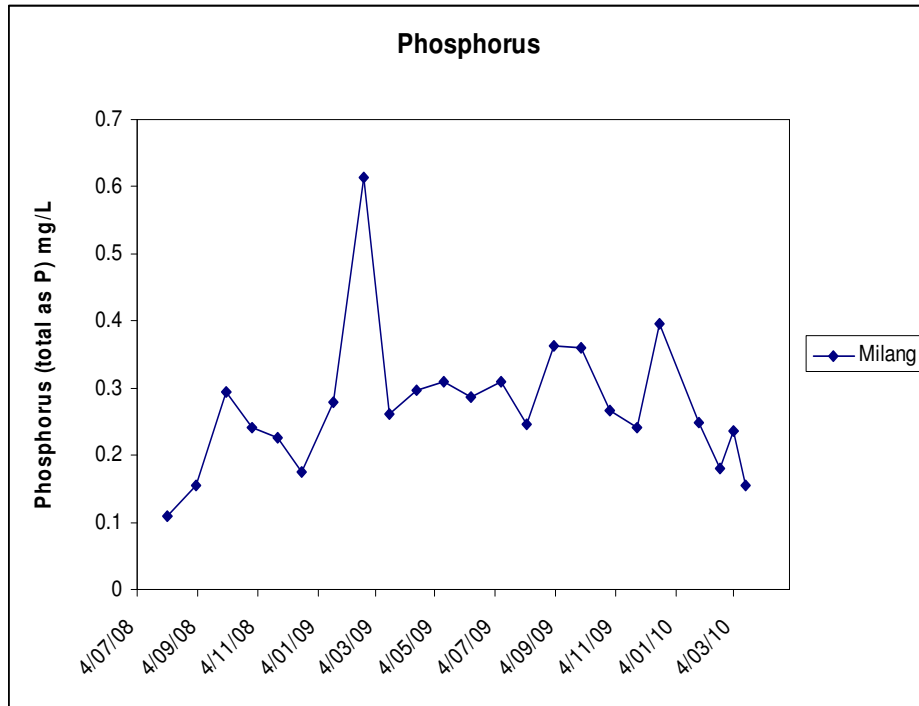
Figure 8 – Total Phosphorus at Milang

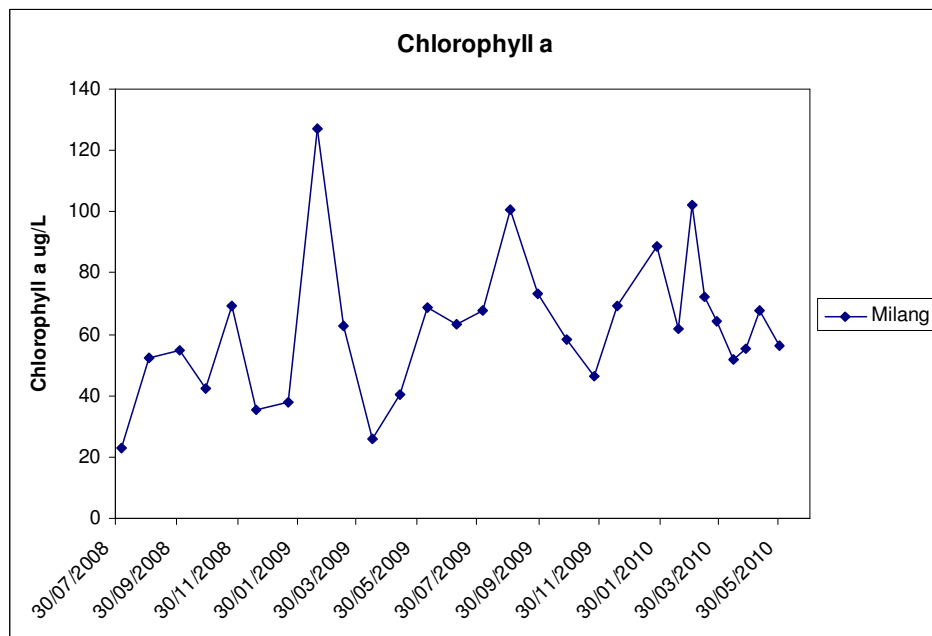
- Chlorophyll *a* is also at very high levels in Lake Alexandrina (see Milang data in Figure 9). These levels are well in excess of historical values and the ANZECC guidelines (<15 µg/L) and indicate a highly nutrient enriched (hyper-eutrophic) system. While the chlorophyll levels in Lake Alexandrina are very high, no potentially toxic blue-green algal blooms are present.

Figure 9 – Chlorophyll at Milang

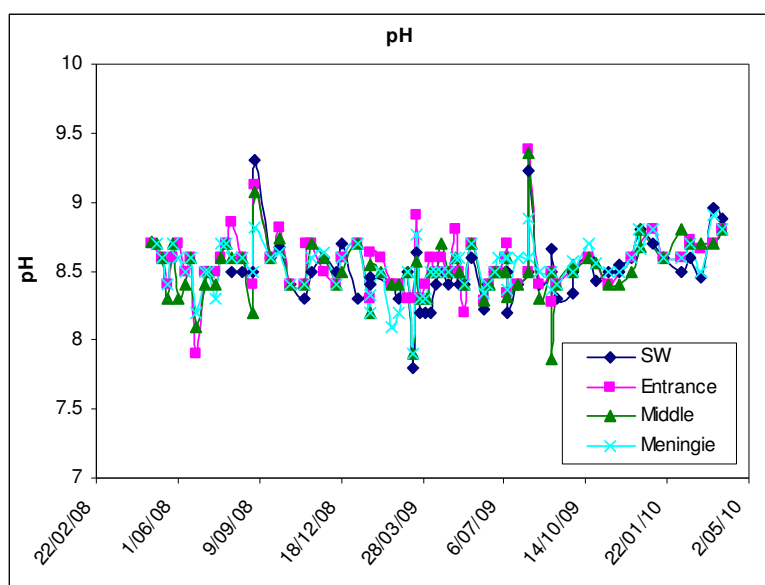
- pH levels are stable and within ANZECC guideline levels (pH 6.5-9.0) at all sites in the main Lake Albert water body (Figure 10).

Figure 10 – pH at the Lake Albert ambient monitoring sites

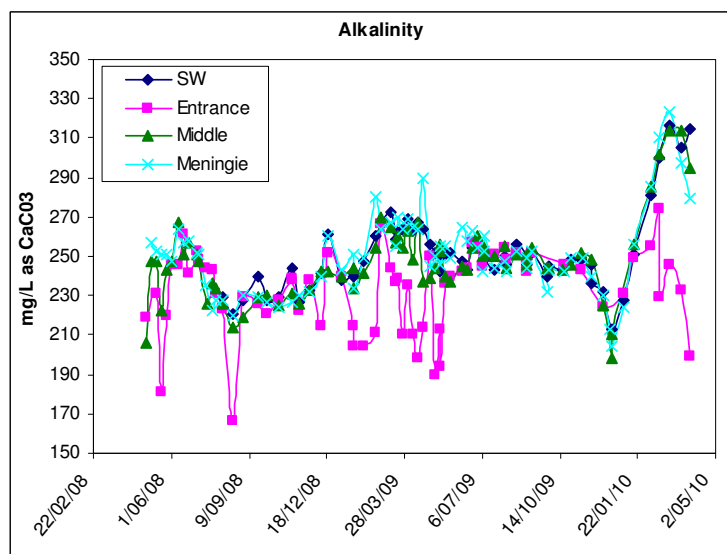
- Lake Albert alkalinity remains high and rapid increases were seen in January (270 - 310 mg/L as CaCO_3 , Figure 11). The reason for this increase is unclear as the alkalinity levels now greatly exceed those in Alexandrina and previously the lake has been calculated to be super-saturated with CaCO_3 . Alkalinity has been decreasing over the last month at all sites. This is presumably due to the increasing dilution from lower alkalinity water pumped from Lake Alexandrina with the entrance site recording the largest alkalinity decline.

Figure 11 – Alkalinity at the Lake Albert ambient monitoring sites

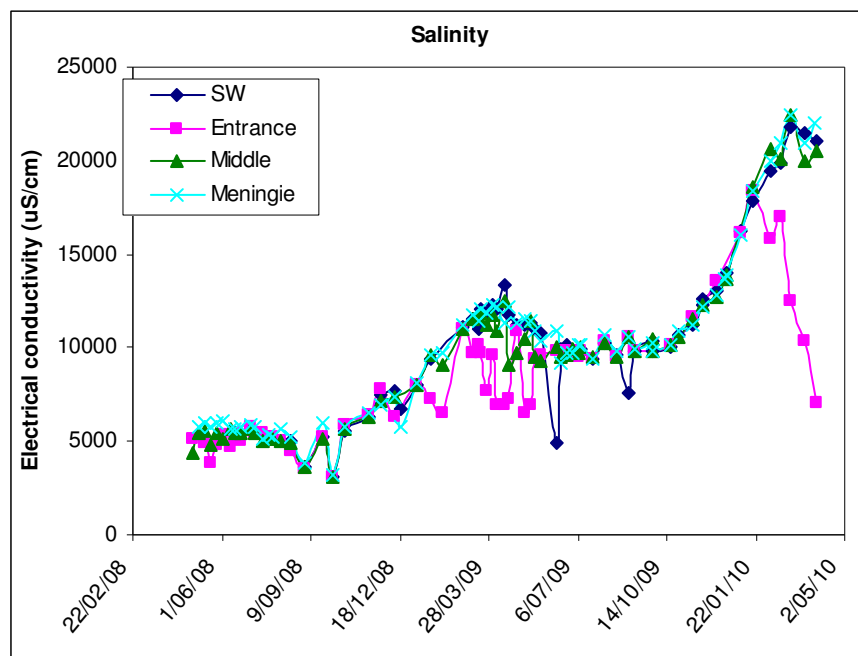
- Salinity remains very high compared to historical levels but has recently decreased at all sites (Figure 12). This is presumably due to the increasing dilution from lower salinity water pumped from Lake Alexandrina with the entrance site recording the greatest salinity decline.

Figure 12 – Salinity at the Lake Albert ambient monitoring sites

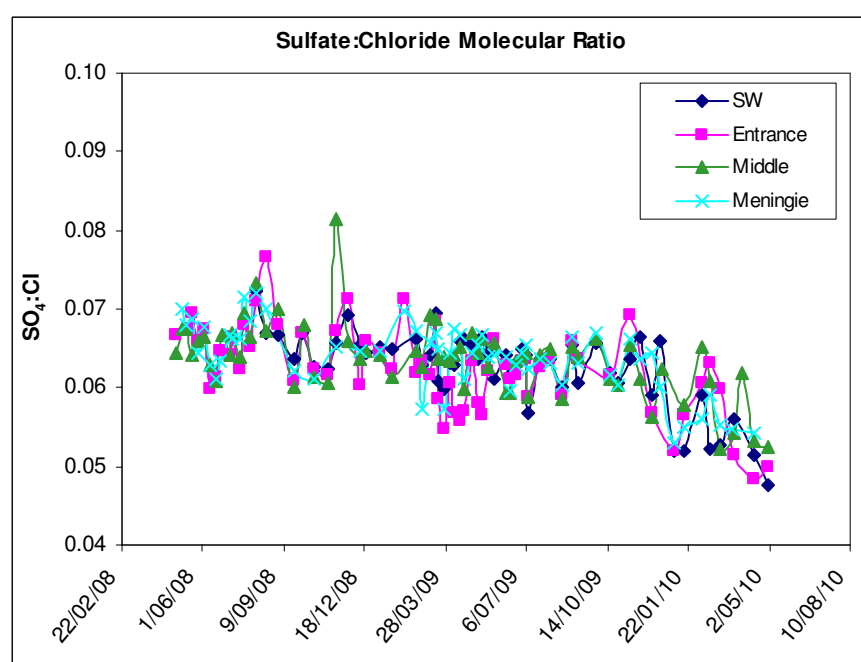
- The sulfate:chloride ratio has decreased over the last few months (Figure 13). This may be related to the dilution from Lake Alexandrina water pumped in (ratio is now similar to that in Lake Alexandrina, see Figure 5).

Figure 13 – Sulfate:chloride ratio at the Lake Albert ambient monitoring sites

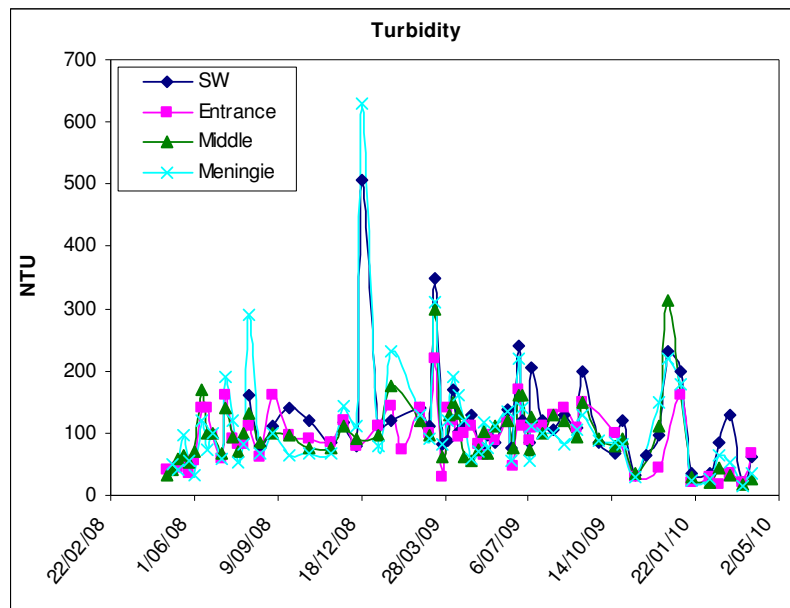
- Turbidity in Lake Albert currently appears relatively low in comparison to levels in the last 2 years (Figure 14).

Figure 14 – Turbidity at the Lake Albert ambient monitoring sites

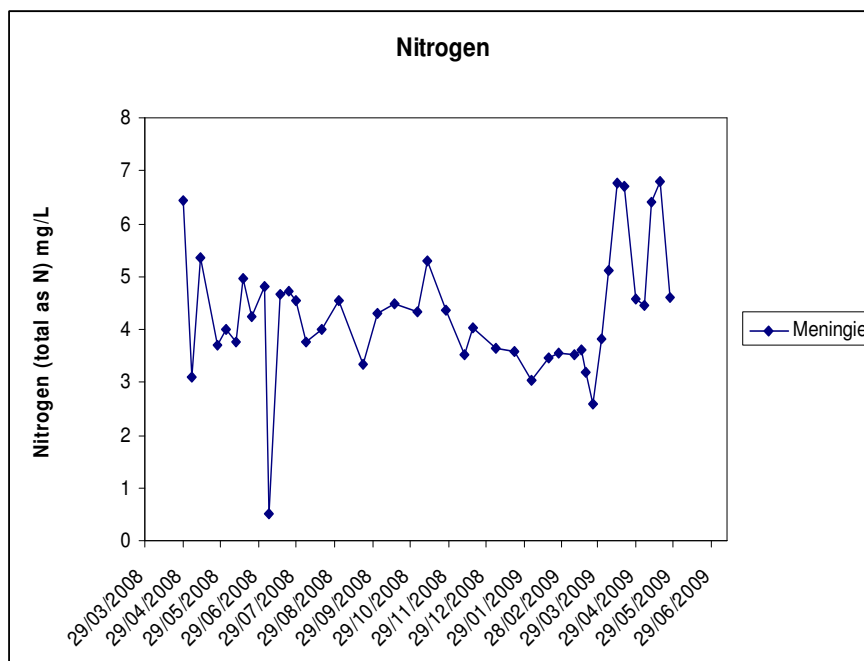
- Total nitrogen and total phosphorus are now at very high levels in Lake Albert (see Meningie data in Figures 15 and 16).

Figure 15 – Total Nitrogen at Meningie

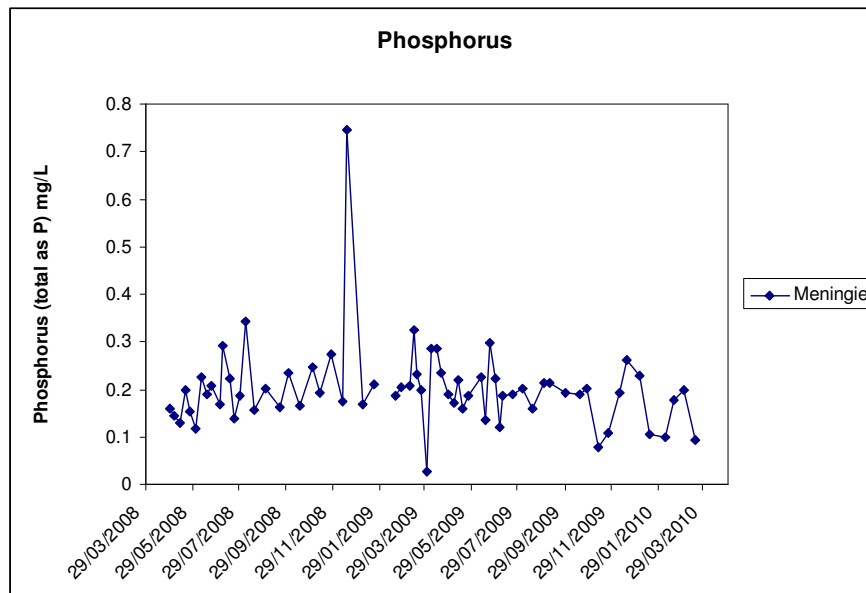
Figure 16 – Total phosphorus at Meningie

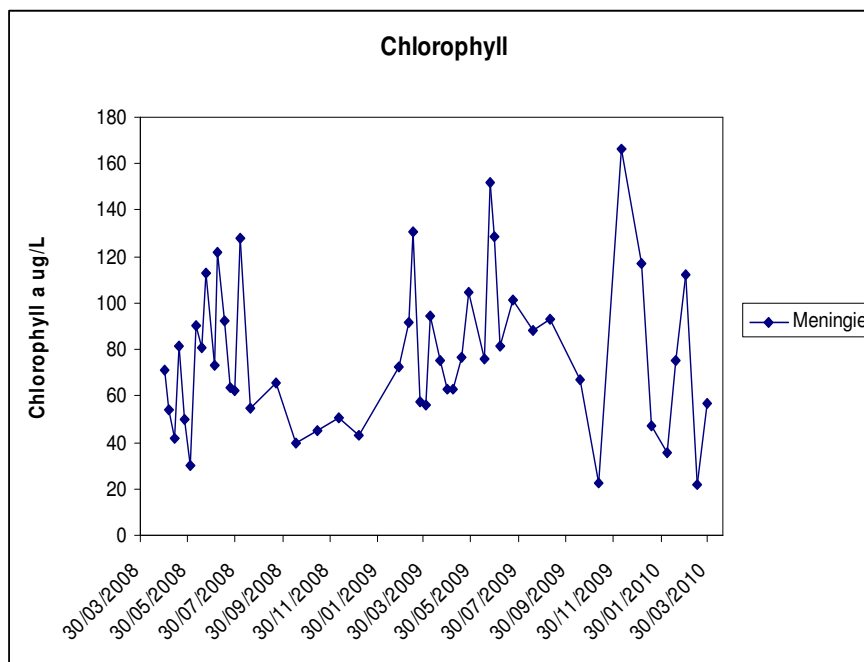
- Chlorophyll *a* is variable but remains at very high levels in Lake Albert (see Meningie data in Figure 17). These levels are well in excess of the ANZECC guidelines (<15 µg/L) and indicate a very nutrient enriched system. No toxic blue-green algal issues are apparent at present although this will be monitored closely over coming months as a large *Nodularia* (potentially toxic blue-green algae) bloom formed last winter.

Figure 17 – Chlorophyll at Meningie

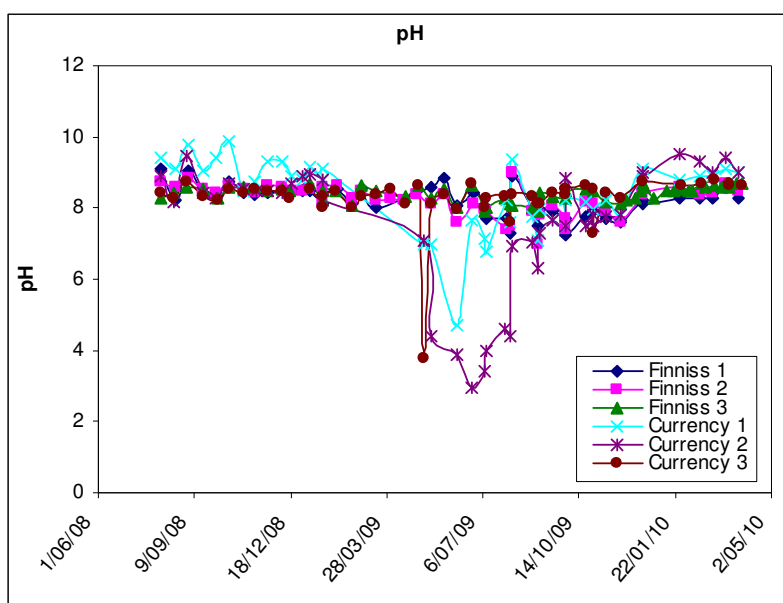
- pH levels are stable and within ANZECC guideline levels (pH 6.5-9.0) at all sites in the tributaries (Figure 18).

Figure 18 – pH at the Tributary ambient monitoring sites

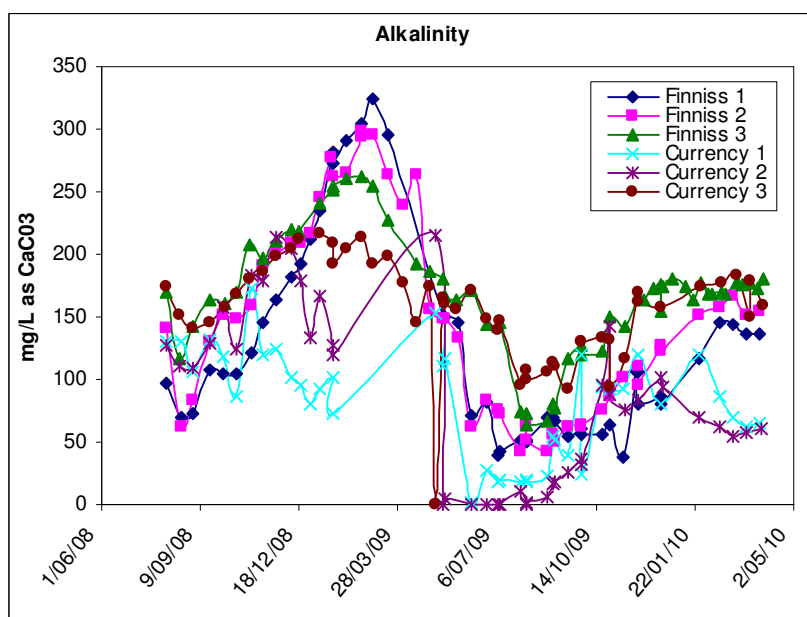
- Alkalinity at most of the tributary sites is satisfactory (Figure 19). The upper Currency Creek region has shown some alkalinity declines and the upper Currency pool now has a low alkalinity (see acidification response section).

Figure 19 – Alkalinity at the Tributary ambient monitoring sites

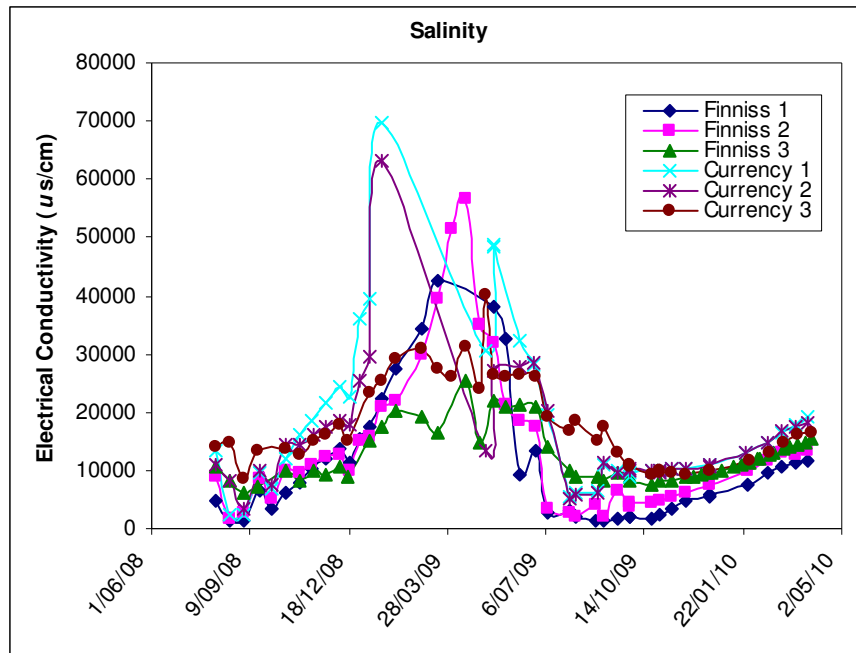
- Salinity is still increasing at all sites due to concentration by evaporation (Figure 20). This area is not receiving any dilution from the recent increased river inflows to Lake Alexandrina.

Figure 20 – Salinity at the Tributary ambient monitoring sites

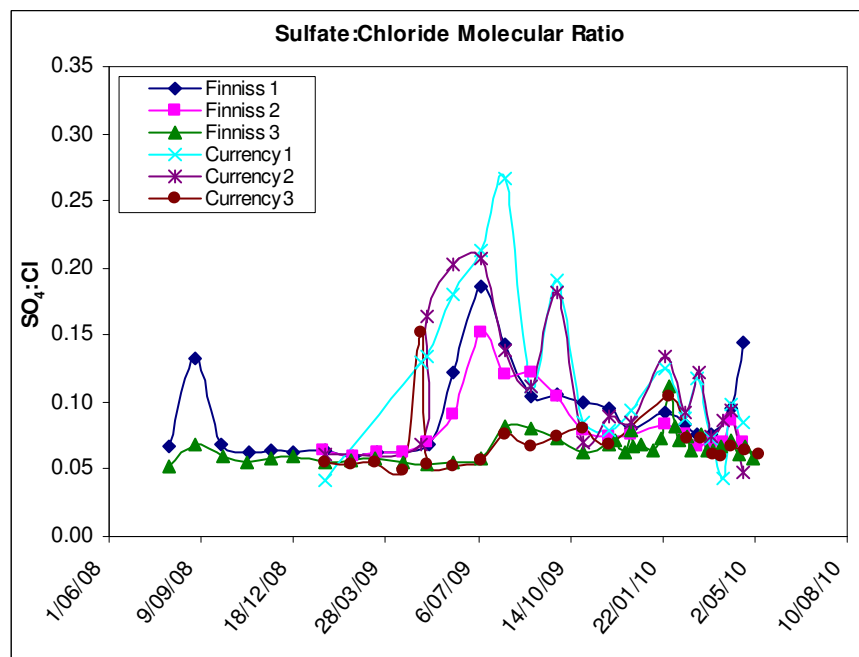
- The sulfate:chloride ratio shows some variability but is currently not showing any clear increasing trends that would suggest widespread acid sulfate soil inputs (Figure 21). Previously during the winter of 2009 there were large increases in this ratio when the Currency region acidified.

Figure 21 – Sulfate:chloride ratio at the Tributary ambient monitoring sites

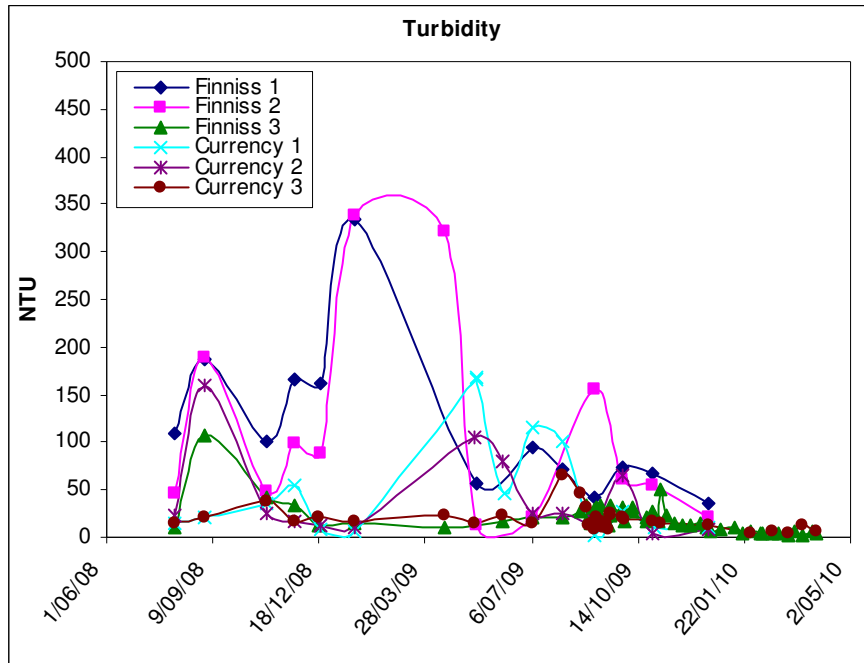
- Since pumping finished into the Goolwa Channel, the turbidity at all the tributary sites within the Clayton regulator has decreased markedly (Figure 22) and are at very low levels (<7NTU) in comparison to other sites in Lake Alexandrina (see Figure 6). The very low turbidity in this region is likely due to increased particle settling and reduced particle resuspension due to a reduction in wind-driven current flows following construction of the Clayton regulator. Salt-induced coagulation and settling of fine clay particles (colloids) is another likely reason for this outcome.

Figure 22 – Turbidity at the Tributary ambient monitoring sites

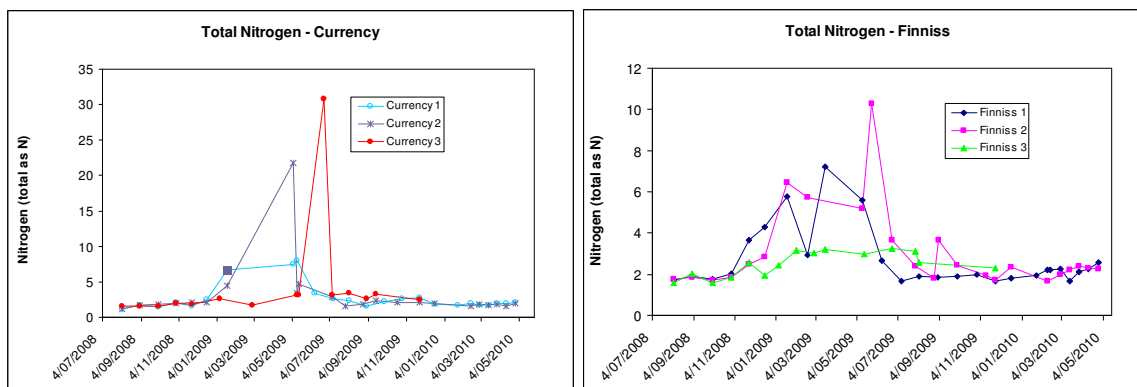
- Total nitrogen and phosphorus is at high levels in the tributaries although levels are presently much lower than during last winter (Figures 23 and 24).

Figure 23 – Total Nitrogen at the Tributary ambient monitoring sites

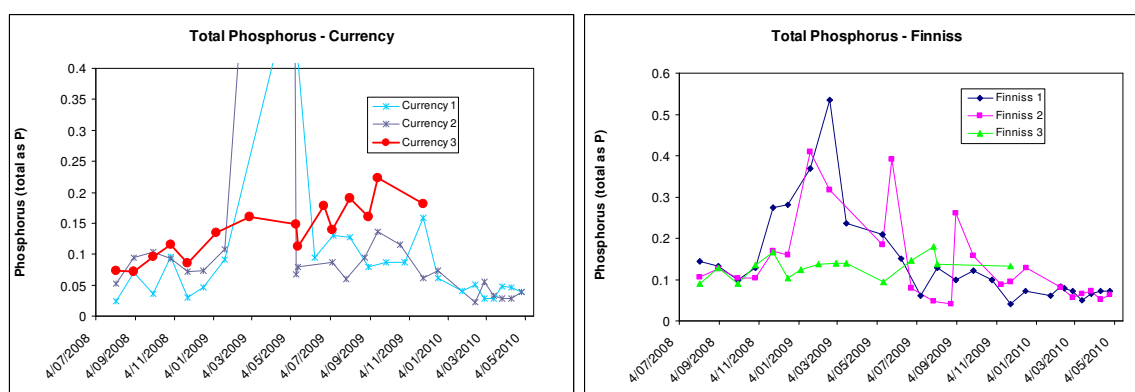
Figure 24 – Total phosphorus at the Tributary ambient monitoring sites

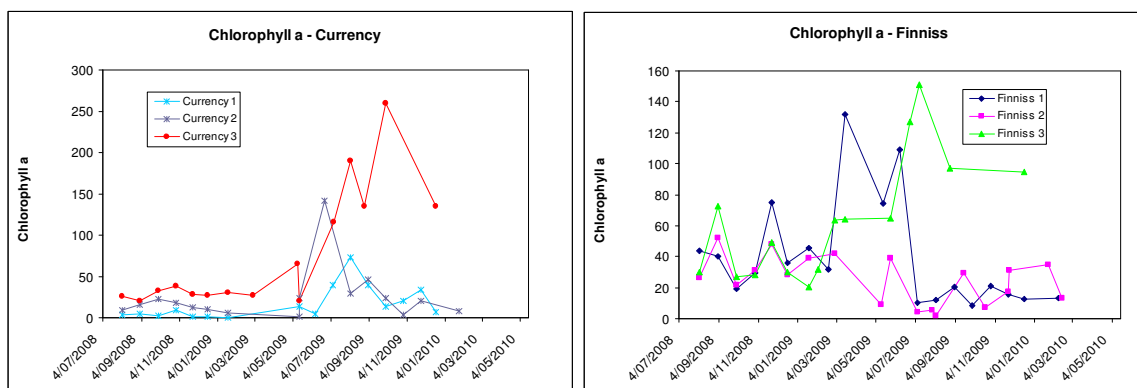
- Chlorophyll *a* is at very high levels at the lower tributary sites (Figure 25). These levels are well in excess of the ANZECC guidelines (<15 µg/L) and indicate a very nutrient enriched system. No toxic blue-green algal issues are apparent at present. A large increase in filamentous (*Cladophora* sp.) and macro-algal growth (*Stuckenia pectinata*) has been observed in this region, presumably as a result of the greater water clarity allowing more light to stimulate algal growth.

Figure 25 – Chlorophyll *a* at the Tributary ambient monitoring sites

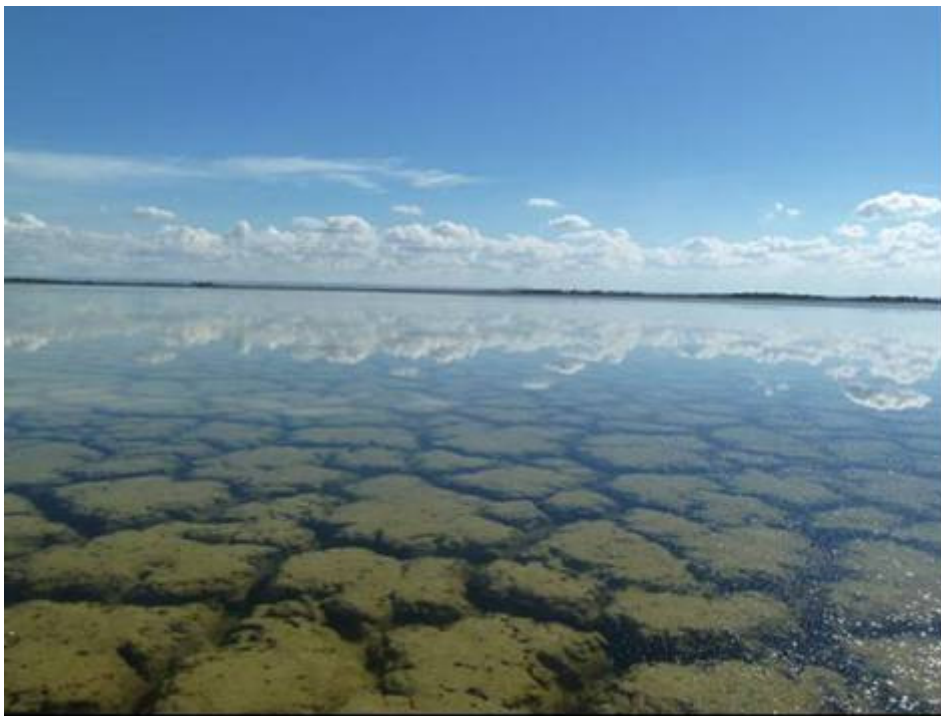
Boggy Lake is a shallow lagoon situated within the north-western corner of Lake Alexandrina. The lagoon is connected to the main water body on its eastern side. During the summer periods of 2008/09 and 09/10 a large proportion of Boggy Lake dried, exposing acid sulfate soils (predominantly cracking clays) with high net acidity to atmospheric oxygen and allowing the oxidation of pyrite to occur.

The oxidation of pyrite generates acidity (hydrogen ions, dissolved iron) in the soil. If severe acid conditions ($\text{pH} < 4$) develop in the soil, precipitation of secondary acidic minerals (e.g. Jarosite) often occurs and weathering of aluminosilicate (e.g. clay) minerals is enhanced. High concentrations of soluble aluminium are a common outcome of this weathering process.

Following recent rainfall events and water level increase in Lake Alexandrina, Boggy Lake has been rewet and progressively inundated (Figure 26).

Figure 26 – Acidified surface water (pH 2-3) overlying cracked clay soils

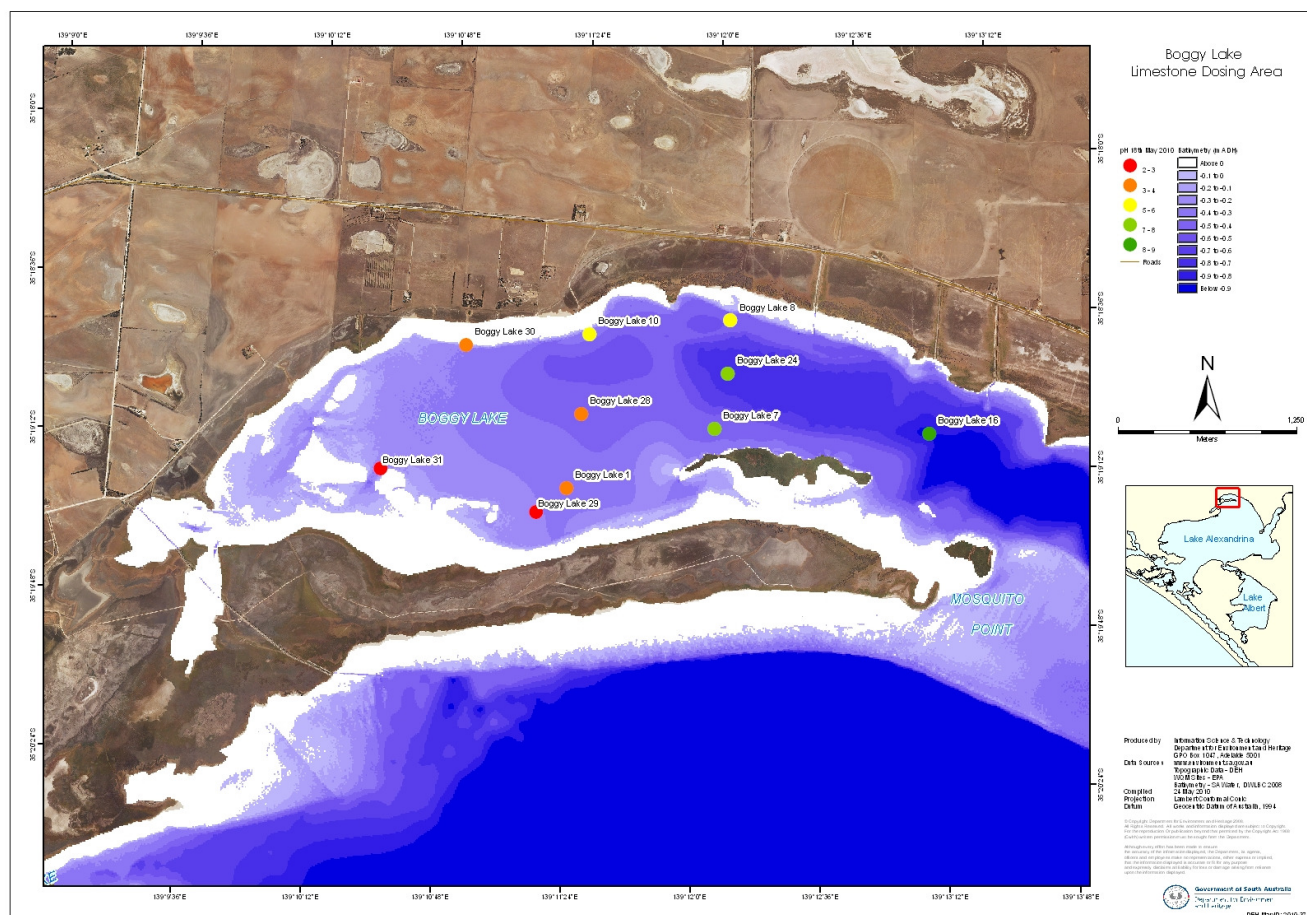
Figure 27 shows a map of pH levels at 10 sites in Boggy Lake sampled on 18/5/2010. Very low pH (2-3, red dots on figure) was present in the north-western margins of the lagoon. Approximately 250ha of surface water is acidic (pH<6.5) at present. The acidic sections of the lagoon have low turbidity, high acidity (up to 2500 mg/L as CaCO₃) and dissolved metal (Al, Fe) concentrations. The Boggy Lake waters increase in pH as they mix with the alkaline waters of Lake Alexandrina. Brown iron oxide precipitates are forming as the water is neutralised but precipitates (suspected to be Schwertmannite) are also forming in acidic areas. The area was limestone dosed starting on 28/5/2009.

Figure 27 – Map of Boggy Lake pH levels on 18/5/2010

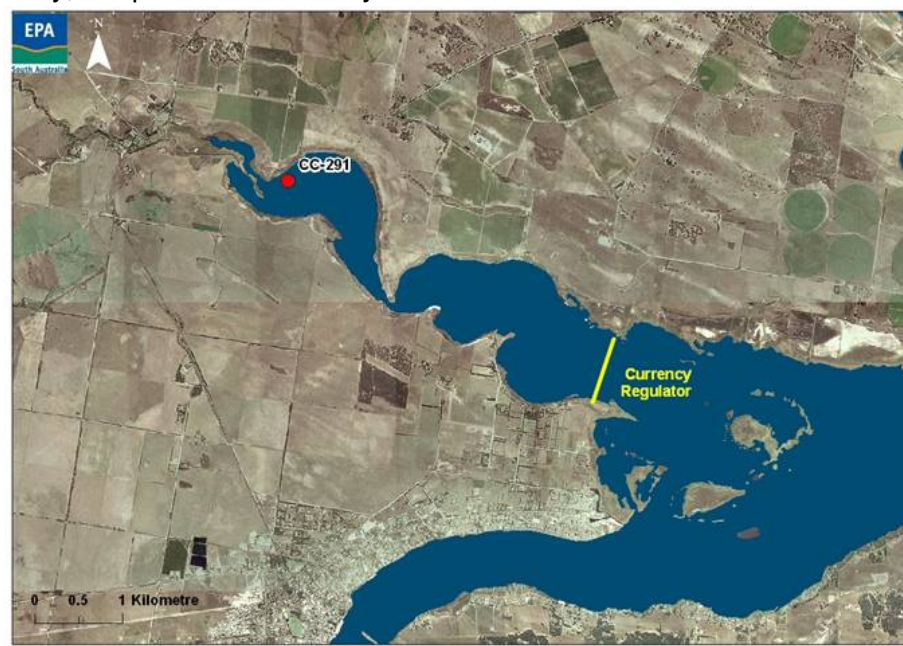
Upper Currency Creek is a large pool representing the transition from the narrow creek to the open waterbody. The pool is constrained by a narrow bottle neck which separates the pool from Goolwa channel (Figure 28). The pool completely dried out over the summer of 2008-09 exposing large areas of acid sulfate soils. Rainfall events in May 2009 allowed the pooling over the acid sulfate soils causing areas of localised acidification. In response to the acidification events, the area was aerial dosed with 1000 tonnes of limestone. Following the addition of limestone, and the construction of a regulator to keep sediments covered with water, the area recovered somewhat with increasing pH and alkalinity (69 mg/L as CaCO₃ on 18/1/2010). However, after the 2009-10 summer, alkalinity began to decrease again from 40 mg/L as CaCO₃ on 1/4/2010 to 11.5 mg/L as CaCO₃ on 17/5/2010. Large areas of orange/brown

Figure 28 – Upper Currency Creek – CC291 indicates main monitoring location

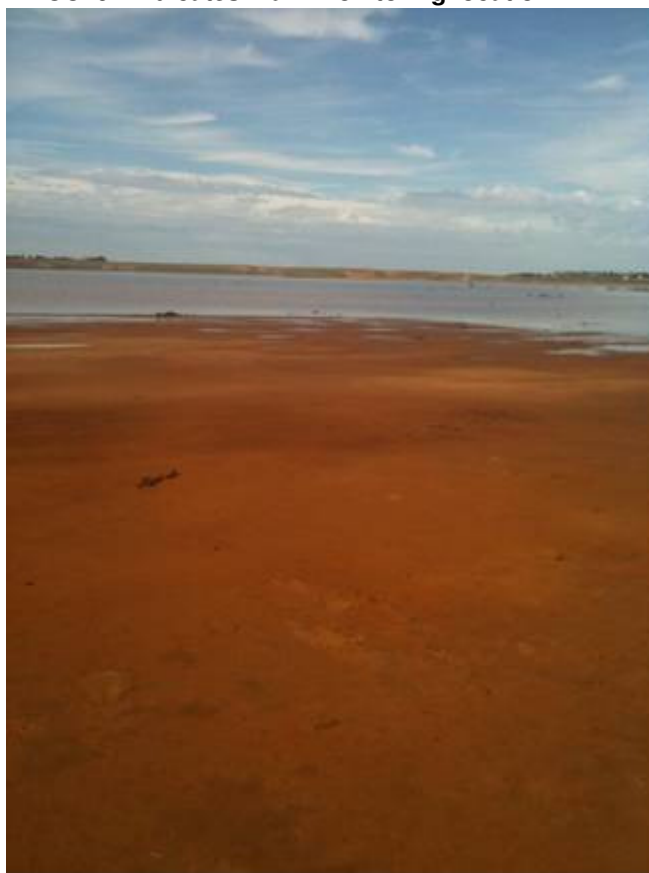
precipitate have been observed around the north-western side of the pool (see Figure 29) which is suspected to be an iron oxide precipitate. This site is currently being monitored twice weekly for decreases in alkalinity, the presence of acidity and metal release.

Figure 29 – Red/orange precipitate on the shoreline of Upper Currency Creek near monitoring location

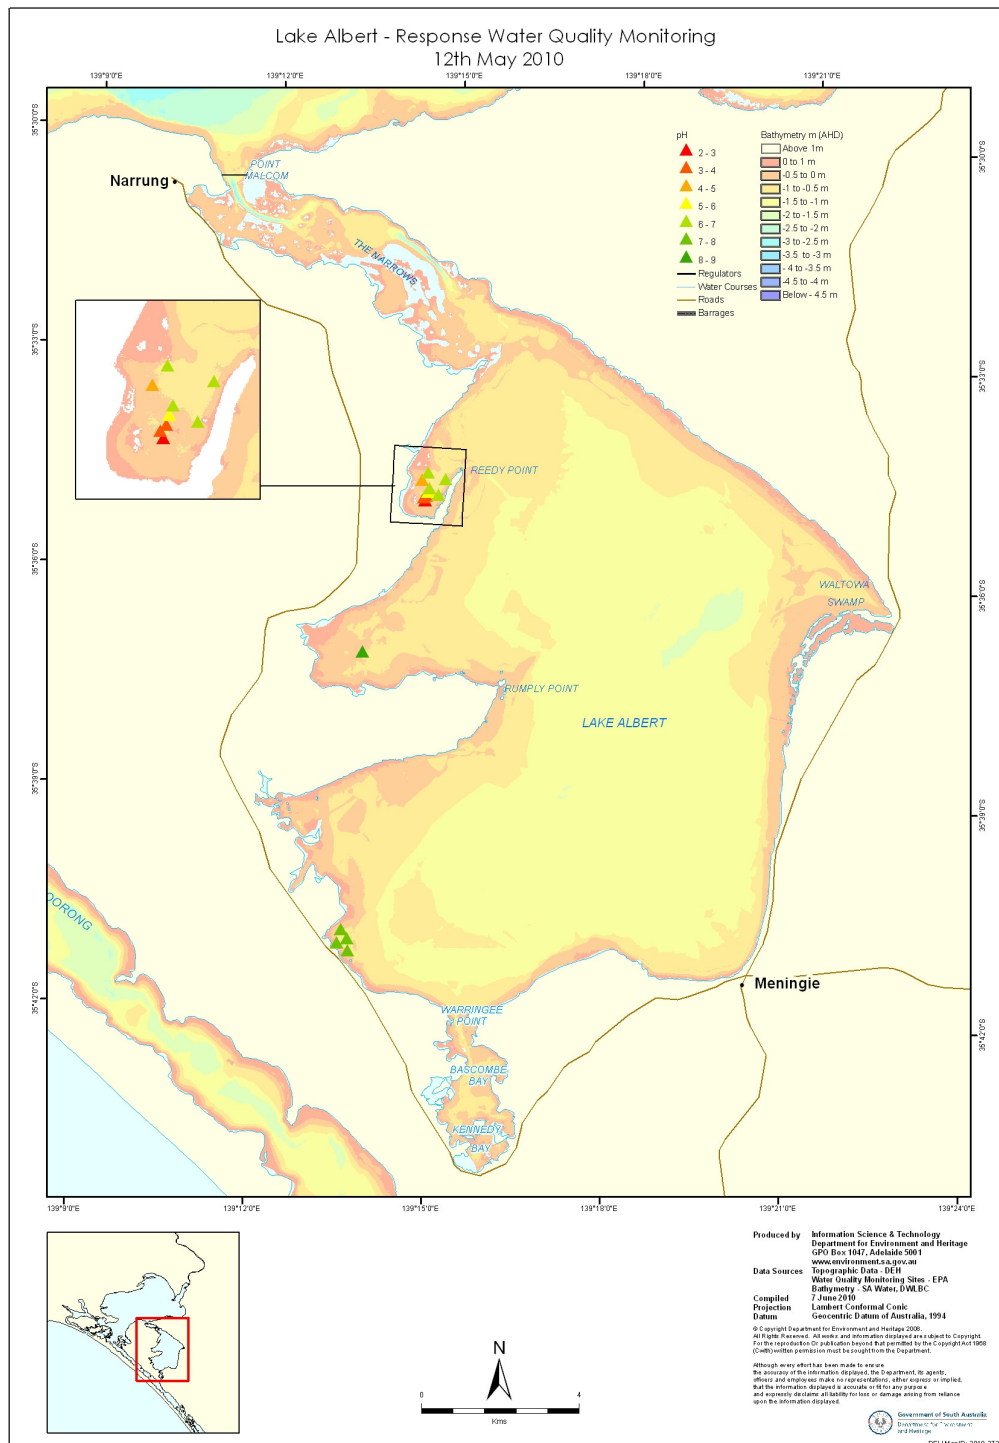
Water quality monitoring of Lake Albert's western shoreline 12th May 2010 sought to map the extent of 3 sites that had previously been screened to have low pH values. Nine sites were monitored in the bay to the west of Reedy Point of which all had pH below 7, ranging from 2.72-6.46 (Figure 30). A significant amount of acidity was present at these sites with values ranging from 95-945 mg/L CaCO₃. Scum deposits were also visible (Figure 31). The pool to the west of Rumpy Point previously tested was no longer present, monitoring of the closest water body revealed pH of 8.28 and alkalinity of 240 mg/L CaCO₃. The pool south-west of Rumpy Point previously tested had pH values ranging from 7.76-7.86 and alkalinity present at all sites, values ranging from 54-116 mg/L CaCO₃.

Figure 30 – Map of western Lake Albert pH levels in May 2010

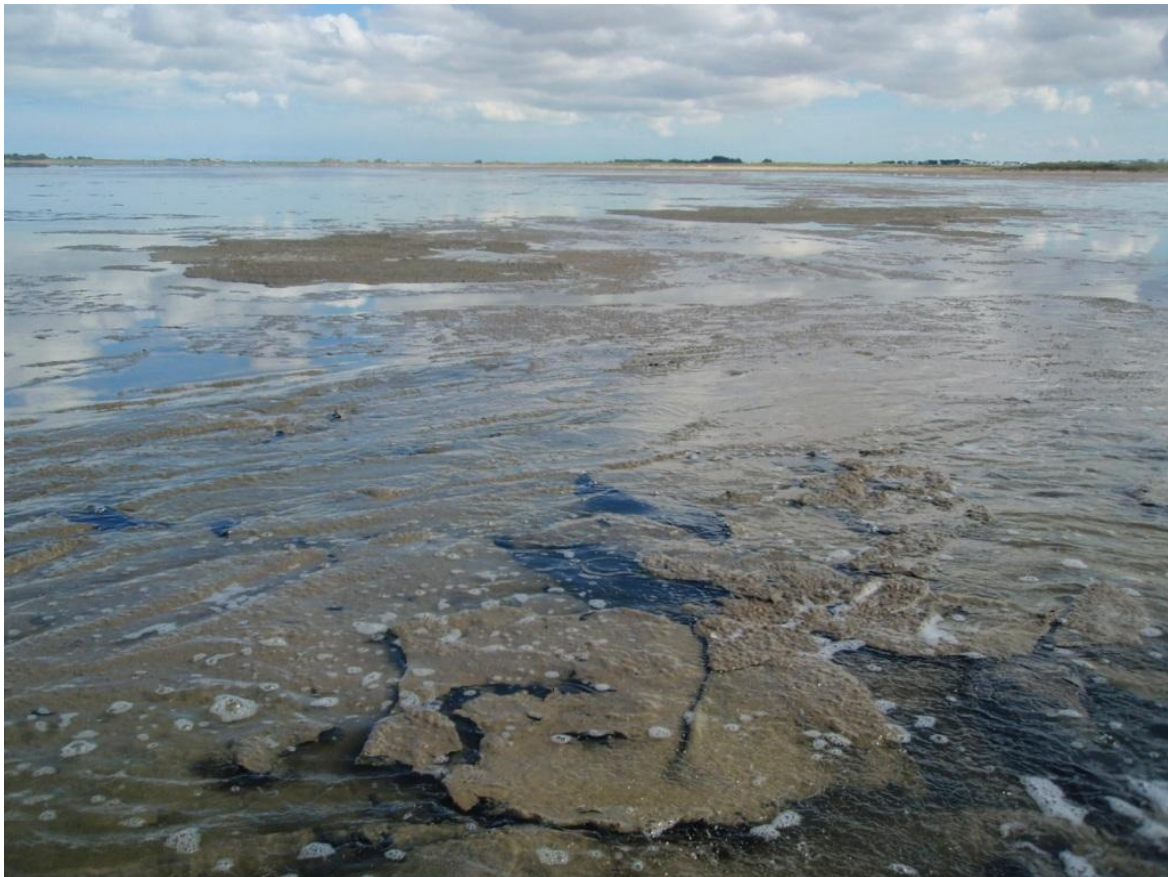
Figure 31 - Photos of water acidification and scum deposits at Reedy Point, Lake Albert

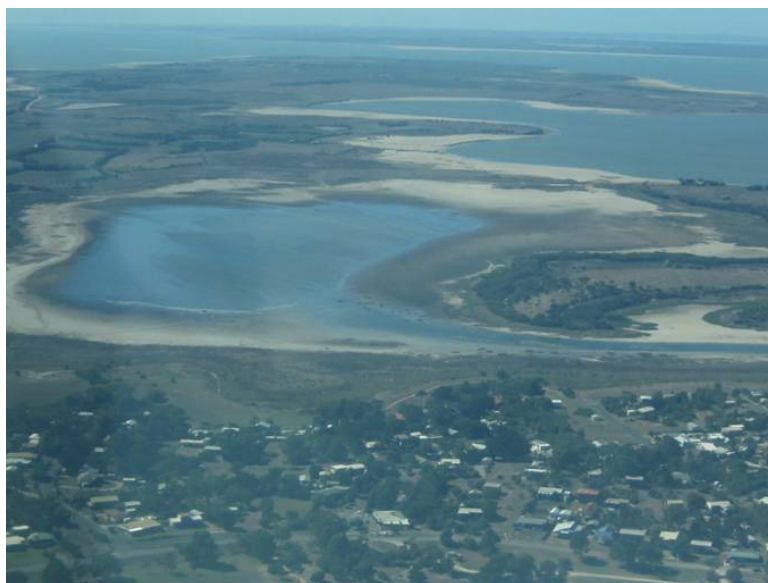
Dunn's Lagoon is near Clayton in Lake Alexandrina (Figures 1 and 32). This lagoon dried during 2008-2009 but has been recently rewet as a result of the water level rise. In 2009, acidic surface water was found pooled following a rainfall event, however follow up sampling during March 2010 has found the lagoon pH is now neutral (pH 7-8) at all sites. Dunn's Lagoon decreases in alkalinity away from the entrance of the lagoon to Lake Alexandrina, as the influence of alkaline Lake Alexandrina water reduces. The site closest to the channel entrance records alkalinity of 159-239 mg as CaCO_3 , compared to the middle of the lagoon which record low to moderate alkalinities (86-150 mg/L as CaCO_3). This suggests there has been some release of acidity from the soil into the waterbody but currently this is able to be neutralised by dilution by Lake Alexandrina water. Water exchange has been occurring routinely from the channel near Clayton but it has been noted that mixing with the main lake via the east channel has also occurred. Due to the occurrence of acidic water in the marginal cracks of Dunn's lagoon (as observed in April 2010), Dunn's lagoon is monitored regularly to ensure that pH and alkalinity remain acceptable.

Figure 32: Aerial photo of Dunn's Lagoon near Clayton (foreground) in Lake Alexandrina

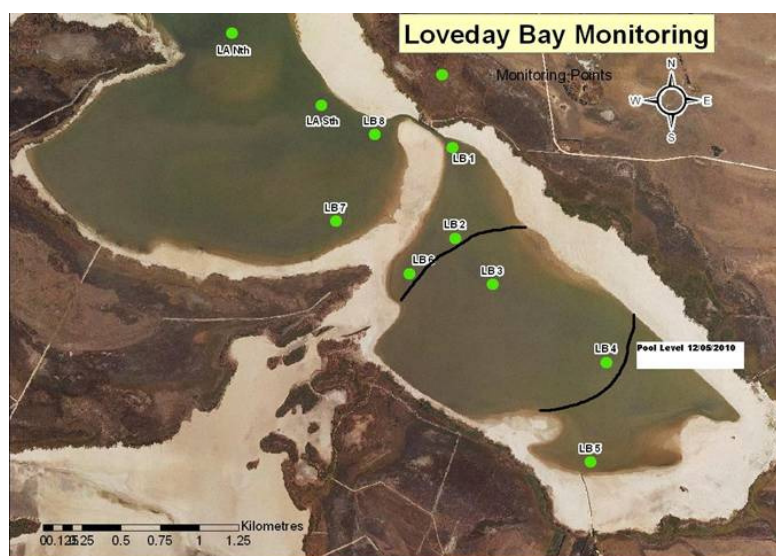
Loveday Bay is a shallow lagoon located at the south eastern shore of Lake Alexandrina (Figure 1). When water levels are below -0.3 AHD the lagoon is separated from Lake Alexandrina by a natural sand barrier (Figure 33). There is periodic connection to the main water body during some large wind events which can raise water levels on the Lake Alexandrina side. Large areas of Loveday Bay dried in the summer of 2008-09 allowing the oxidation of acid sulfate soils. Following rewetting from winter rains, the lagoon displayed large areas of acidic water ($\text{pH} < 3$), iron precipitates and partially or completely dissolved mussel shells. Since this time the EPA has monitored Loveday Bay on a fortnightly basis and low pH and high acidity has been present at most sites since mid 2009. The area has again dried over the 2009-10 summer, exposing sediments to oxidation. Recent samples indicate the water body is now neutral pH after a second winter rainfall rewetting and partial connection to Lake Alexandrina. Further follow-up sampling is underway.

Figure 33 Map of Loveday Bay showing natural sand barrier
