Report 15, to end of May 2010

Lower Lakes and Tributaries

Water Quality Report

Ambient and Response Monitoring

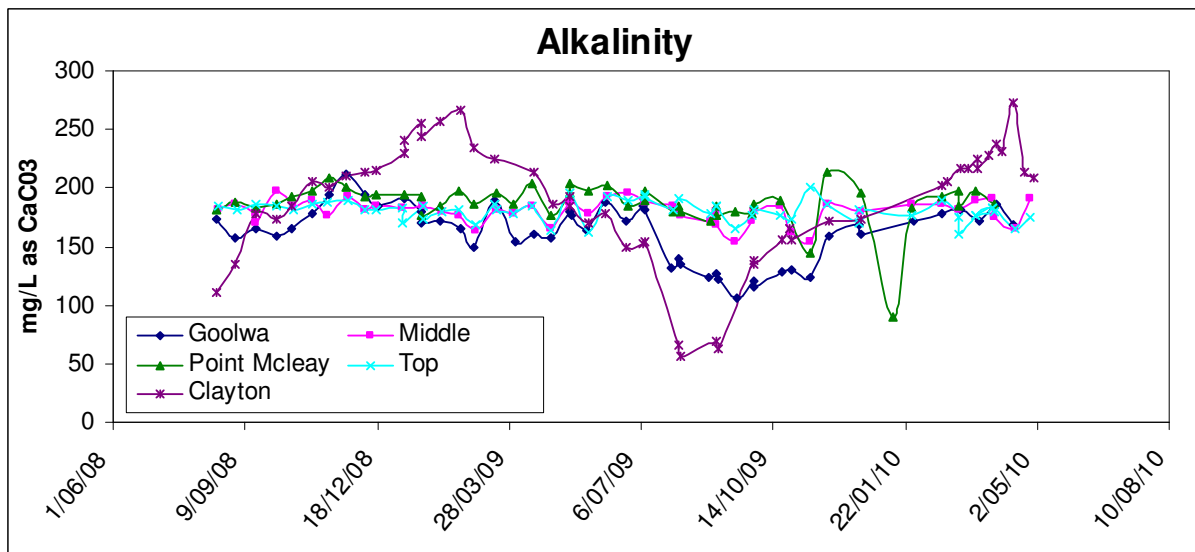
- Alkalinity remains stable and satisfactory for all sites in the main areas of Lake Alexandrina (Figure 3).

Figure 3 – Alkalinity at the Lake Alexandrina ambient monitoring sites

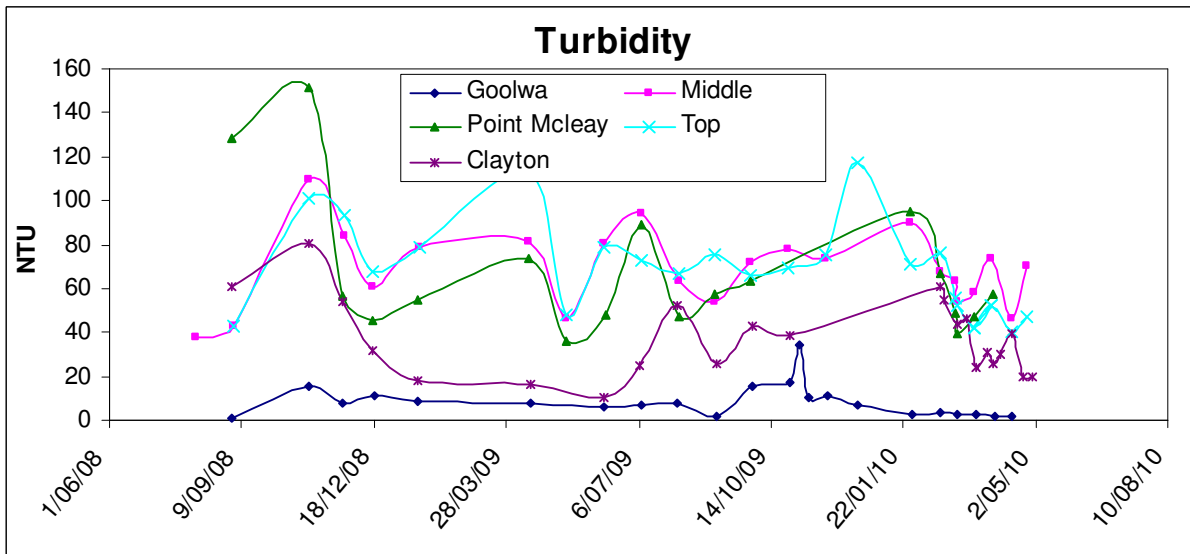
- Turbidity is very variable in Lake Alexandrina and influenced primarily by wind events (Figure 6). The sites at Goolwa and near Clayton appear to have much lower turbidity than the other sites at present. This is likely to be due to less current and wind-driven re suspension of sediment as a consequence of the Clayton regulator being in place. The aggregation and settling of suspended particles is also likely to be increased by the high salinities at these two sites (Figure 4).

Figure 6 – Turbidity at the Lake Alexandrina ambient monitoring sites

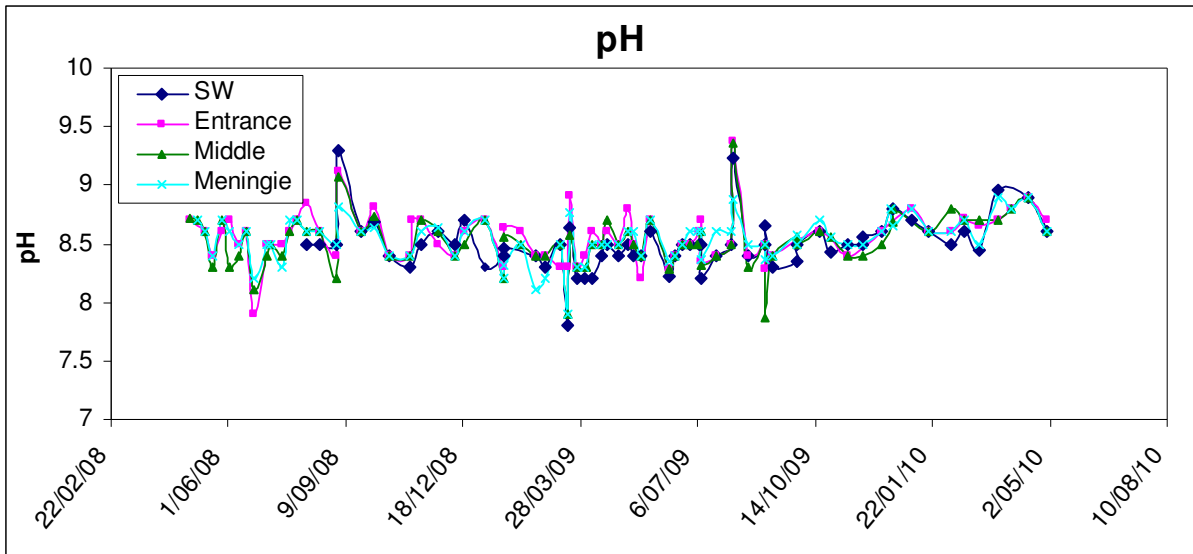
- pH levels are stable and within ANZECC guideline levels (pH 6.5-9.0) at all sites in the main Lake Albert water body (Figure 10).

Figure 10 – pH at the Lake Albert ambient monitoring sites

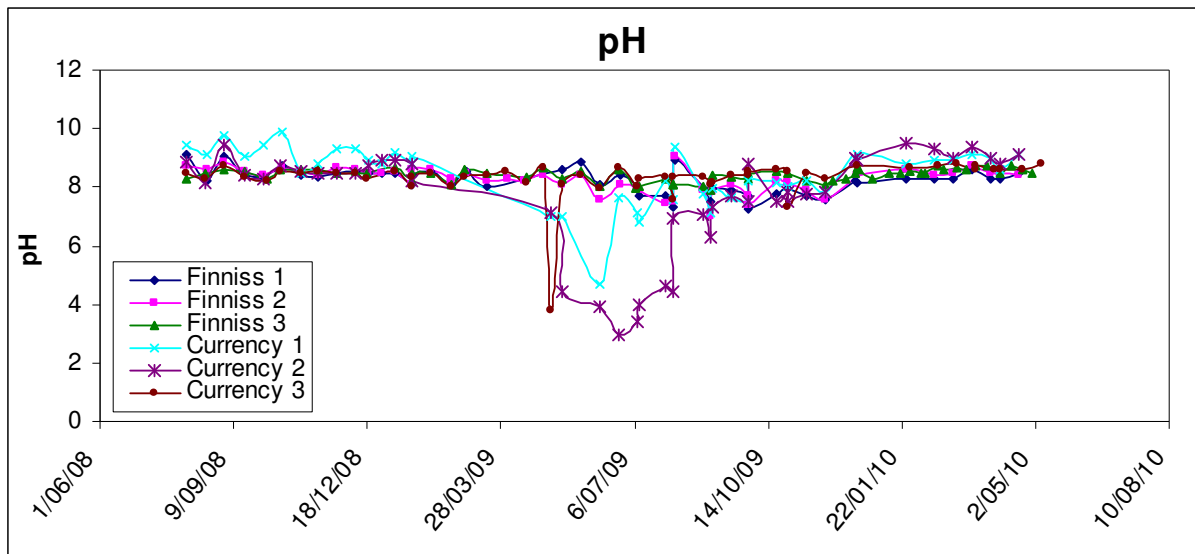
- pH levels are stable and within ANZECC guideline levels (pH 6.5-9.5) at all sites in the tributaries (Figure 18).

Figure 18 – pH at the Tributary ambient monitoring sites

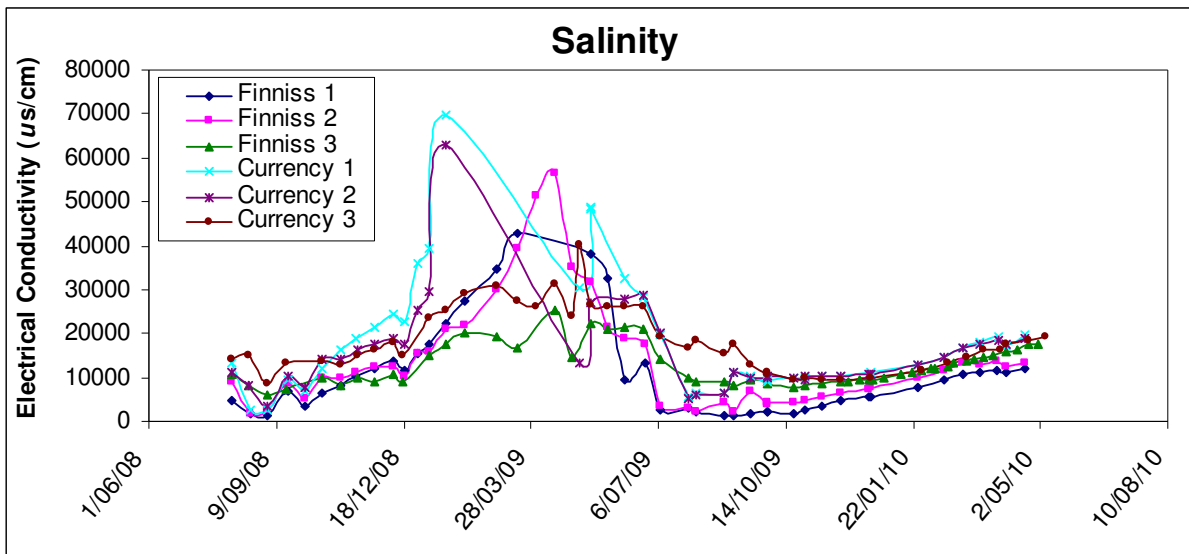
- Salinity is still increasing at all sites due to concentration by evaporation (Figure 20). This area is not receiving any dilution from the recent increased river inflows to Lake Alexandrina due to the physical restriction of the Goolwa Regulator.

Figure 20 – Salinity at the Tributary ambient monitoring sites

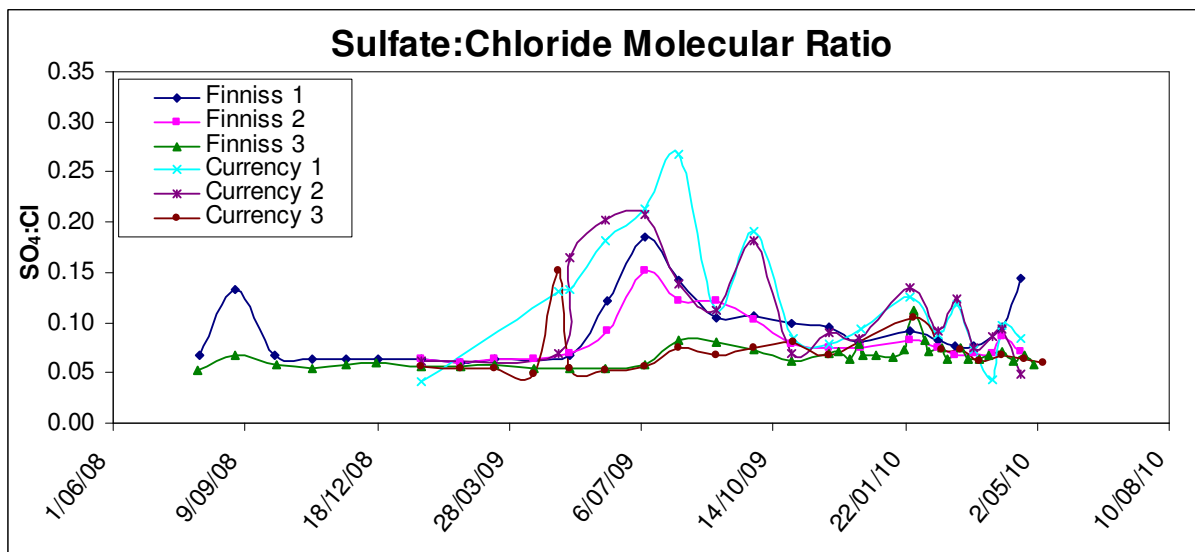
- The sulfate:chloride ratio shows some variability but is not showing any clear increasing trends that would suggest widespread acid sulfate soil inputs (Figure 21). Previously, during the winter of 2009, there were large increases in this ratio when the Currency region acidified.

Figure 21 – Sulfate:chloride molecular ratio at the Tributary ambient monitoring sites

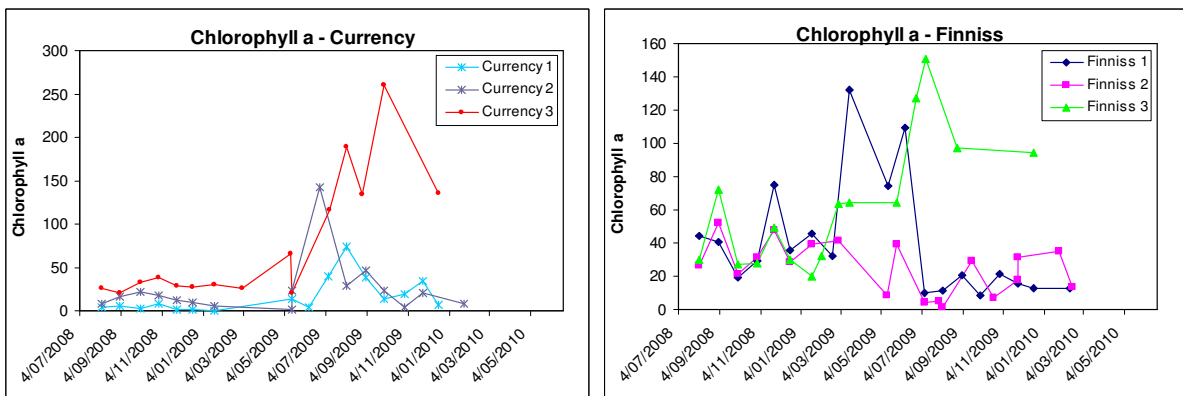
- Chlorophyll *a* is at very high levels at the lower tributary sites (Figure 25). These levels are well in excess of the ANZECC guidelines (<15 µg/L) and indicate a very nutrient enriched system. No toxic blue-green algal issues are apparent at present. A large increase in filamentous (*Cladophora sp.*) and macro-algal growth (*Stuckenia pectinata*) was observed in this region over the summer of 2009/10, presumably as a result of the greater water clarity allowing more light to stimulate algal growth.

Figure 25 – Chlorophyll *a* at the Tributary ambient monitoring sites

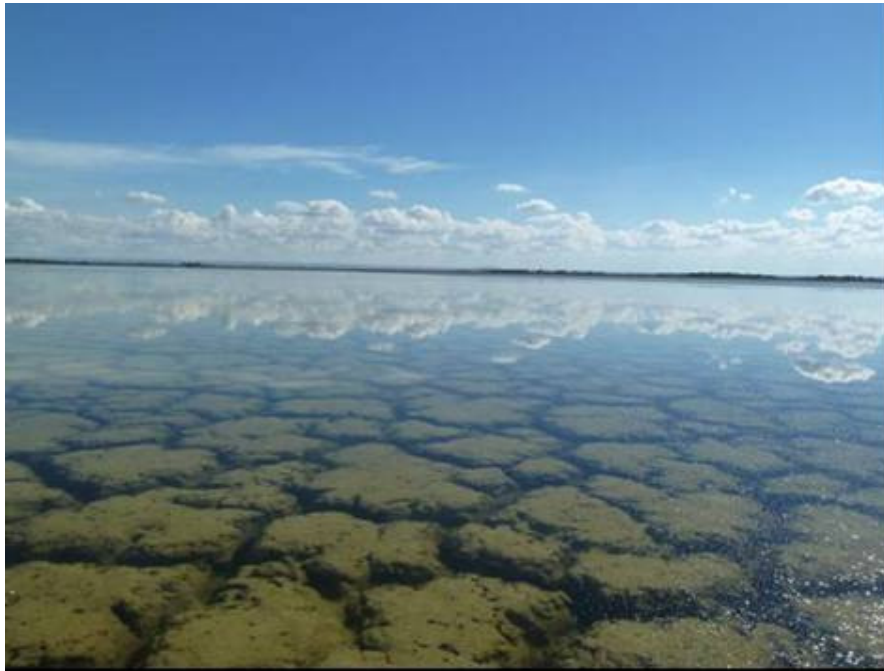
Boggy Lake is a shallow lagoon situated within the north-western corner of Lake Alexandrina. The lagoon is connected to the main water body on its eastern side. During the summer periods of 2008/09 and 2009/10 a large proportion of Boggy Lake dried, exposing acid sulfate soils (predominantly cracking clays) with high net acidity and access to atmospheric oxygen allowing the oxidation of pyrite to occur.

The oxidation of pyrite generates acidity (hydrogen ions, dissolved iron) in the soil. If severe acid conditions ($\text{pH} < 4$) develop in the soil, precipitation of secondary acidic minerals (e.g. Jarosite) often occurs and weathering of alumino-silicate (e.g. clay) minerals is enhanced. High concentrations of soluble aluminium are a common outcome of this weathering process.

Following recent rainfall events and increased flows, Boggy Lake has been rewet and progressively inundated (Figure 26).

Figure 26 – Acidified surface water (pH 2-3) overlying cracked clay soils

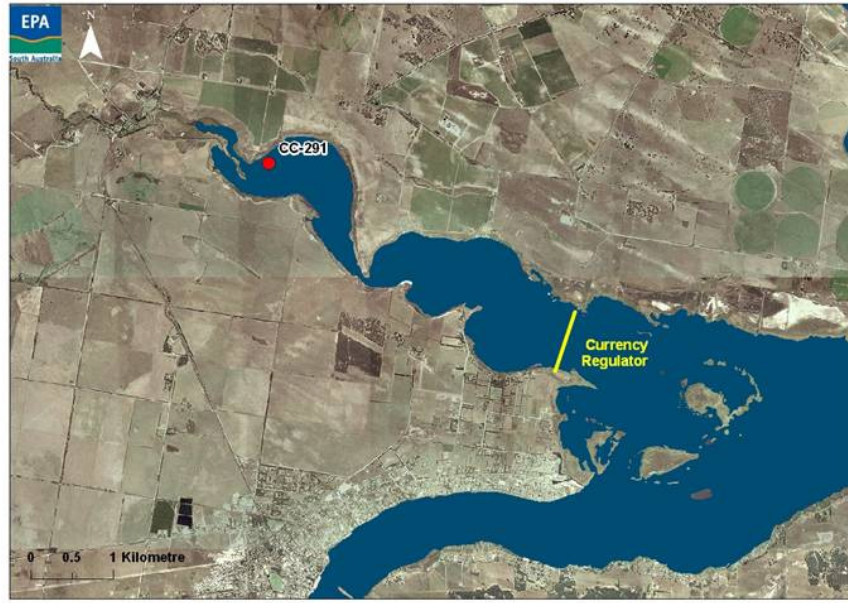
Upper Currency Creek is a large pool representing the transition from the narrow creek to the open waterbody. The pool is constrained by a narrow bottle neck which separates the pool from Goolwa channel (Figure 28). The pool completely dried out over the summer of 2008-09, exposing large areas of acid sulfate soils. Rainfall events in May 2009 allowed pooling over the acid sulfate soils, causing areas of localised acidification. In response to the acidification events, the area was aerial dosed with 1000 tonnes of fine grade limestone. Following the addition of limestone and the construction of a regulator to ensure sediments remain inundated with water, the area recovered somewhat with increasing pH and

Figure 28 – Upper Currency Creek – CC291 indicates main monitoring location

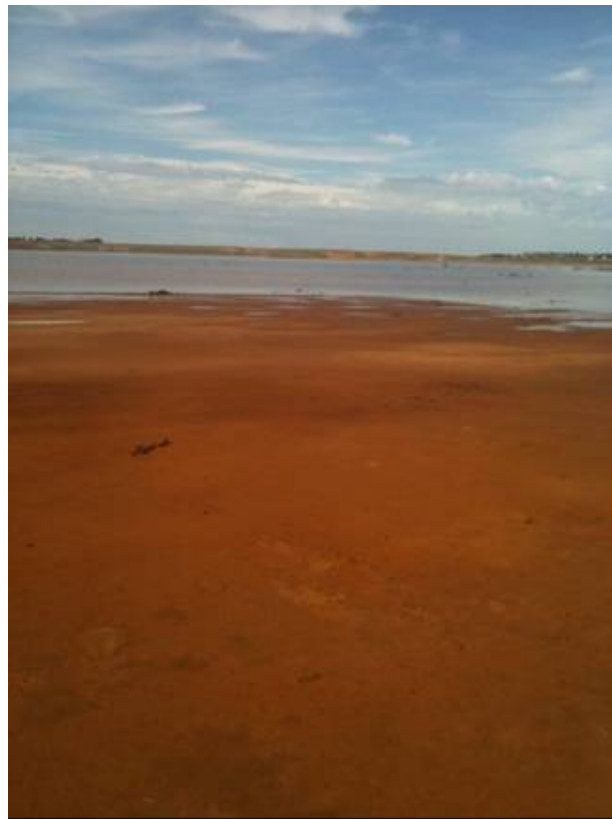
alkalinity (69 mg/L as CaCO₃ on 18/1/2010). However, after the 2009-10 summer, the alkalinity began to decrease again from 40 mg/L as CaCO₃ on 1/4/2010 to 11.5 mg/L as CaCO₃ on 17/5/2010. Large areas of orange/brown precipitate have been observed around the north-western side of the pool (see Figure 29) which is suspected to be an iron oxide precipitate indicating a significant acidification event. This site is currently being monitored twice weekly for decreases in alkalinity, the presence of acidity and metal release.

Figure 29 – Red/orange precipitate on the shoreline of Upper Currency Creek near monitoring location

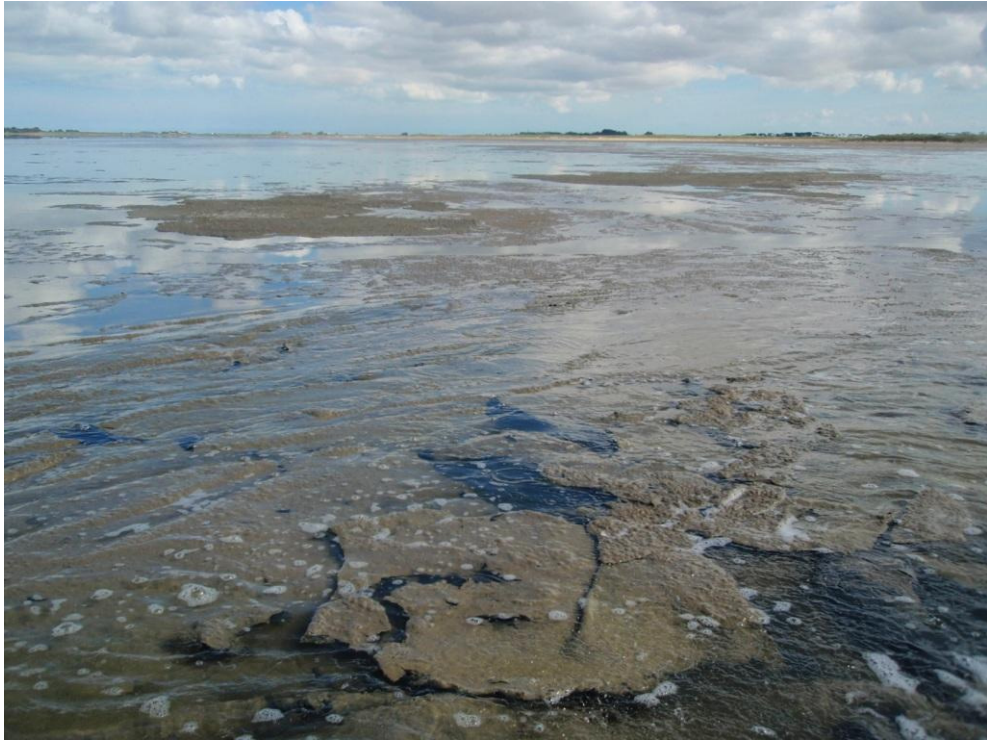
Figure 31 - Photos of water acidification and scum deposits at Reedy Point, Lake Albert

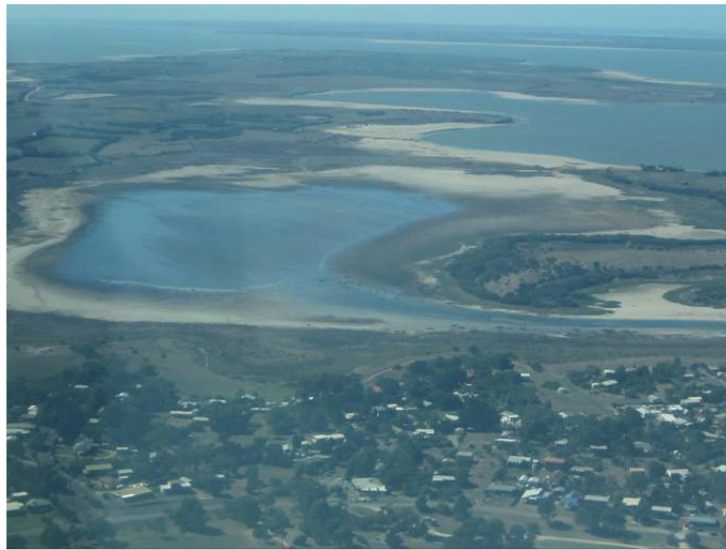
Dunn's Lagoon is near Clayton on the Goolwa Channel (Figures 1 and 32). This lagoon dried during 2008-09 but has been recently rewet as a result of the water level rise. In 2009, acidic surface water was found pooled following a rainfall event, however follow up sampling during March 2010 has found the lagoon pH is now neutral (pH 7-8) at all sites. Decreases in alkalinity have been observed away from the entrance, as the influence of alkaline Lake Alexandrina water reduces. The site closest to the channel entrance records alkalinity of 159-239 mg as CaCO₃, compared to the middle of the lagoon which records low to moderate alkalinities (86-150 mg/L as CaCO₃). This suggests there has been some release of acidity from the soil into the waterbody but currently this is able to be neutralised by dilution via exchange with Lake Alexandrina water. Water exchange has been occurring routinely from the channel near Clayton, but it has been noted that mixing with the main lake via the east channel has also occurred.

Figure 32: Aerial photo of Dunn's Lagoon near Clayton (foreground) in Lake Alexandrina
