Environmental Assessment Works

South Australian Environment Protection Authority

37 - 41 Cliff Street, Glenelg East

Appendix I: Groundwater and Soil Vapour Point Installation Logs

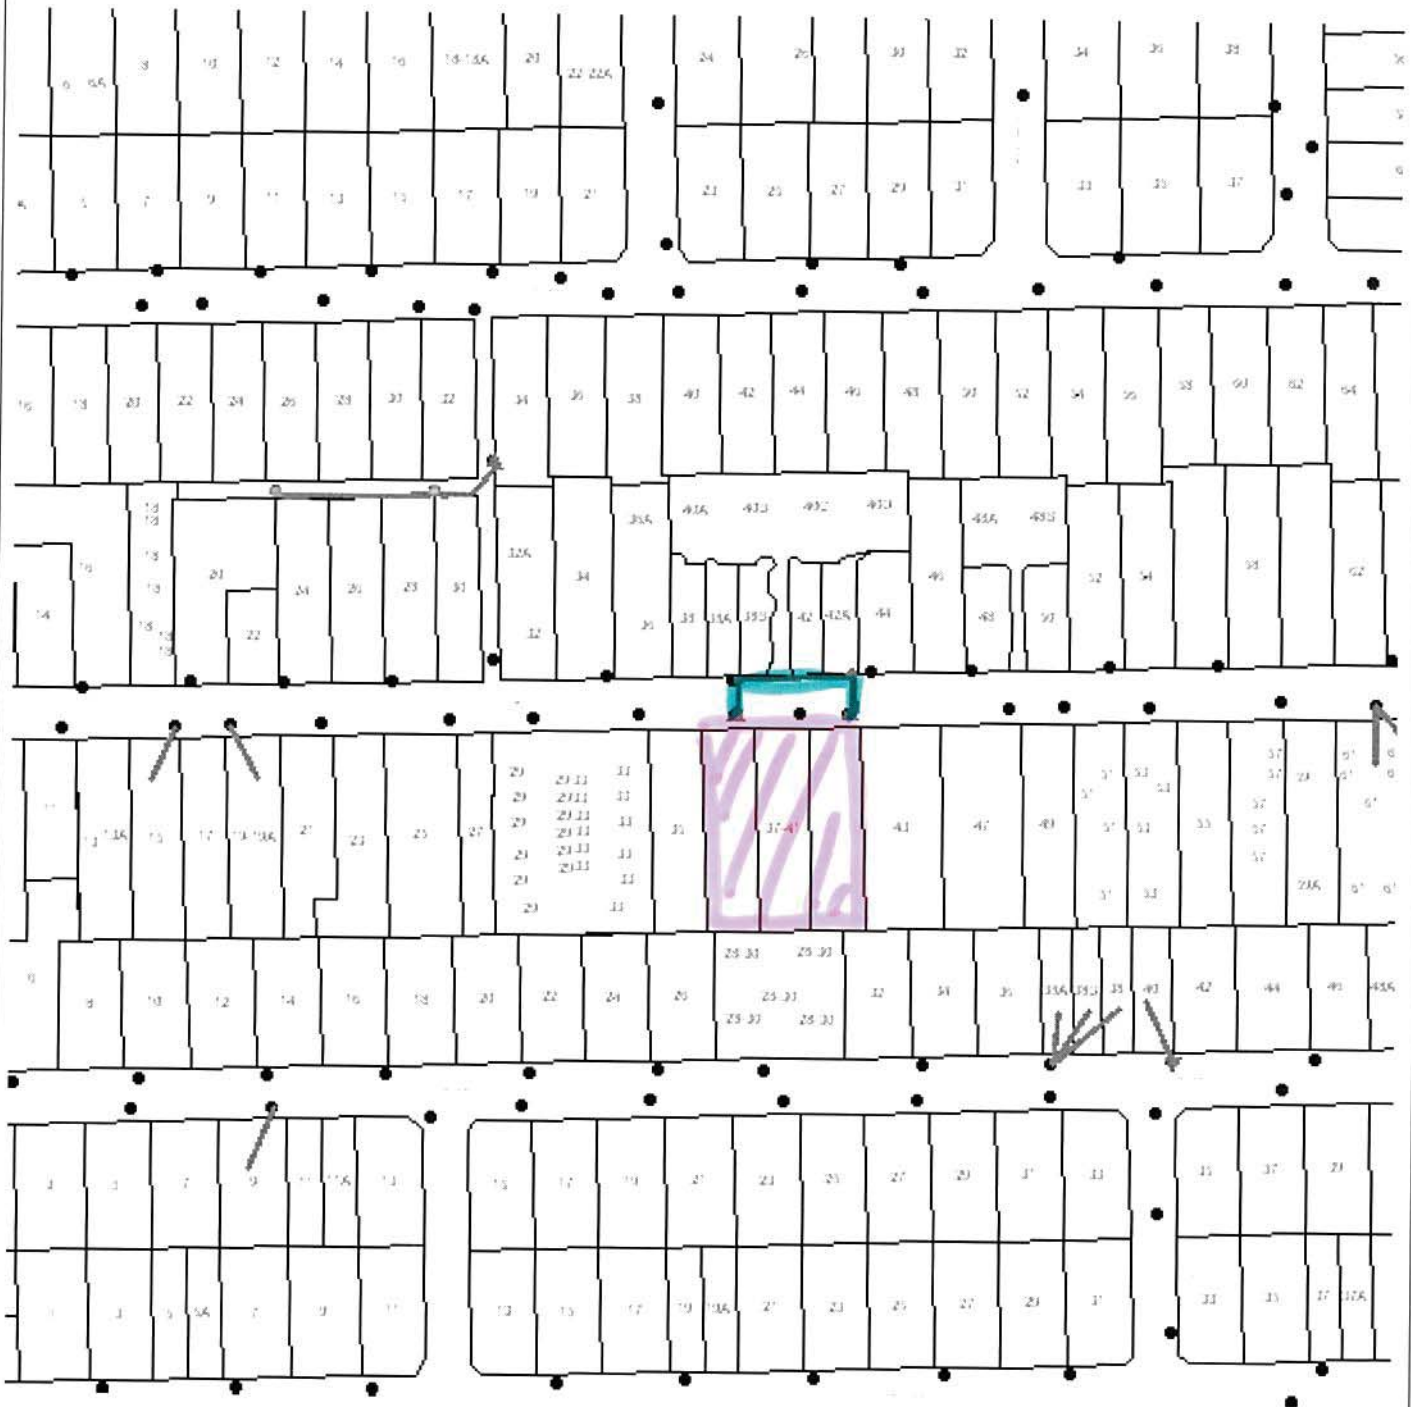
ASSET LOCATION MAP - LOW VOLTAGE

Note: The presence of public lighting columns may indicate additional unidentified cables within the search area

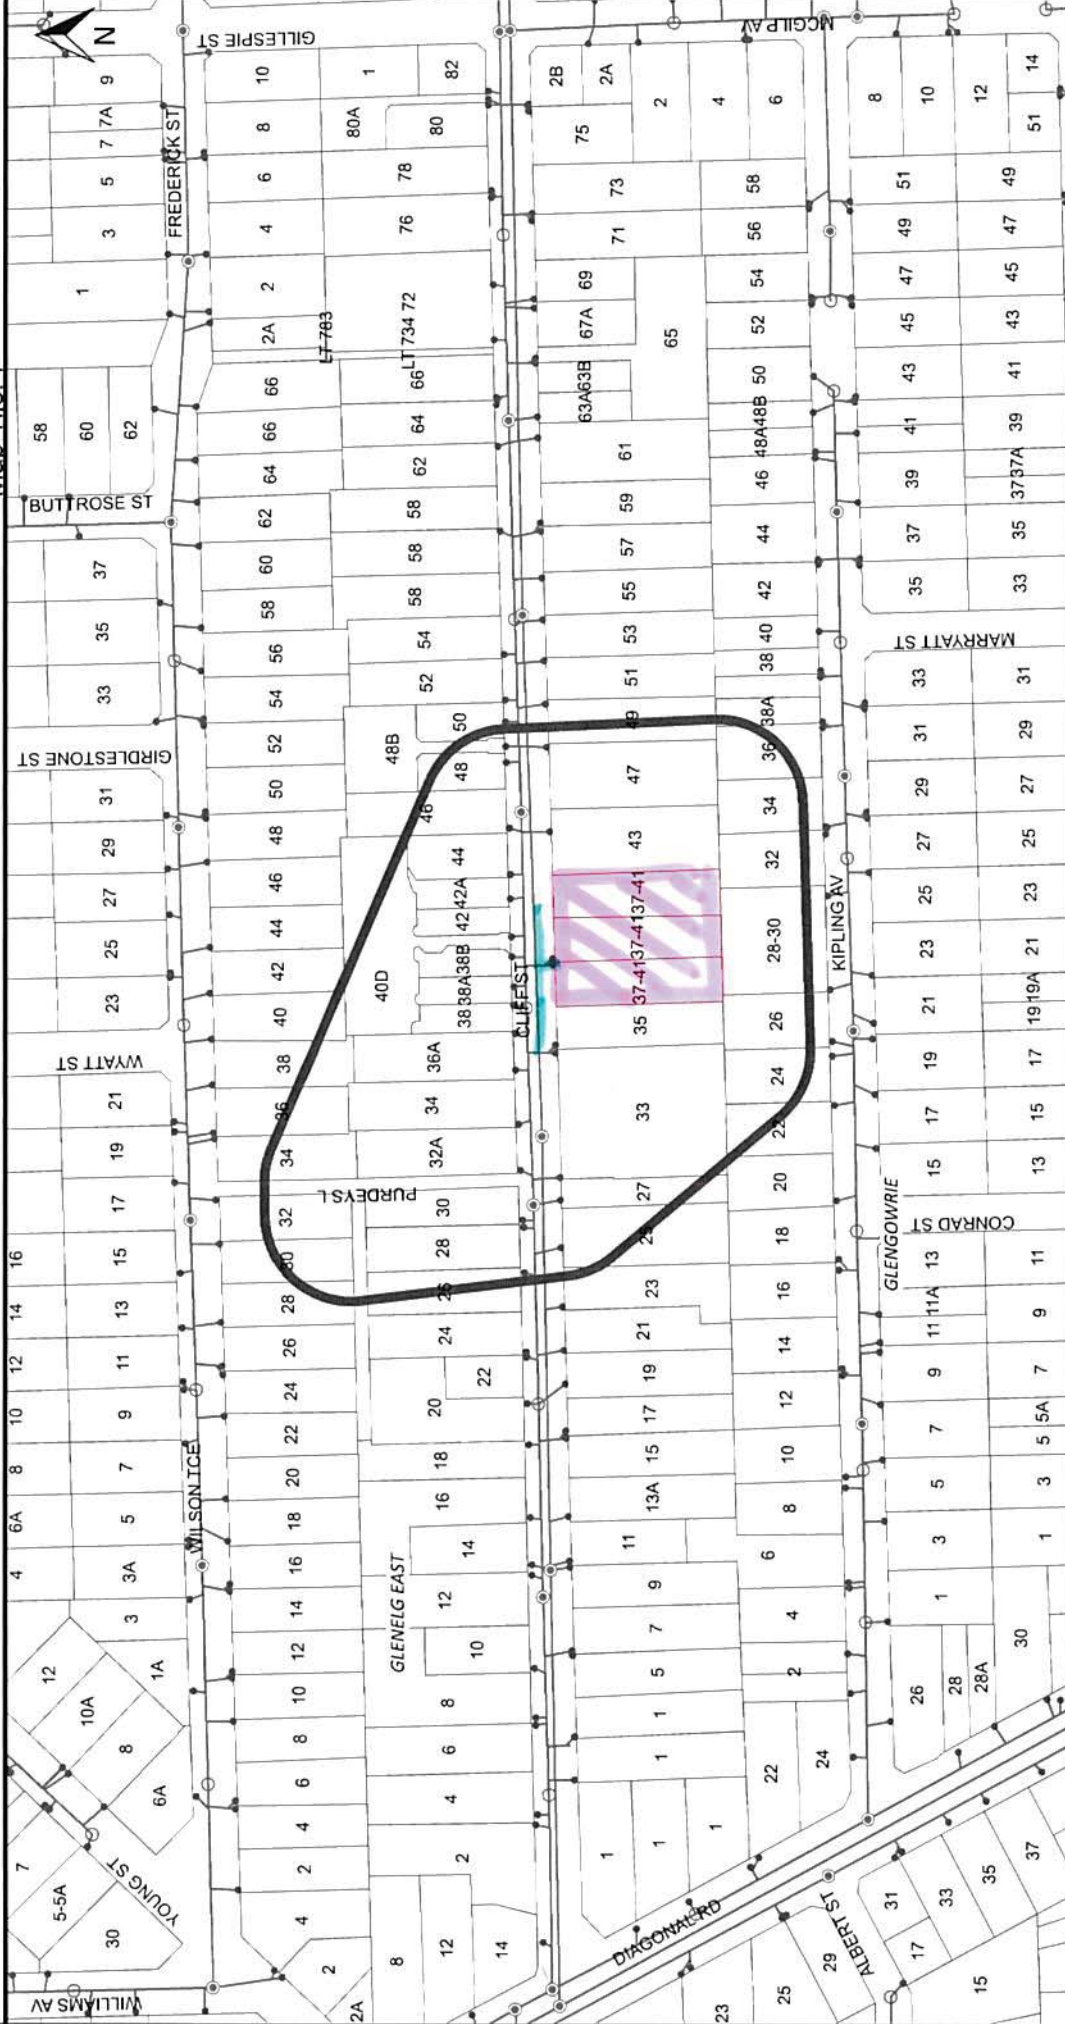
WASTEWATER RETICULATION

DBYD Sequence No: 41675356

Scale @ A4: 1:2500
