Monitoring the recovery of the Tod River following the Eyre Peninsula bushfire of January 2005

Issued June 2008

EPA 799/08: This information sheet provides the results of the monitoring study performed in the Eyre Peninsula following the 2005 bushfire. The Environment Protection Authority studied the effects of the bushfire on the water quality and aquatic invertebrates of the Tod River.

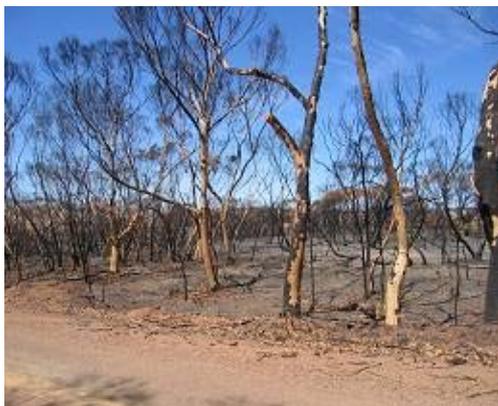
Plate 1 The bushfire destroyed much of the vegetation

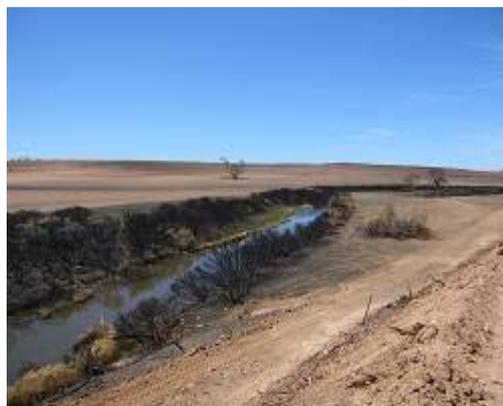
Plate 2 The landscape in some areas became bare with burnt vegetation bordering the river

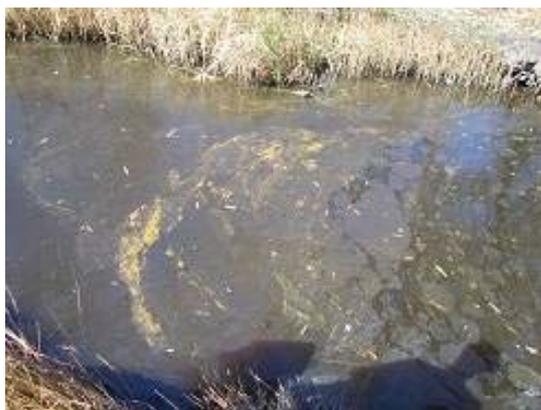
Plate 3 Scum and ash on the water surface of the Tod River near Koppio

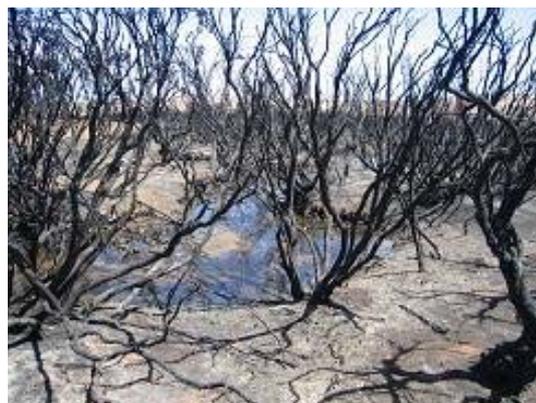
Plate 4 Vegetation along the river bank was destroyed

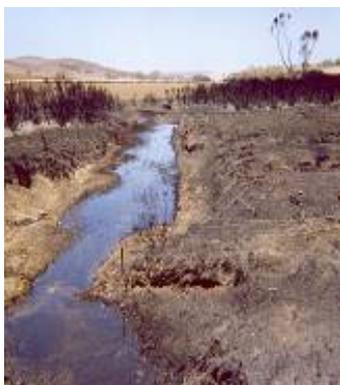
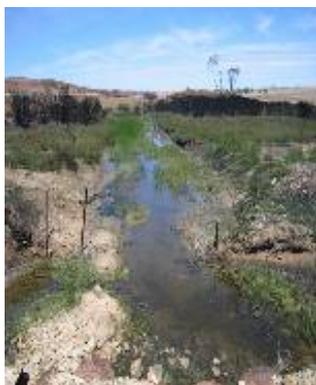
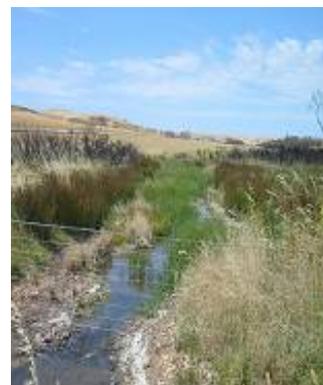
The site at White Flat

While the amount of aquatic vegetation present at each site was not measured, those plant species starting to show signs of significant regrowth were noted, and regular photos were taken of the site to monitor recovery and re-growth along the river bank and within the channel. The plant life was largely destroyed by the fire, as can be seen in the following photos. However, regrowth was rapid and six weeks after the fire a significant amount of emergent aquatic vegetation had returned, especially at the site near White Flat. This rapid re-growth may have been aided by the release of nutrients from the ash

and debris that entered the river during and after the fire. By the end of the year, much of the smaller bank vegetation had returned, with the larger trees and shrubs also starting to show signs of significant regrowth.

The day after the fire
(January 12 2005)

Six weeks later (February
28, 2005)

12 months later (December
21, 2005)

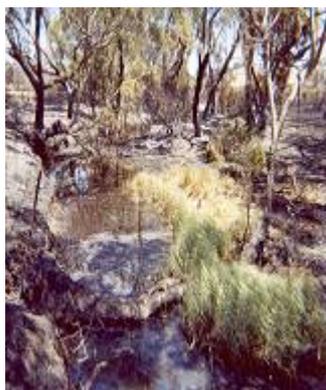
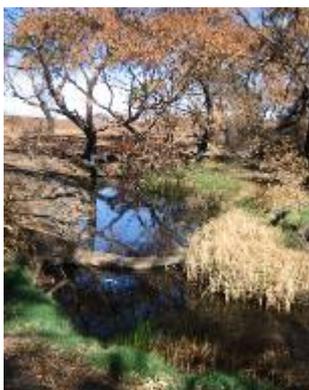
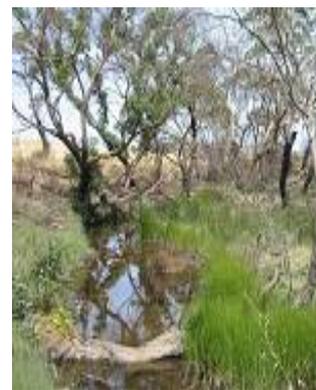
The site at Koppio

The day after the fire
(January 12 2005)

Six weeks later (February
28, 2005)

12 months later
(December 21, 2005)
